# **Traffic Impact Assessment Rio Tinto Rössing Uranium Limited**

## **FINAL REPORT MARCH 2010**

Road Safety Audit Report: Swakopmund to Arandis: Surfaced road B2

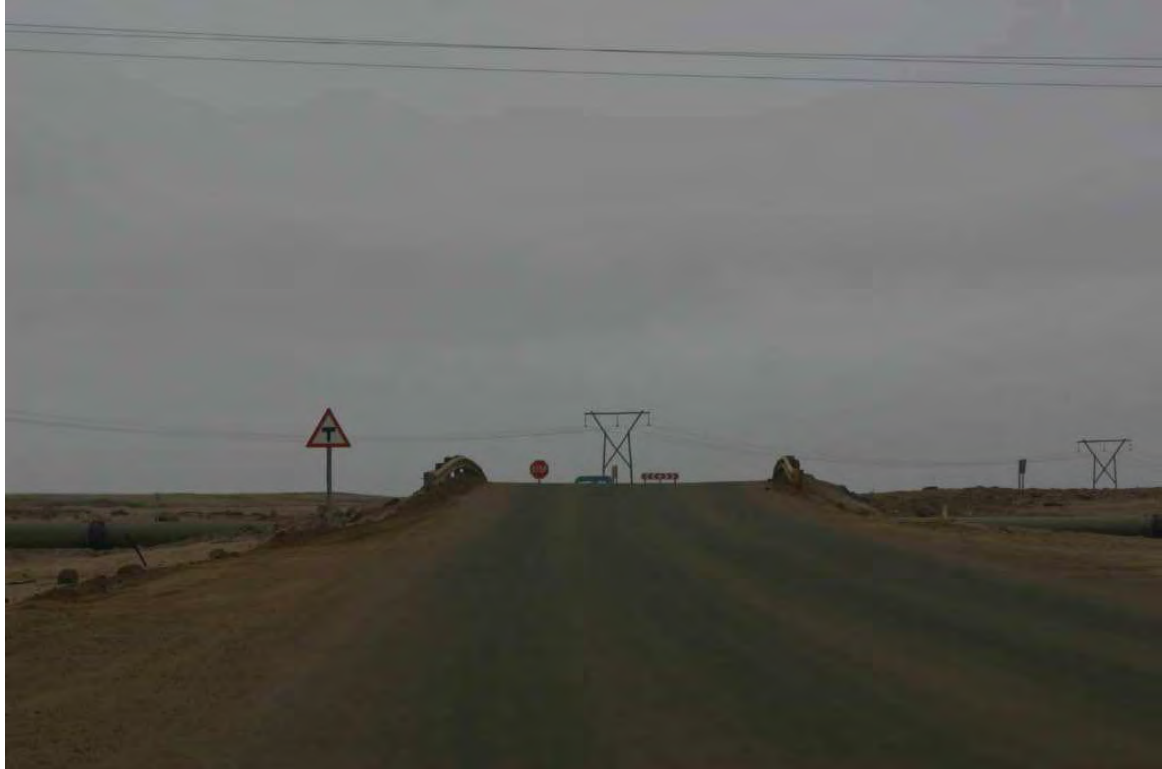
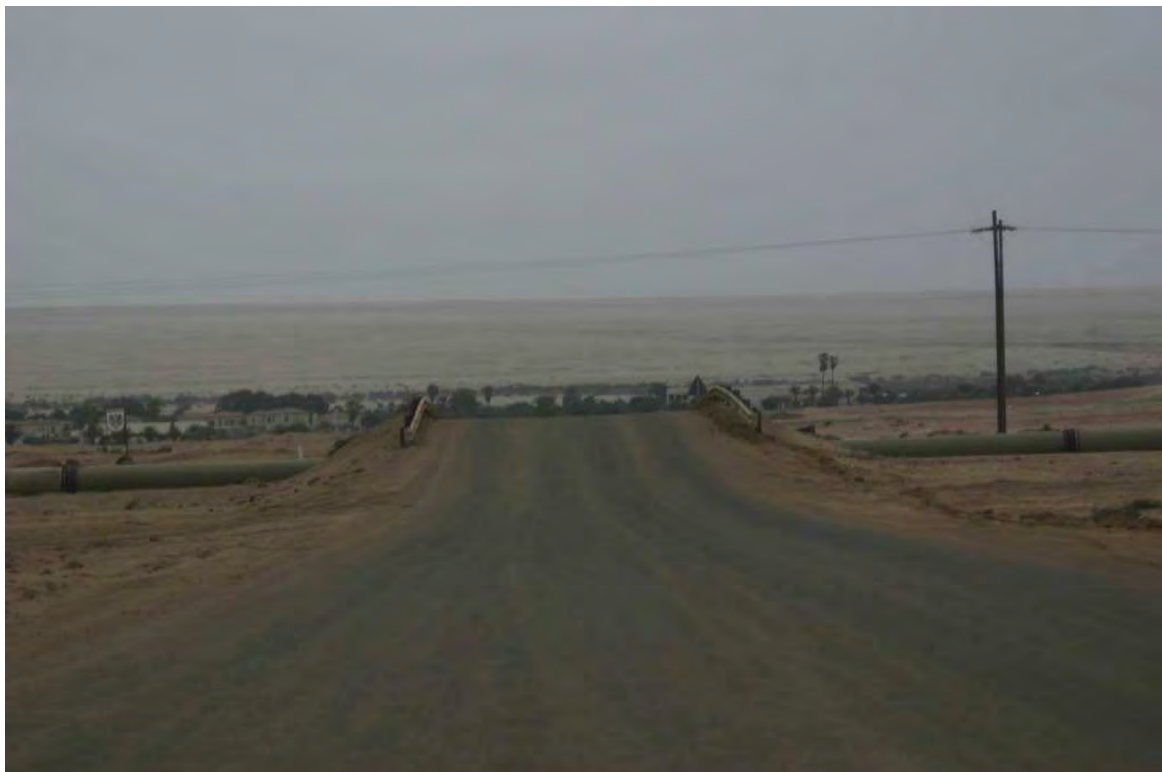
Exhibit 2

Inadequate stopping sight distance at junctions affected by the pipe line on the south side of B2. Also notice sand on the roadway affecting braking and road markings maintenance.

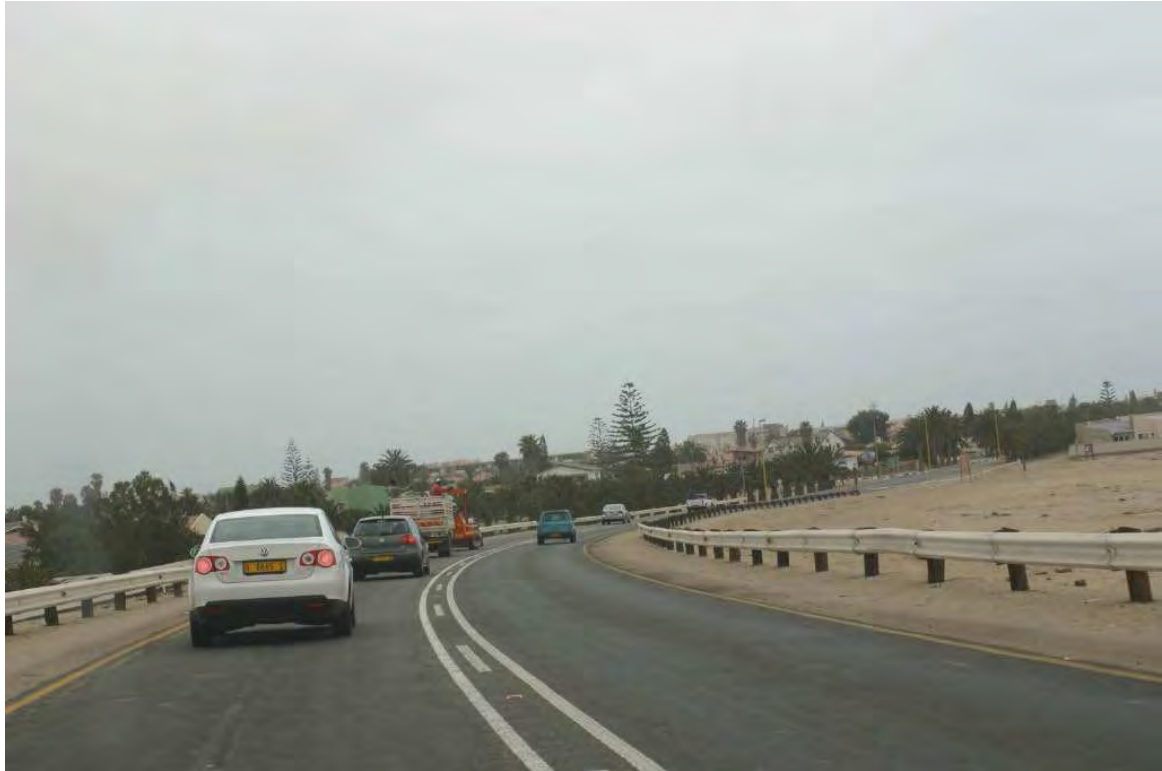
Exhibit 6

Congestion caused by slow moving vehicles. Note illegal over taking.

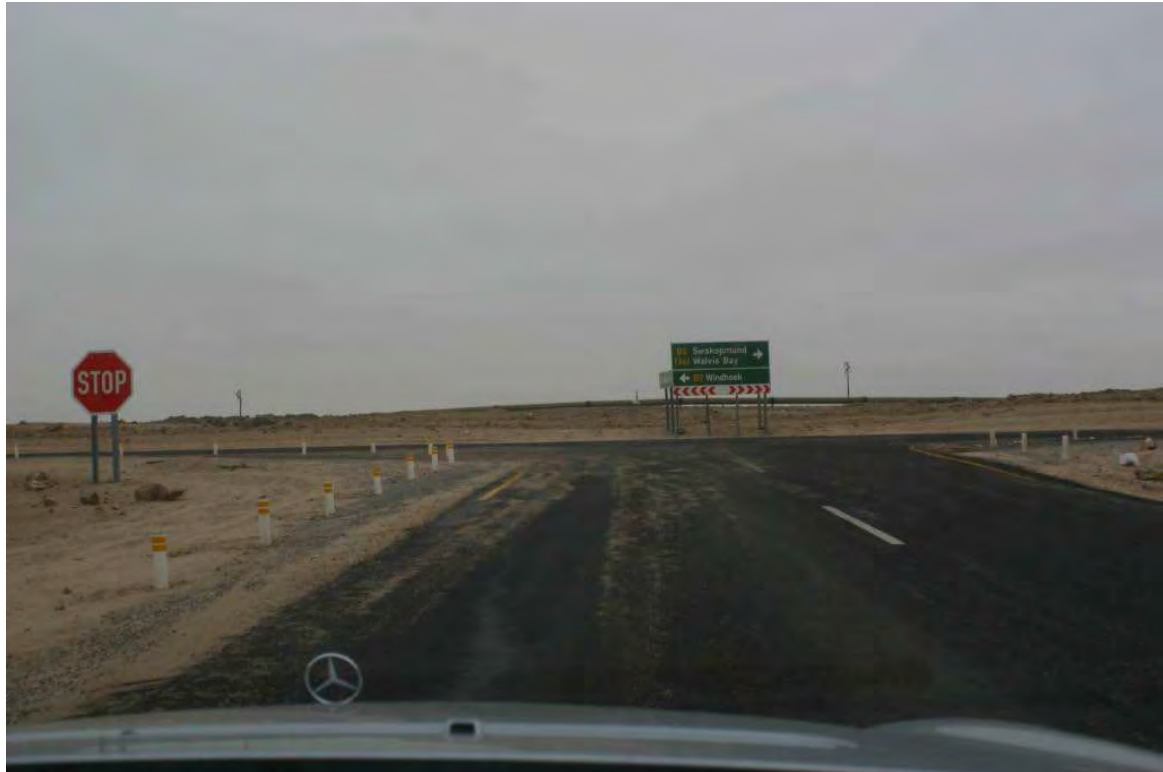
Exhibit 7

Inadequate shoulder widths and / or lack of kerbs at intersections cause sand to be transported on the roadway.

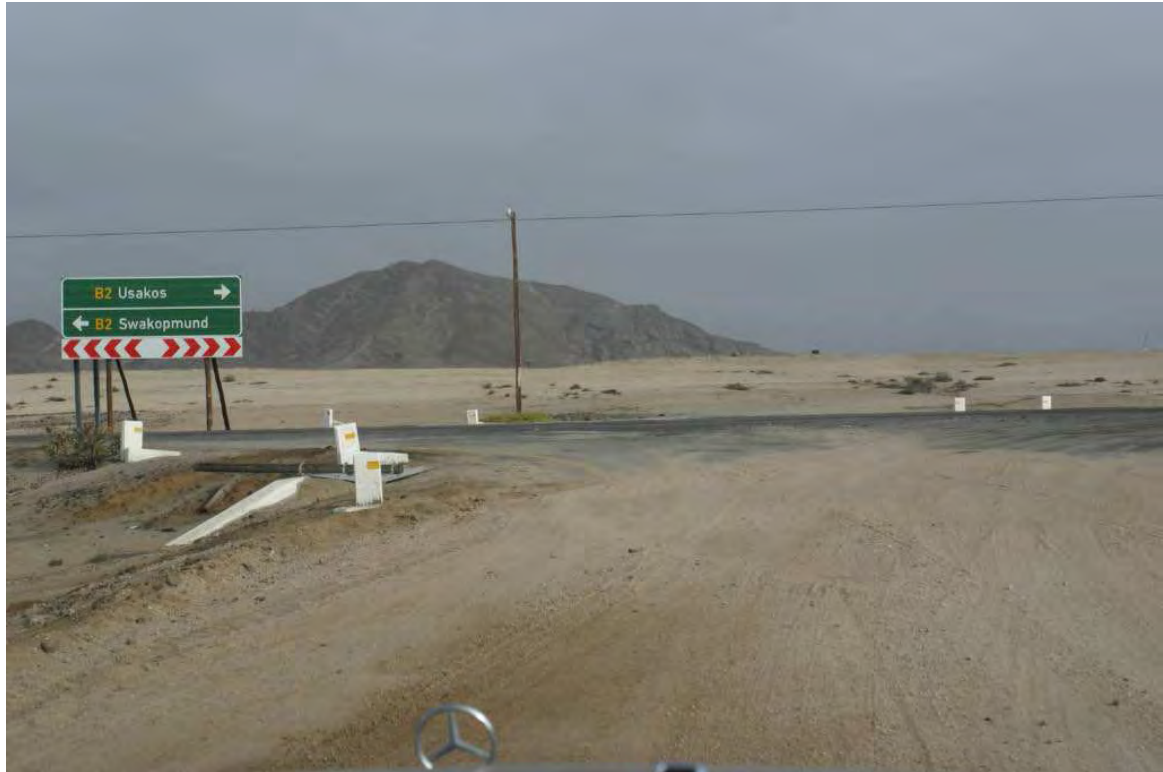
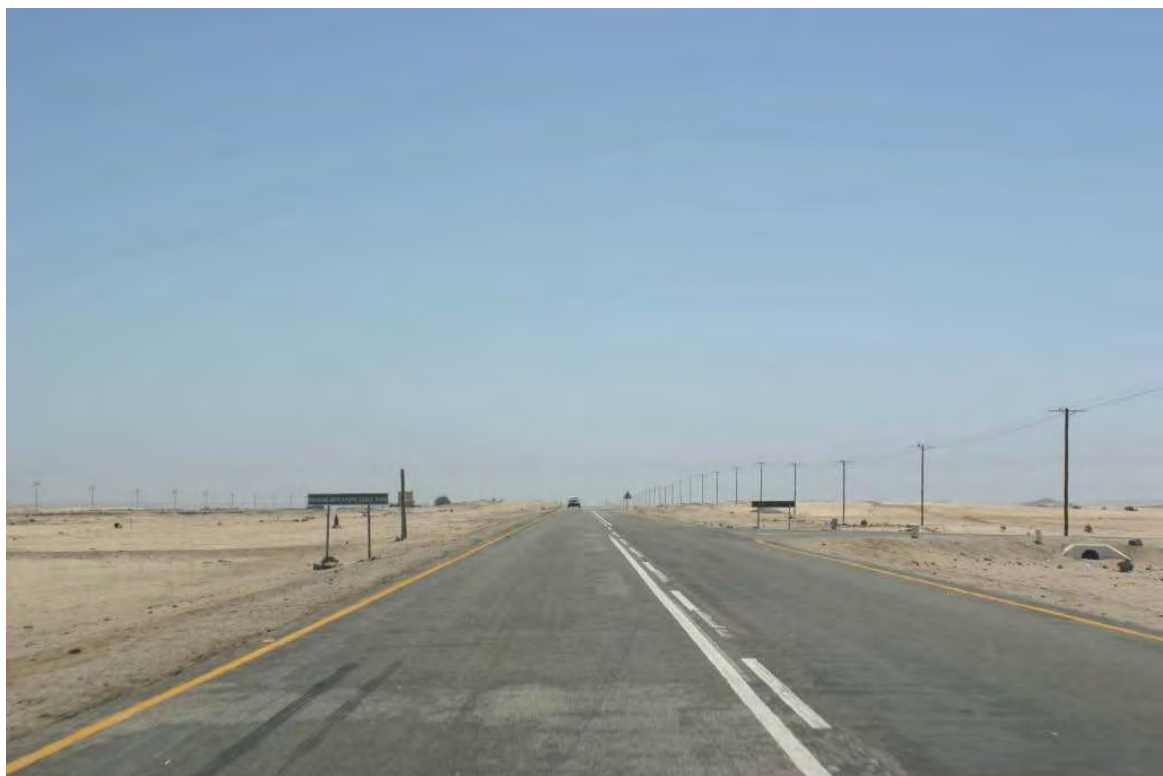
Exhibit 14

Missing signs on the B2: a yield sign lying next to the road and no stop of yield sign on the side road.

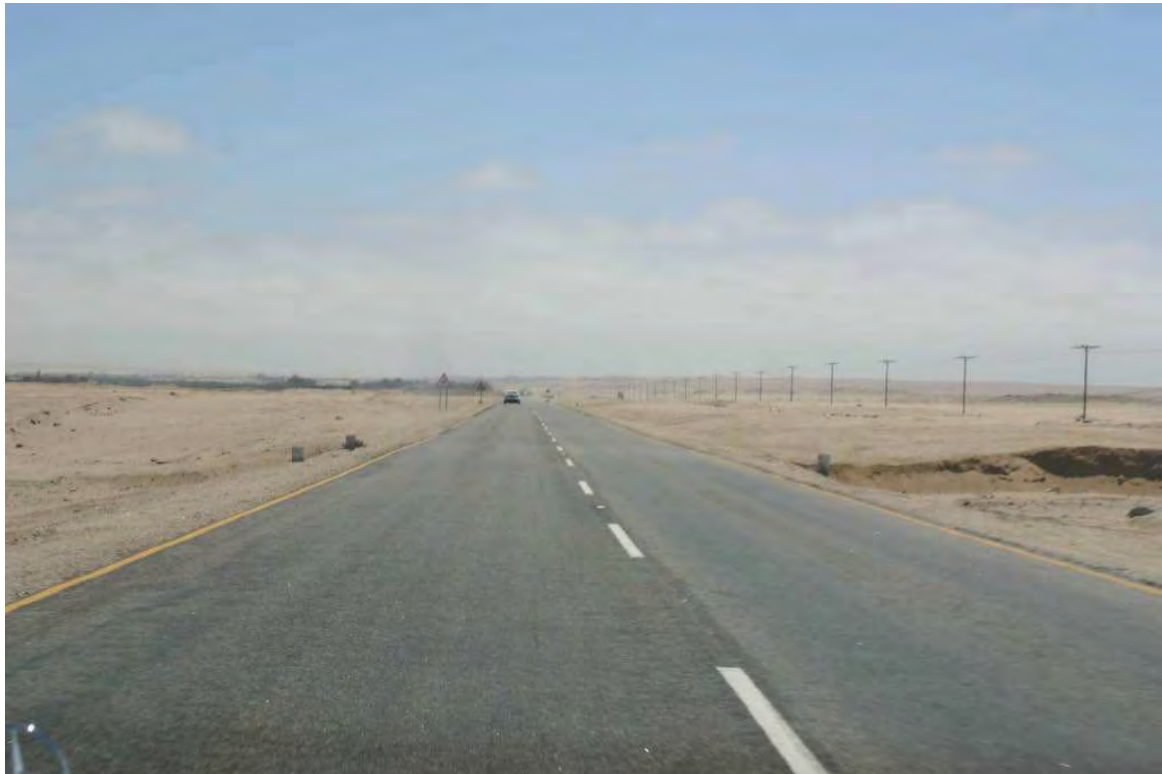
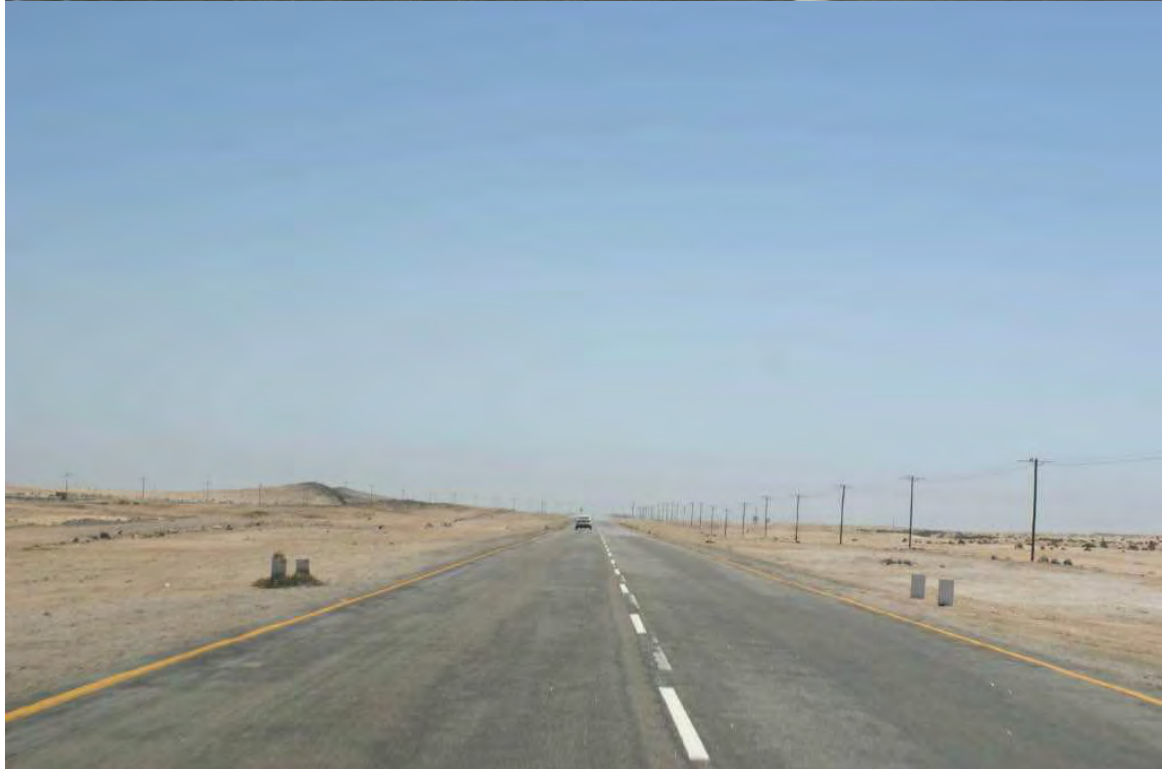
Exhibit 15

The use of hazard markers / delineators at culverts is recommended in favour of the concrete markers which are not as visible and often damaged during shoulder blading.

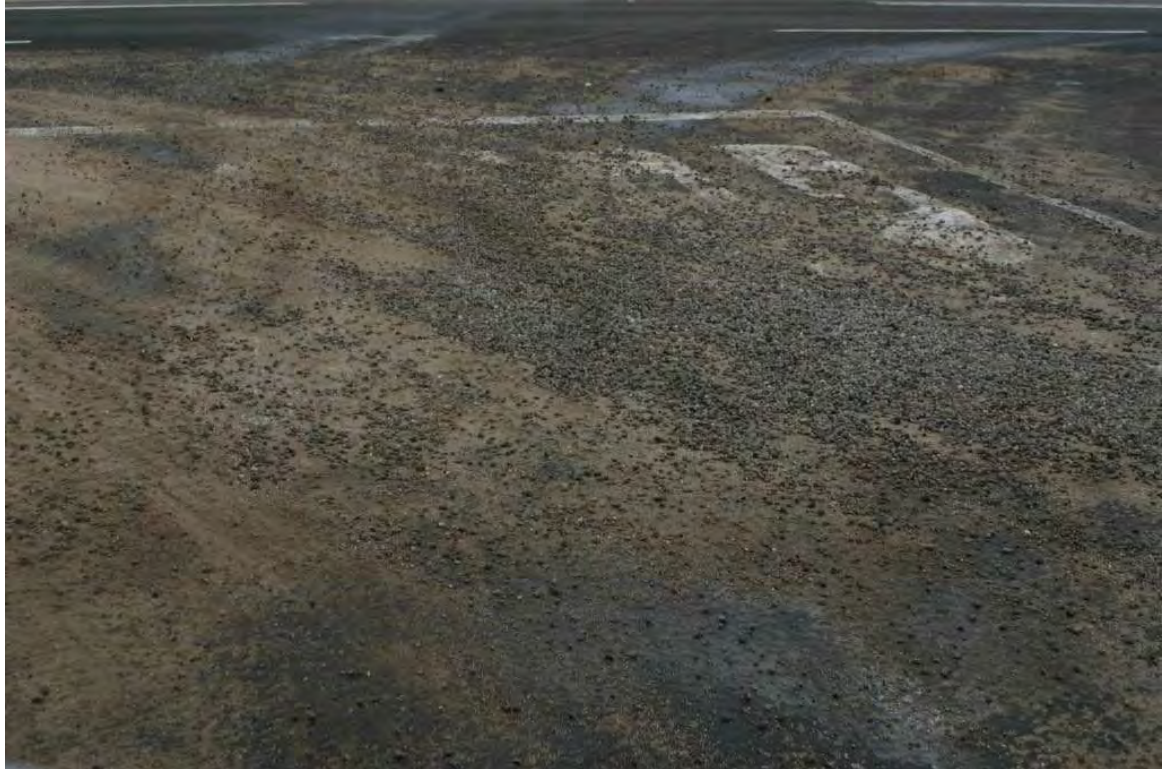
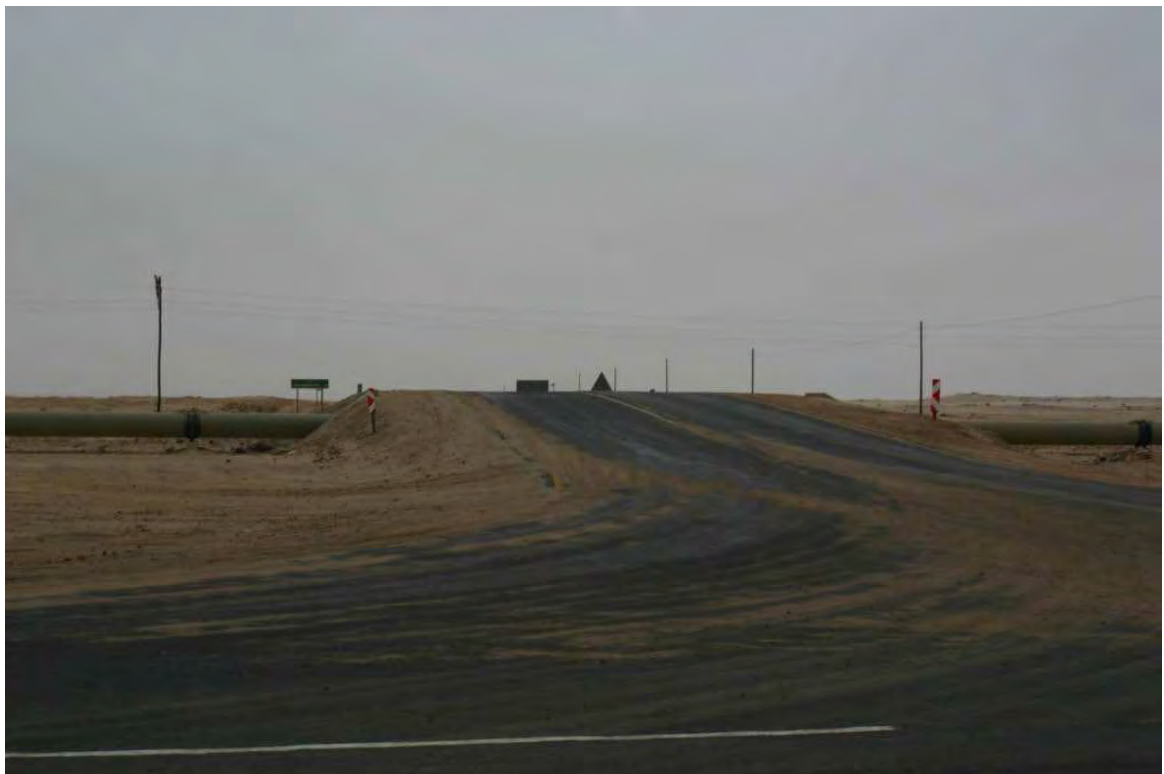
Exhibit 17

Line marking is subject to fading and abrasion. The roadway must be cleaned regularly to prevent damage to markings, and to maintain friction for braking.

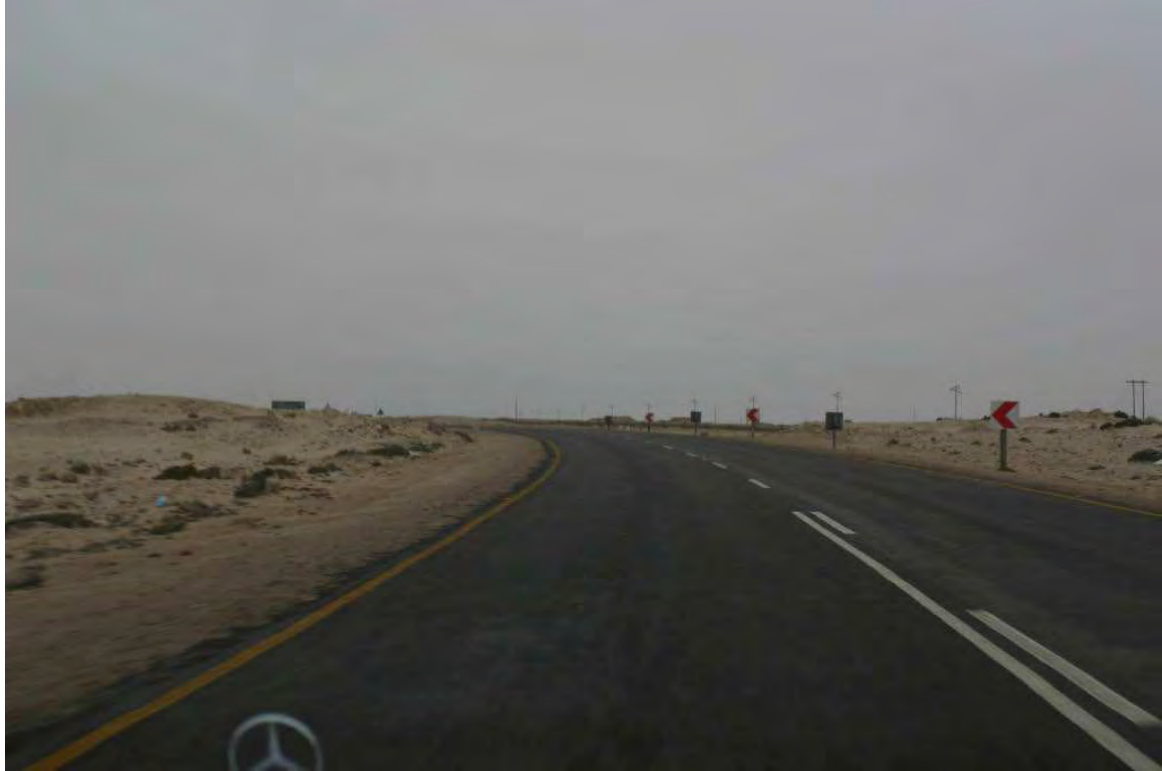
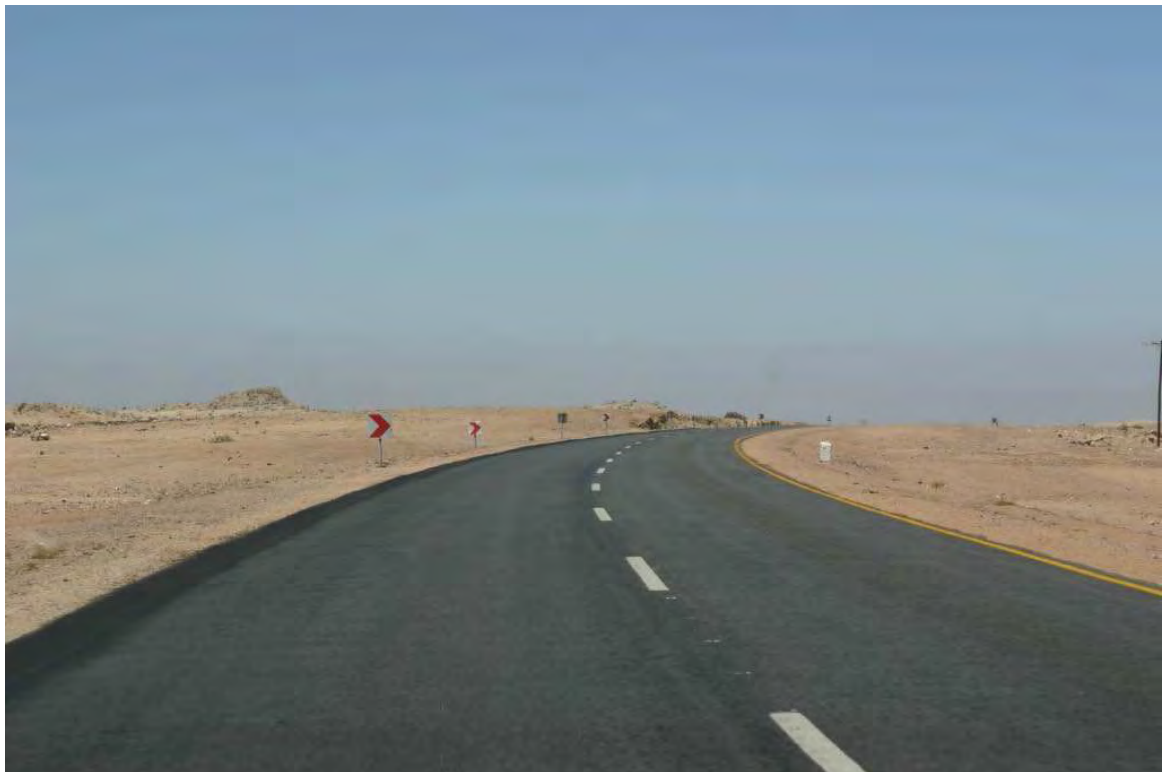
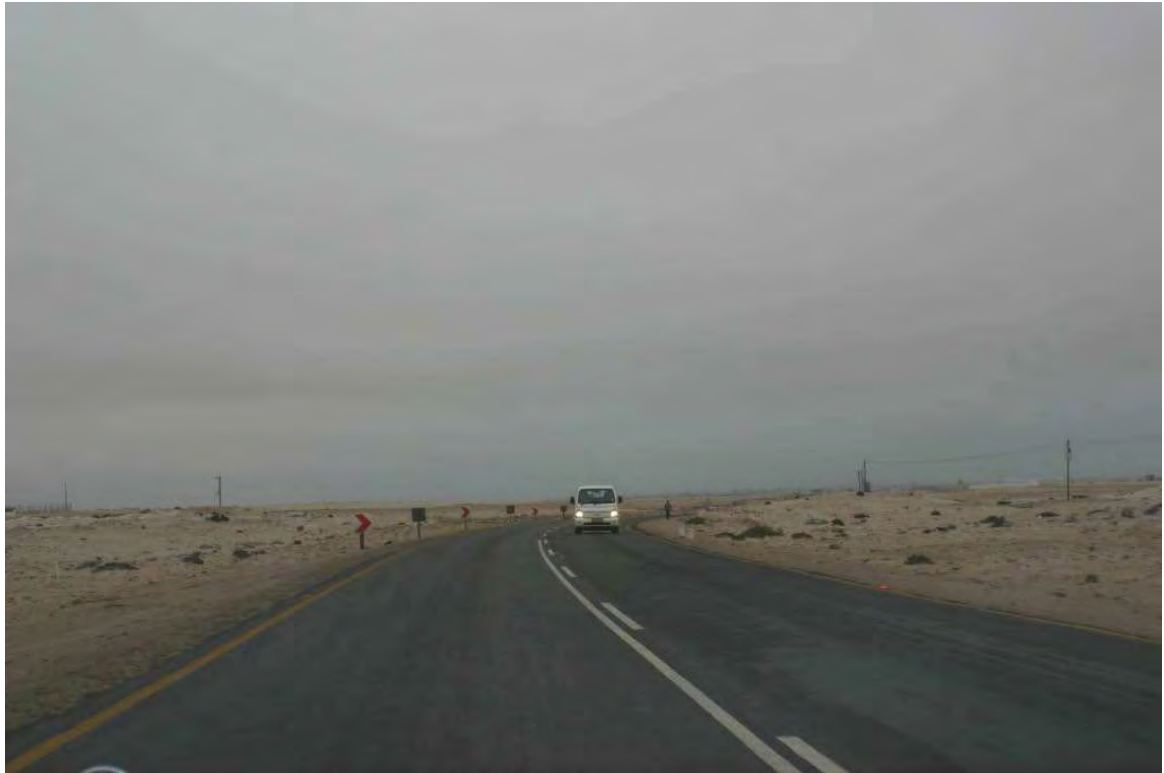
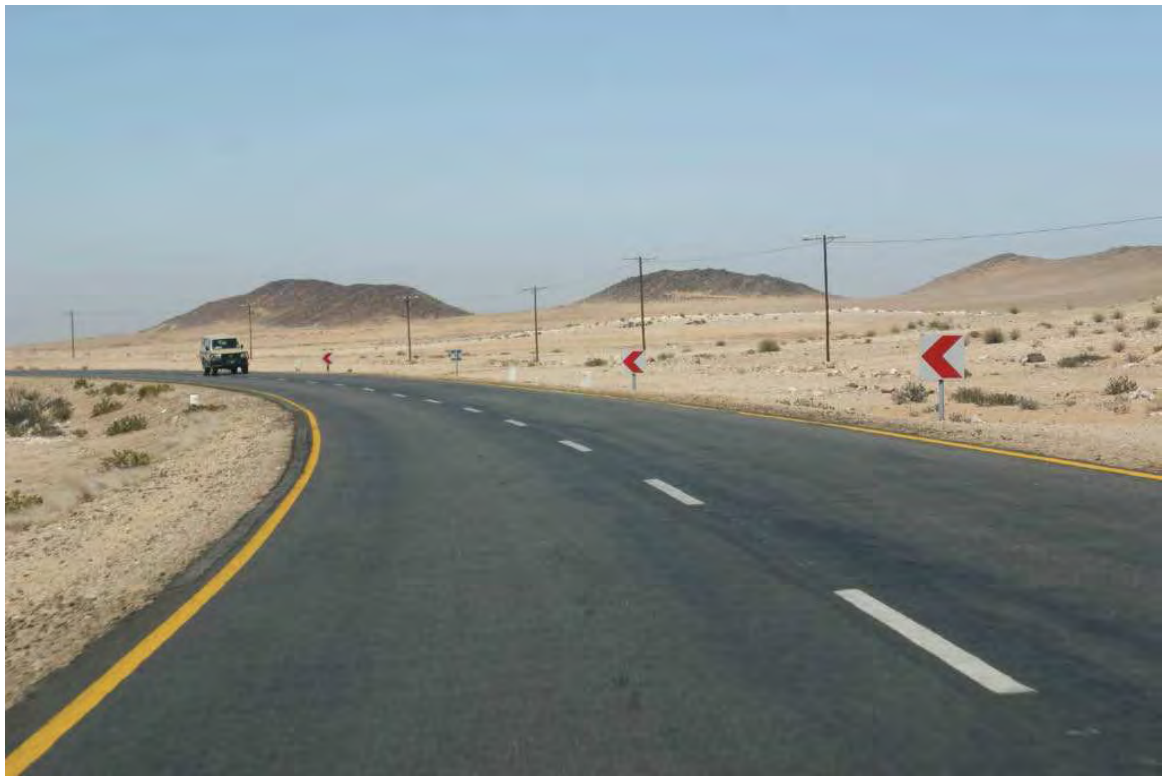
Exhibit 18

No-Overtaking lines of inadequate length or on the wrong side to prevent unsafe overtaking.

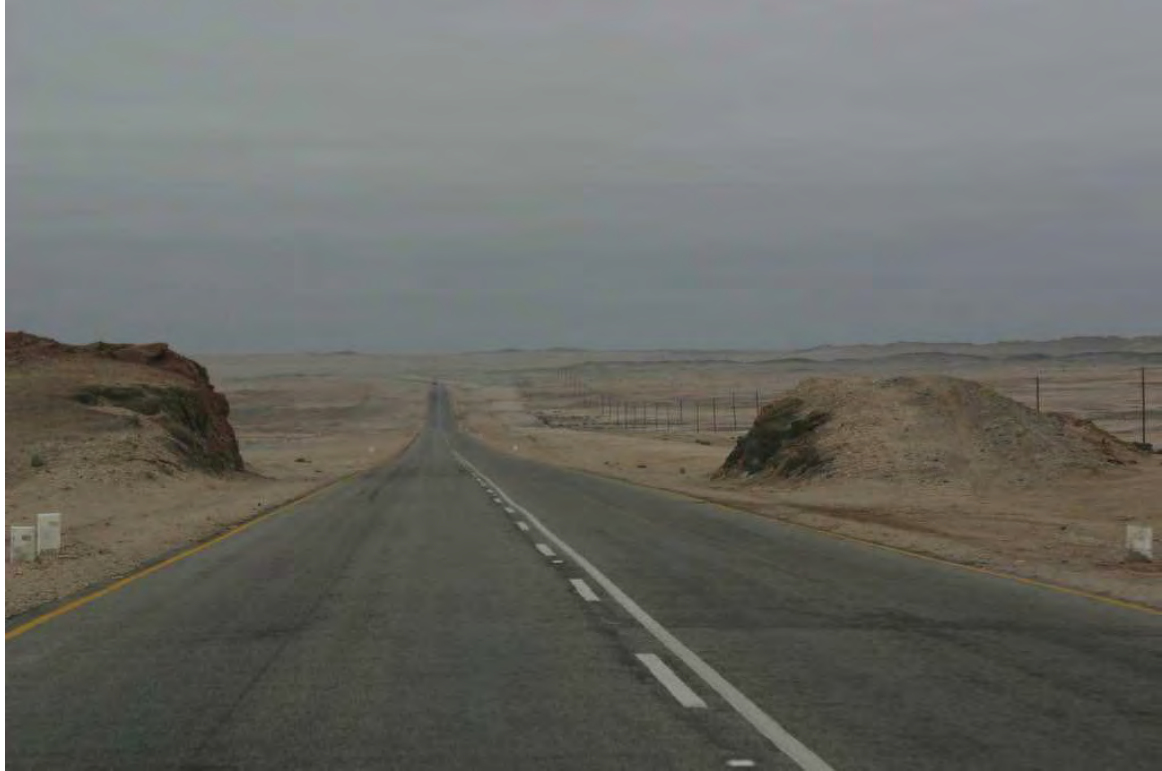
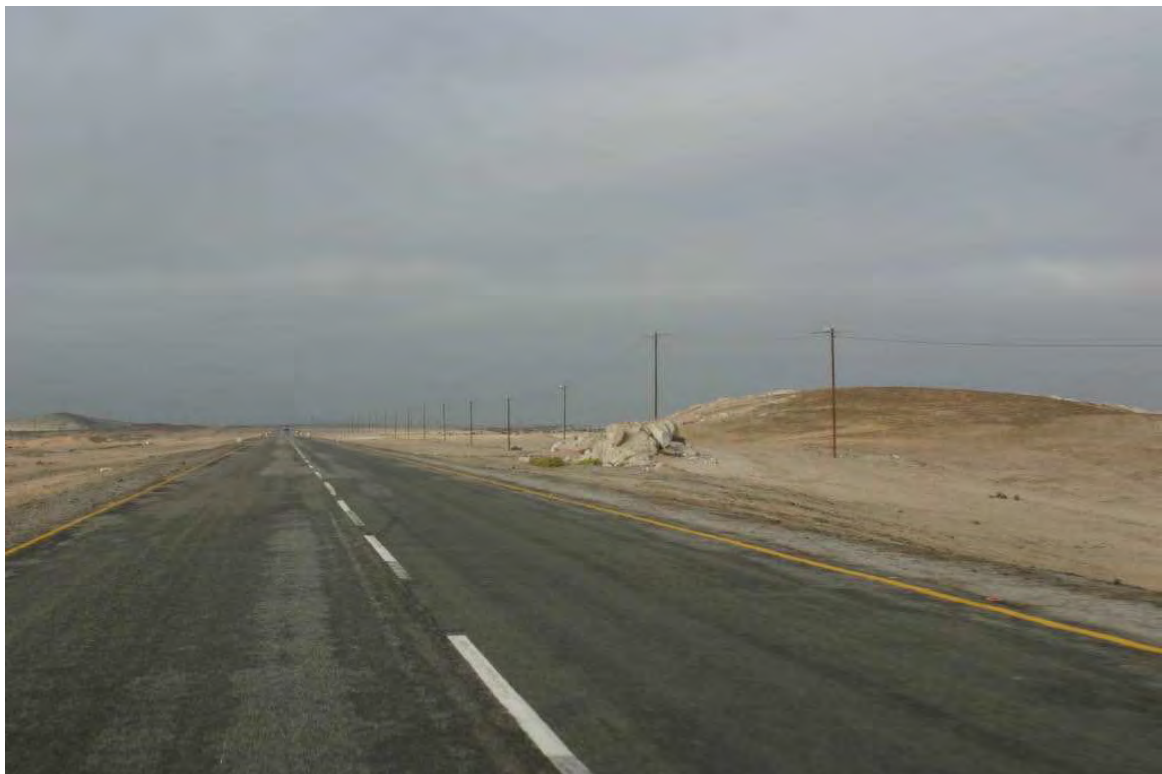
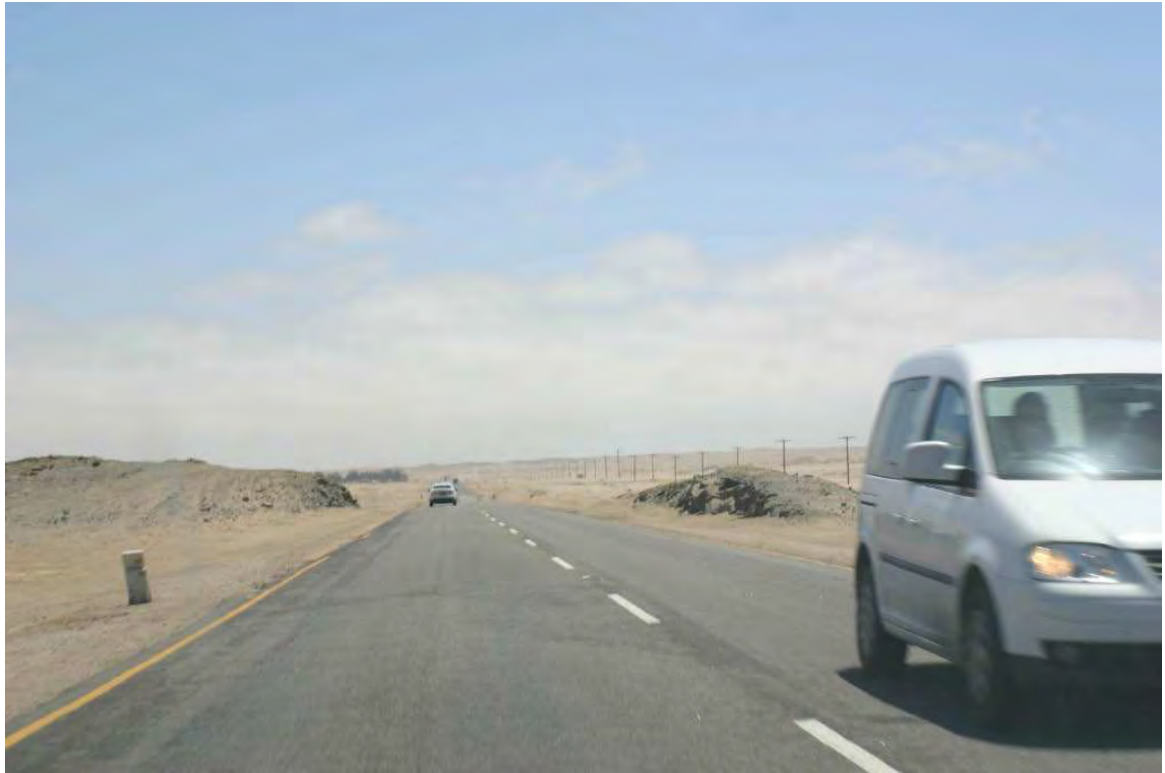
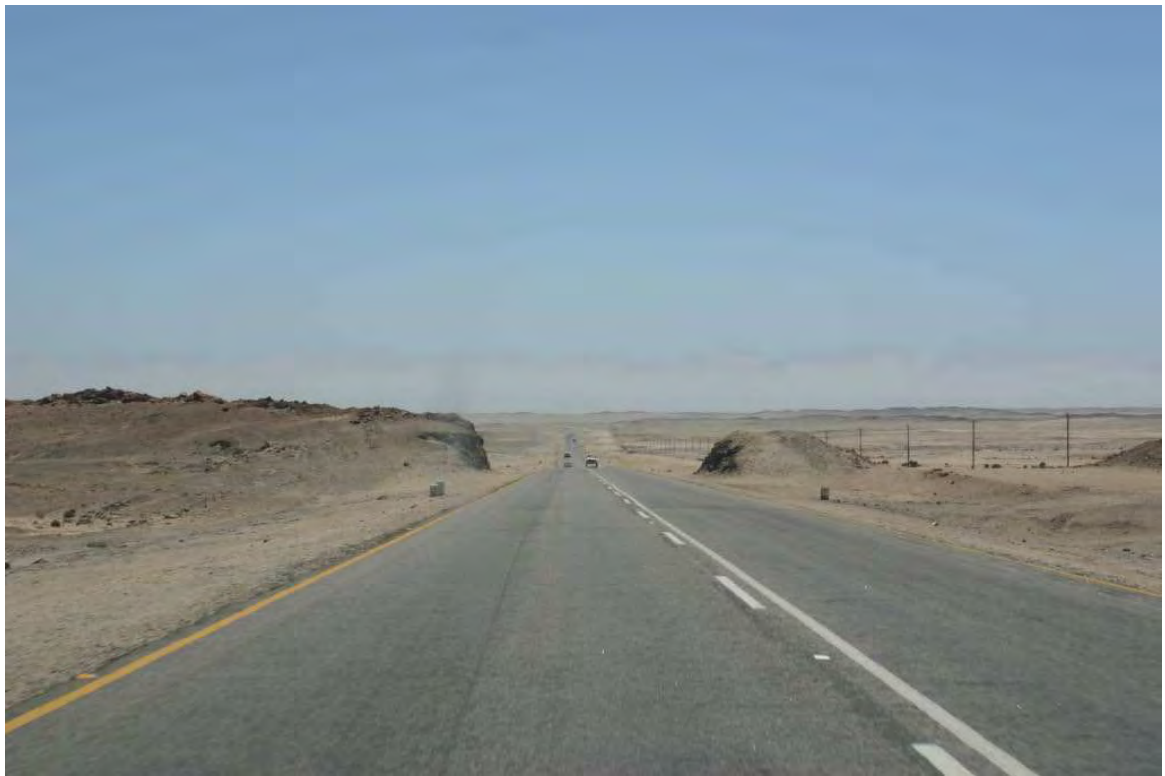
Exhibit 20

Clear zones are affected by local narrow rock cuttings inhibit recovery and pose hazards.

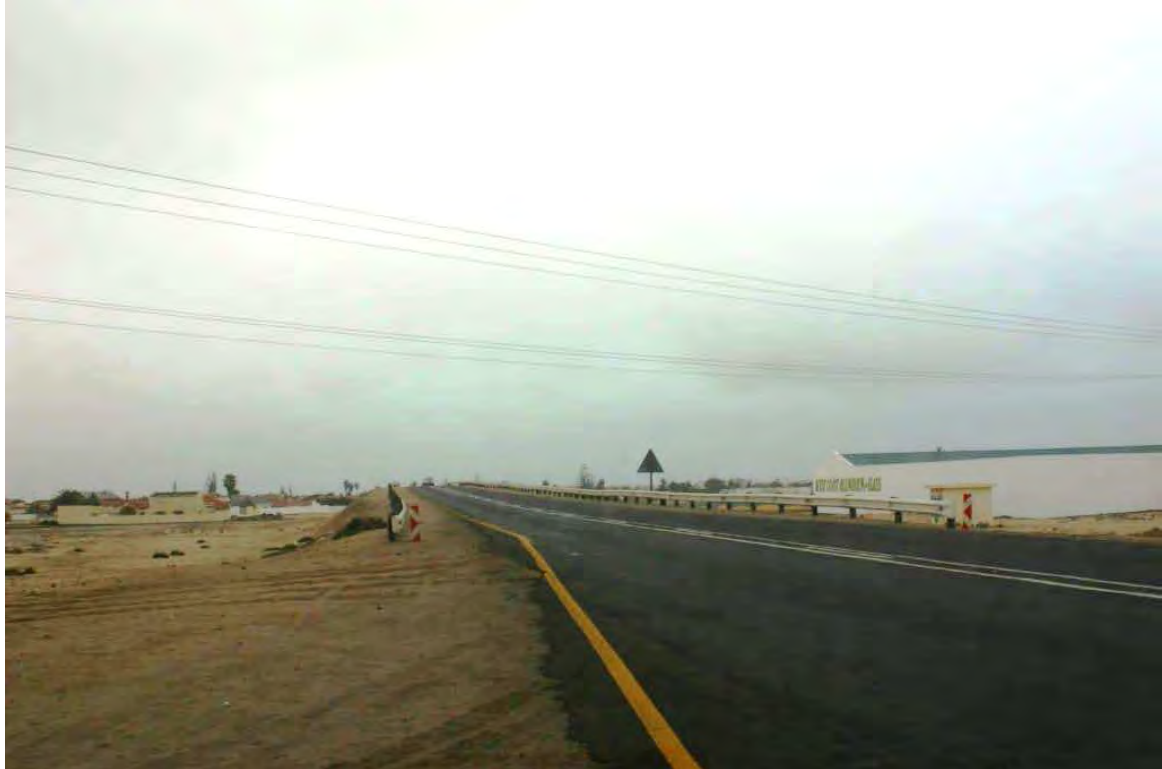
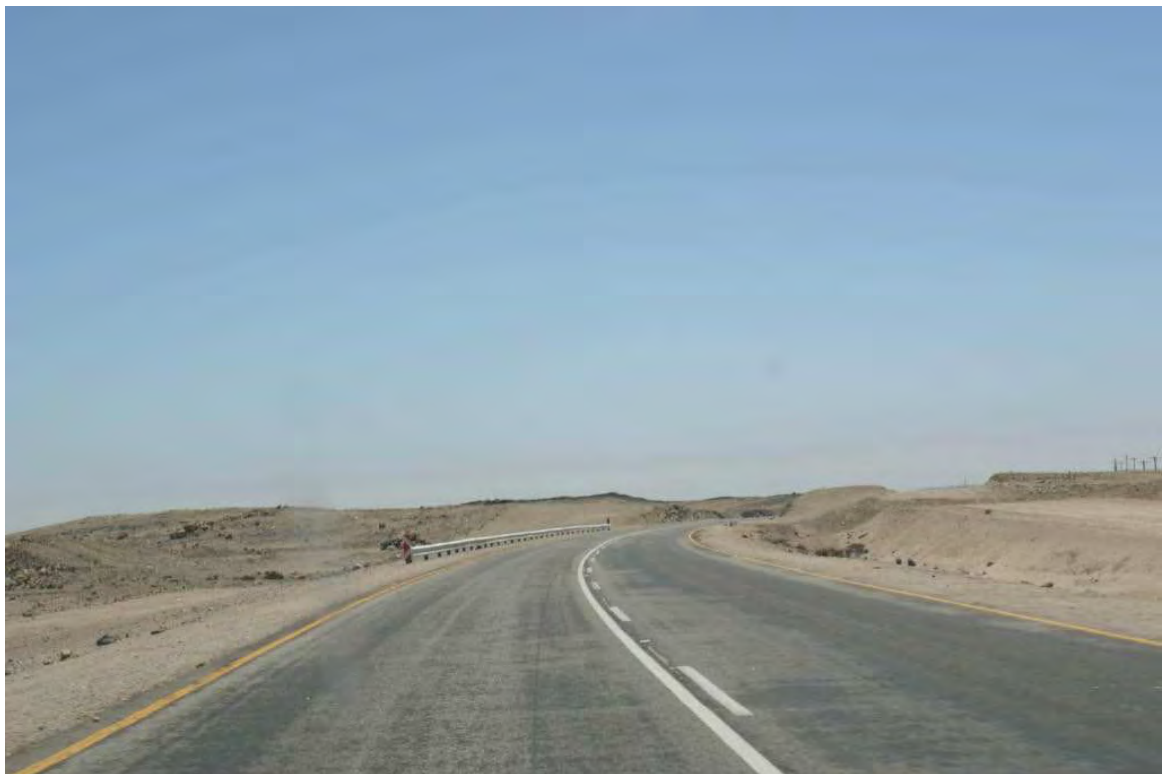
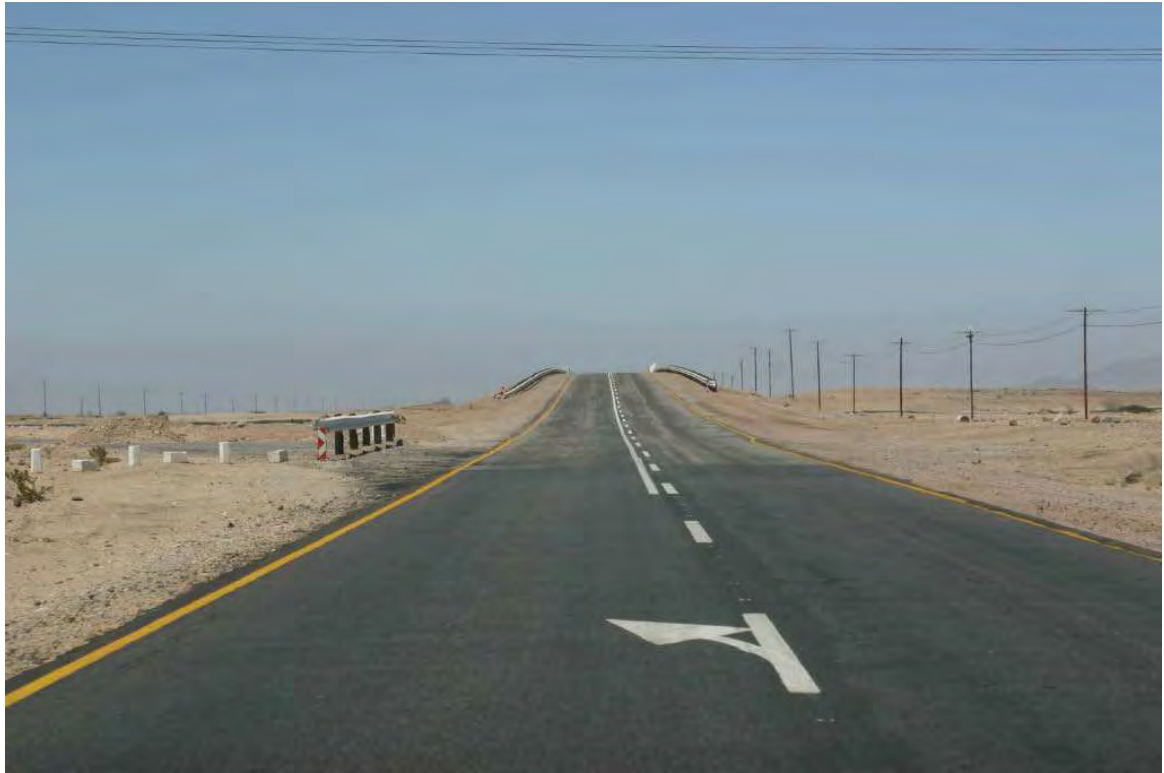
Guard rail should not start with end wings.

Isolated guard rails used as barriers are not recommended.

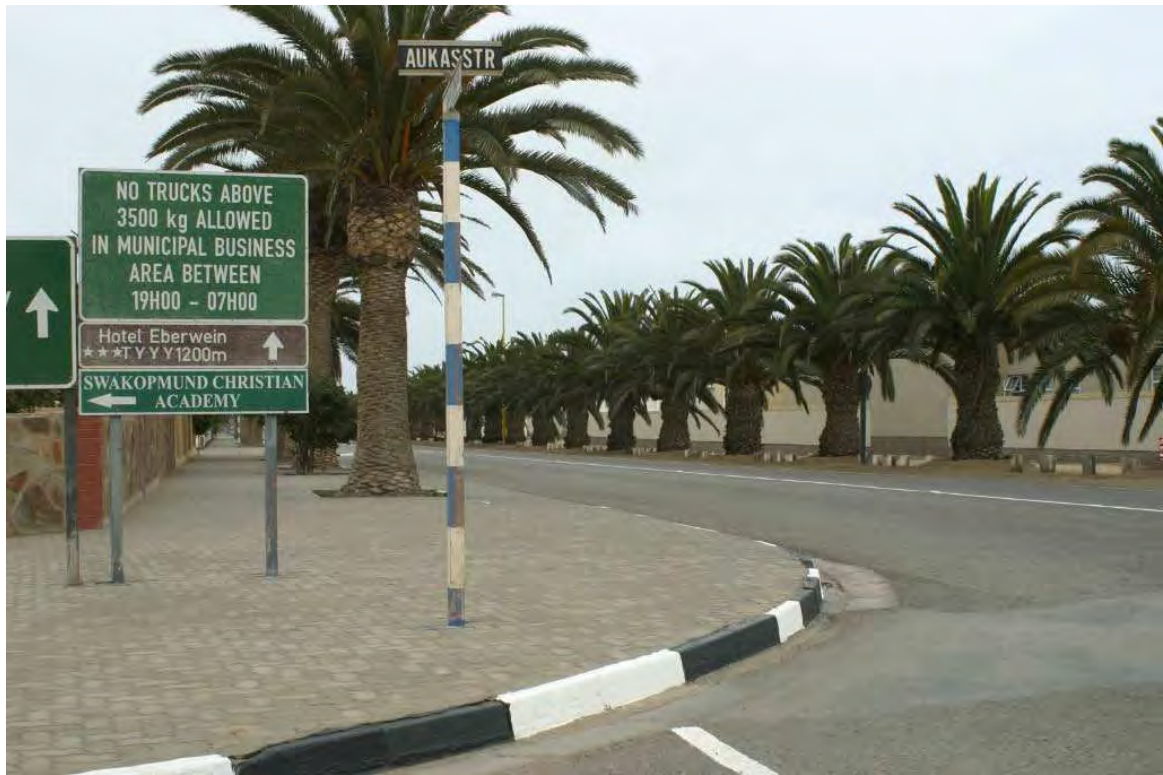
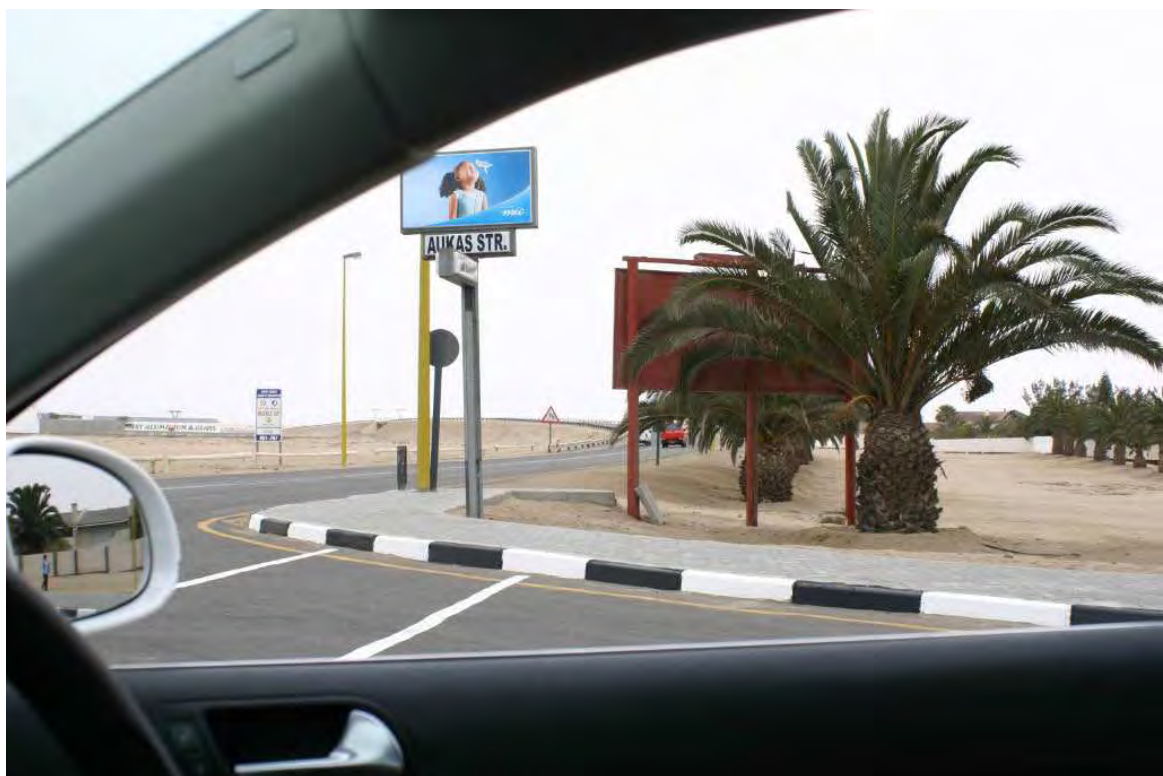
Exhibit 24

Sight lines affected by vegetation in Swakopmund at the junction on the B2.

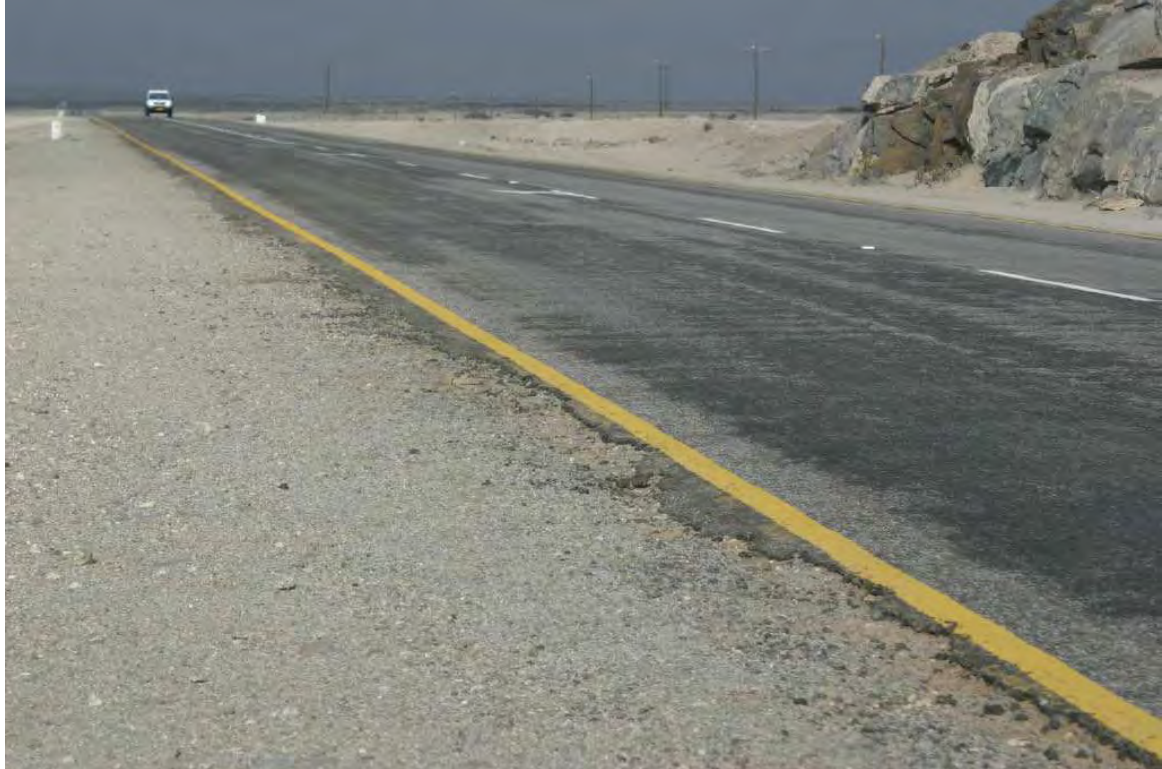
Exhibit 27

General issues: Edge breaks are hazardous for vehicles leaving the road as tyres can get cut or loss of control can occur in trying to re-enter the road.

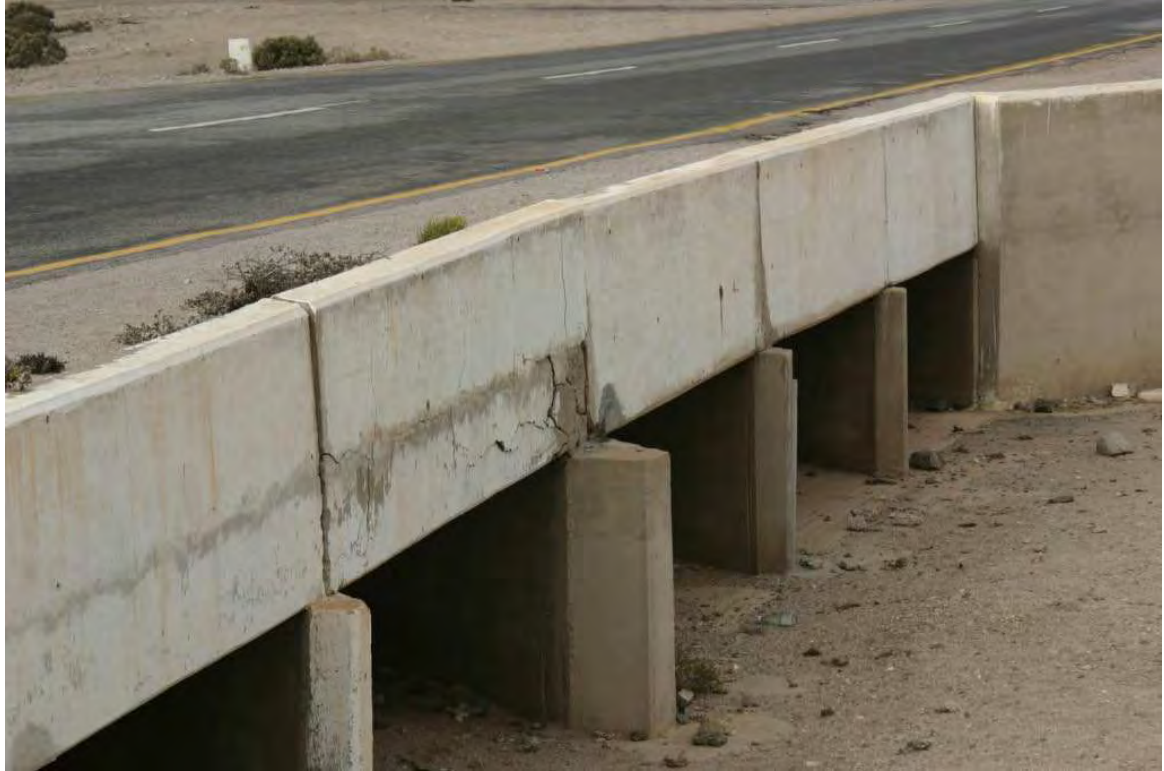
Exhibit 28

Damage to culverts. Damaged or failed culverts can cause subsidence of the road, leading to loss of control of vehicles.
