# **Traffic Impact Assessment Rio Tinto Rössing Uranium Limited**

## **FINAL REPORT MARCH 2010**

Road Safety Audit Report: Swakopmund to Arandis: Surfaced road B2

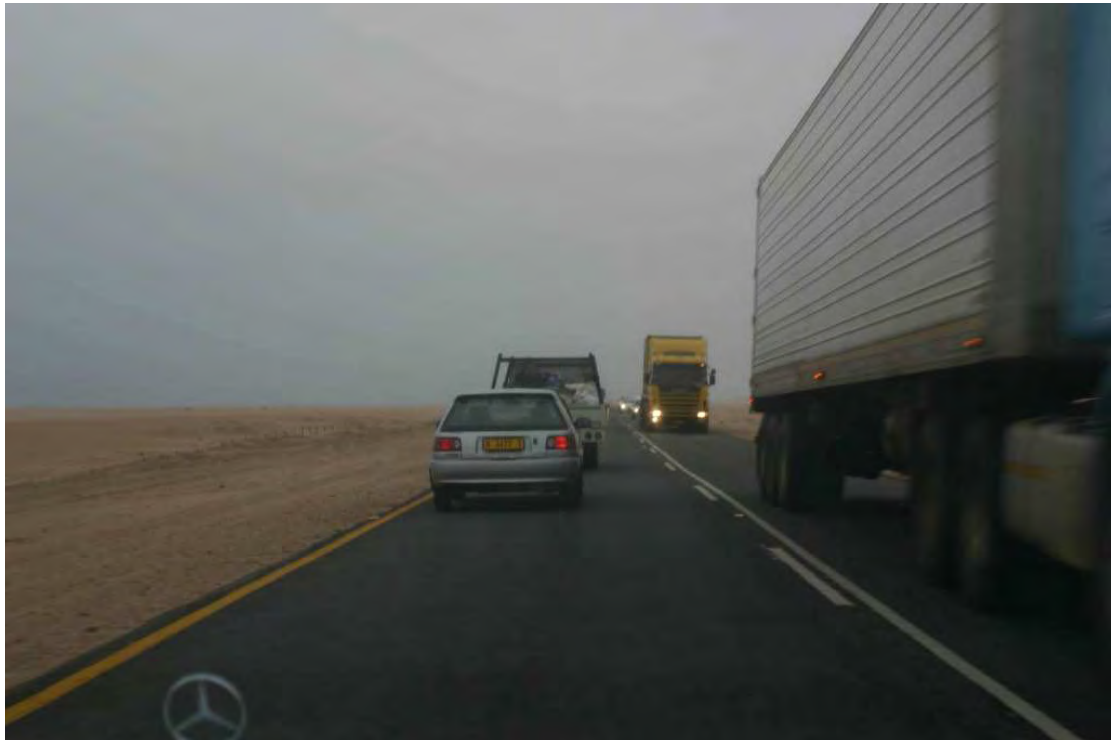
Exhibit 4

Narrow cross section is compensated for by a wide recovery area, but is inadequate for 120 km/h with high volumes of heavy vehicle traffic.  
High volumes of slow moving heavy vehicles cause delays and congestion.

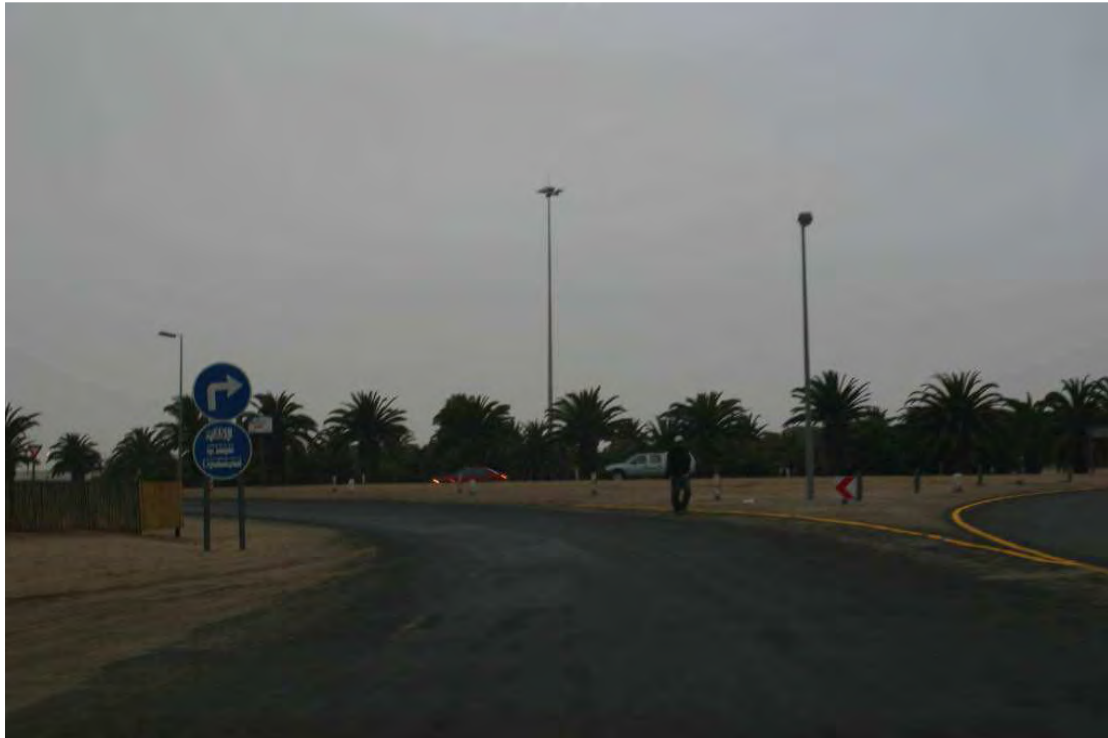
Roundabouts or traffic circles in Walvisbay do not conform to modern design principles. The basic assumption is that vehicles accept gaps in the circulating flow, not merging at will. The entry design in Walvisbay is more of a slip road leading to high speed and acute angles so that traffic cannot be observed from the right.

Note the sand on the roadway.

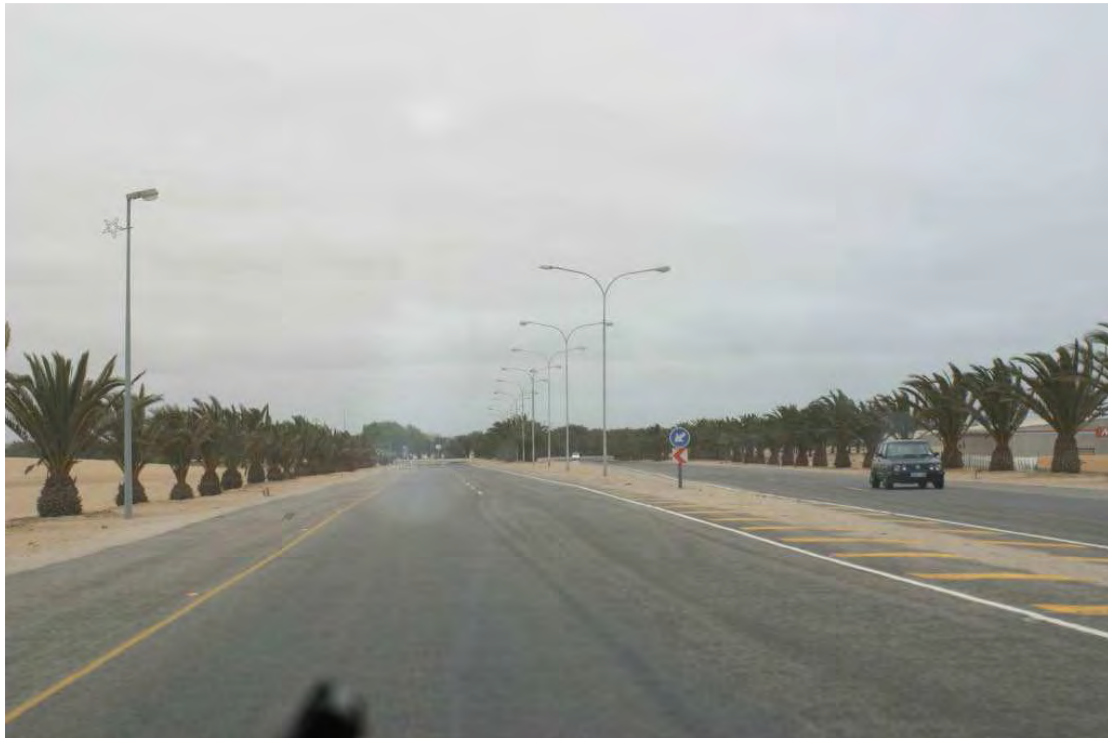
The lighting poles in the median are very vulnerable.

Note how sand collects in the paved central area before the start of the median.

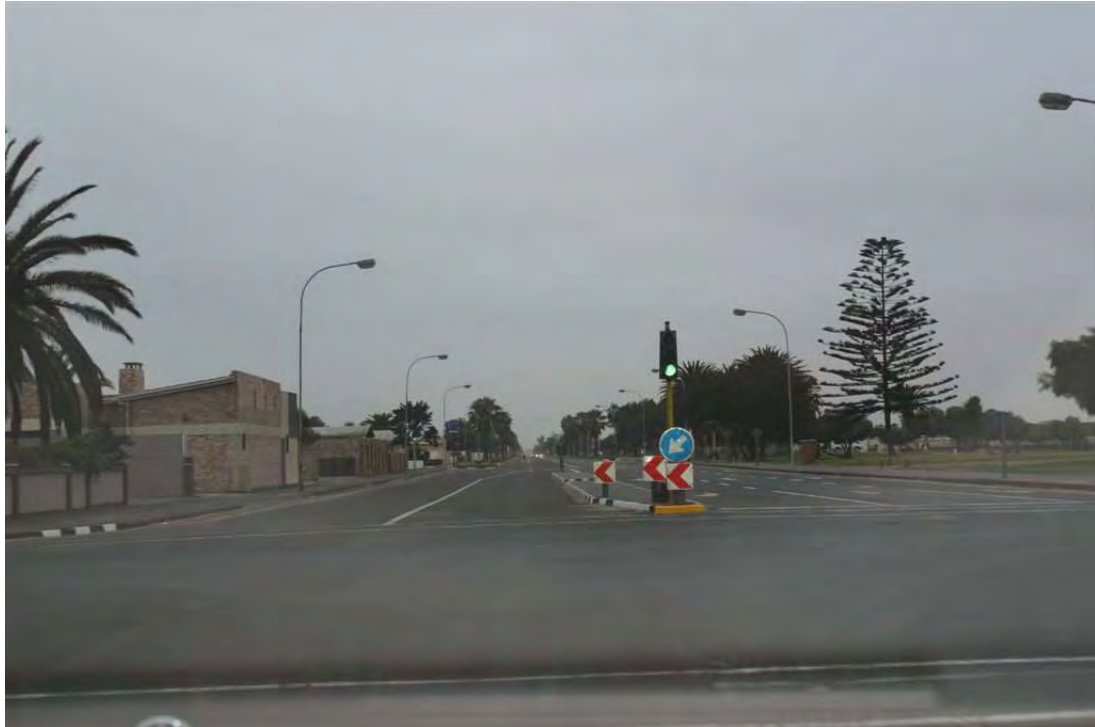
Small islands must be made visible with signs, which then have inadequate lateral clearance.  
Note that the chevron signs used again are sharp curve chevrons.

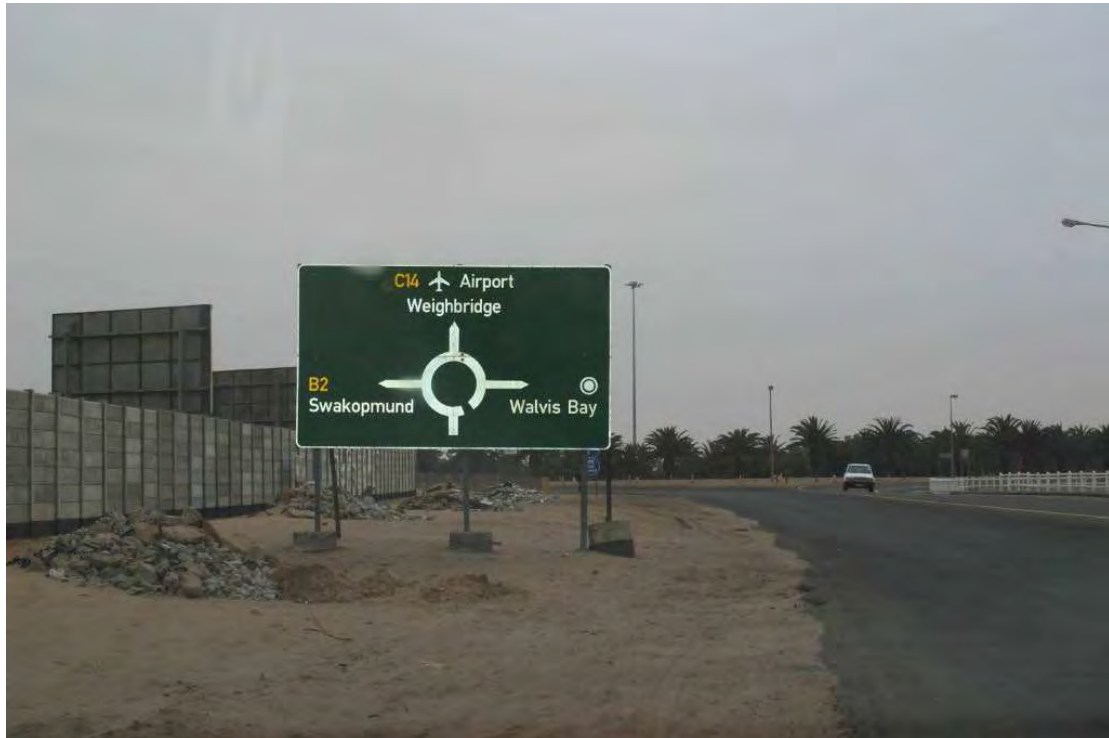
Exhibit 13

Hazardous sign support observed in Walvisbay.

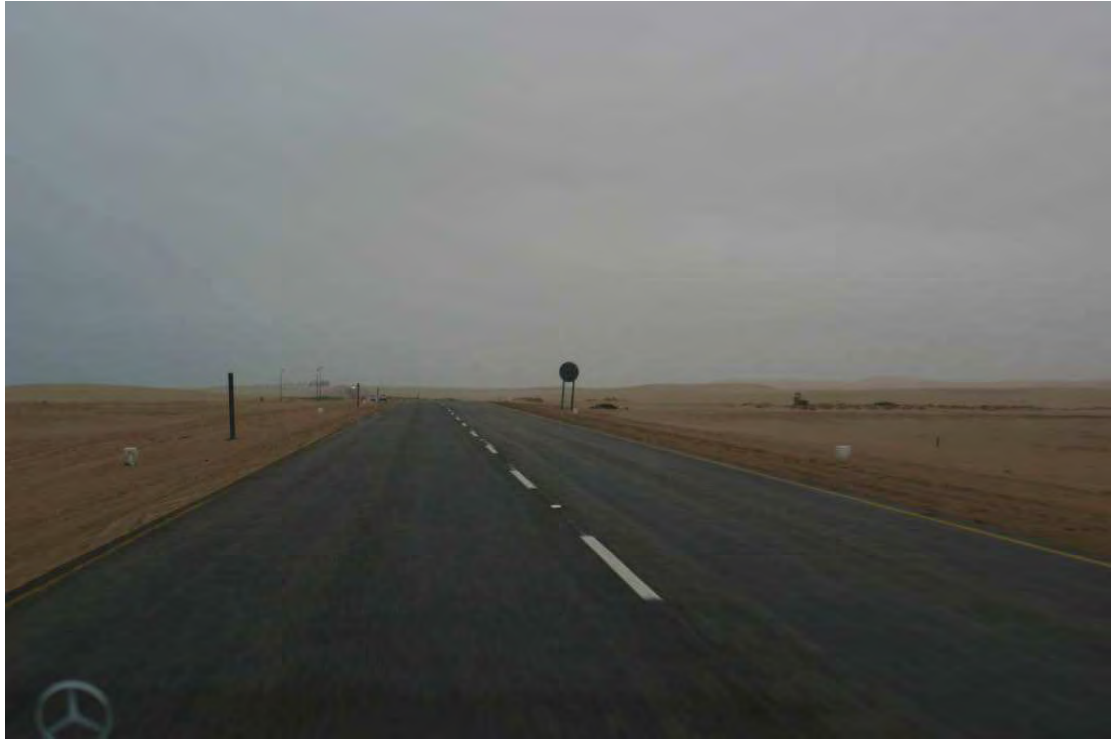
Exhibit 14

Missing signs on the B2: post still standing

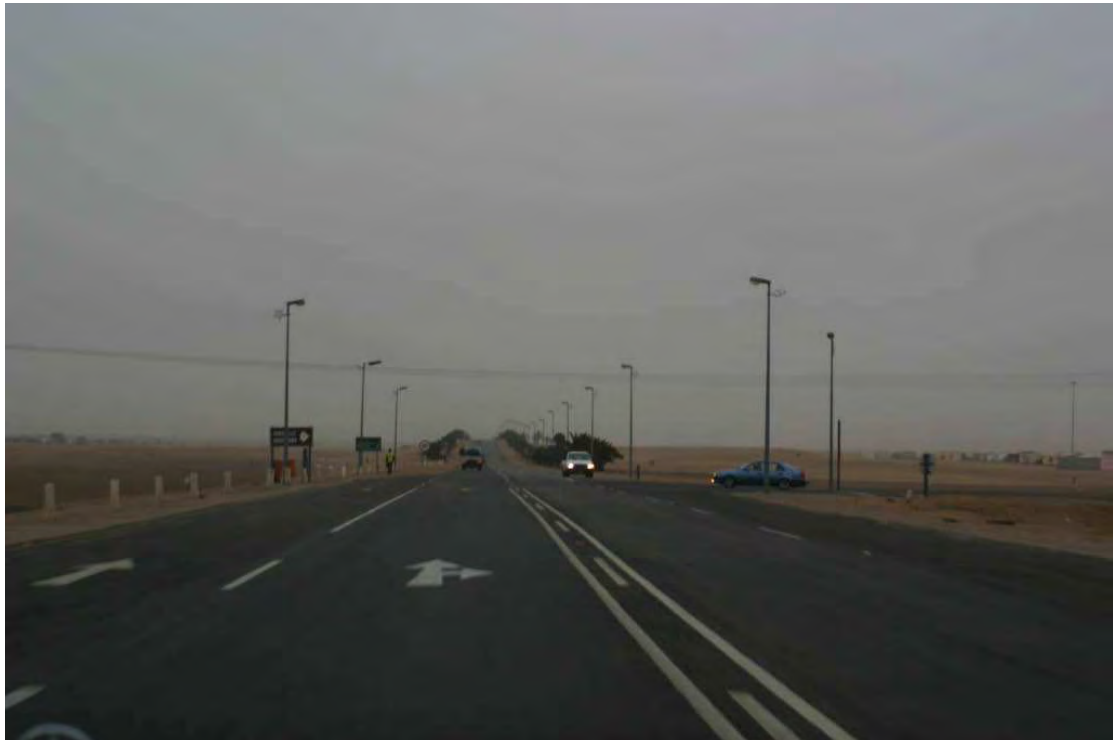
Exhibit 15

Short left through lane to bypass right turning vehicle. A dangerous condition arises when the vehicle in the right hand lane goes straight and adequate merging length is not available..

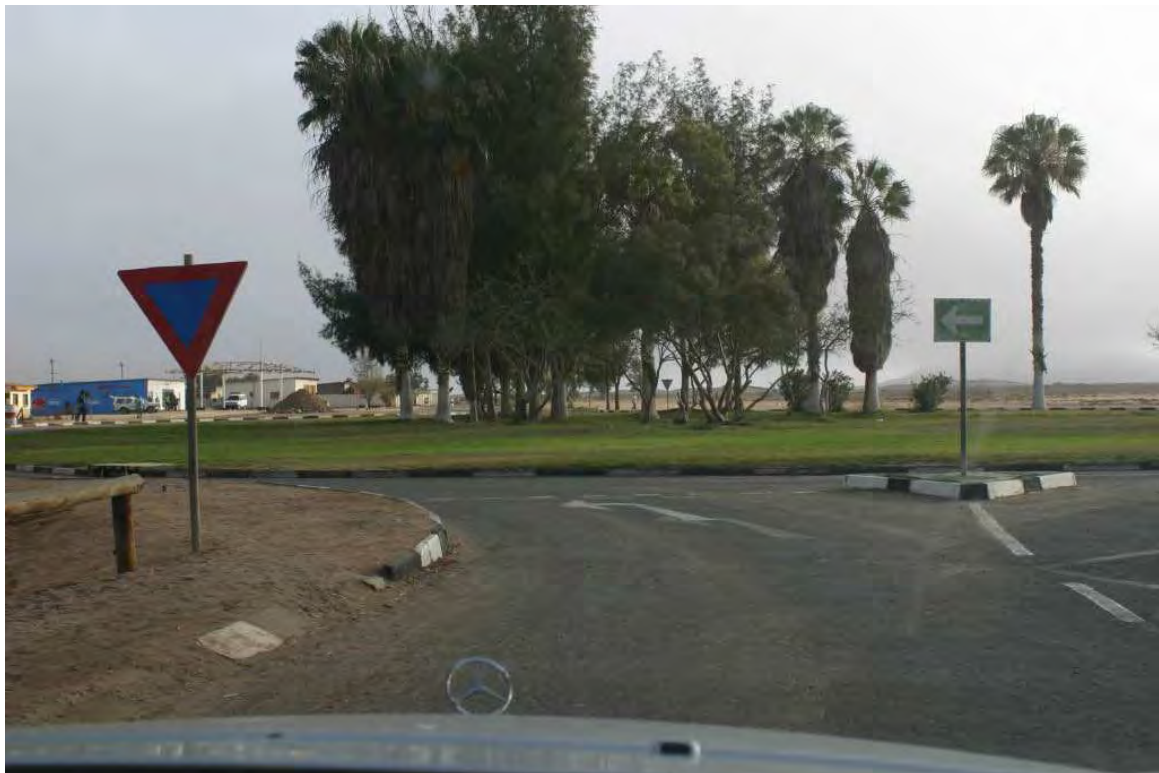
Note the outdated colour of the yield sign: the use of the blue background has been stopped in 1996.

Note the faded one way sign on the small splitter island that will have inadequate clearance to large vehicles. The standard signage does not indicate the use of this sign.

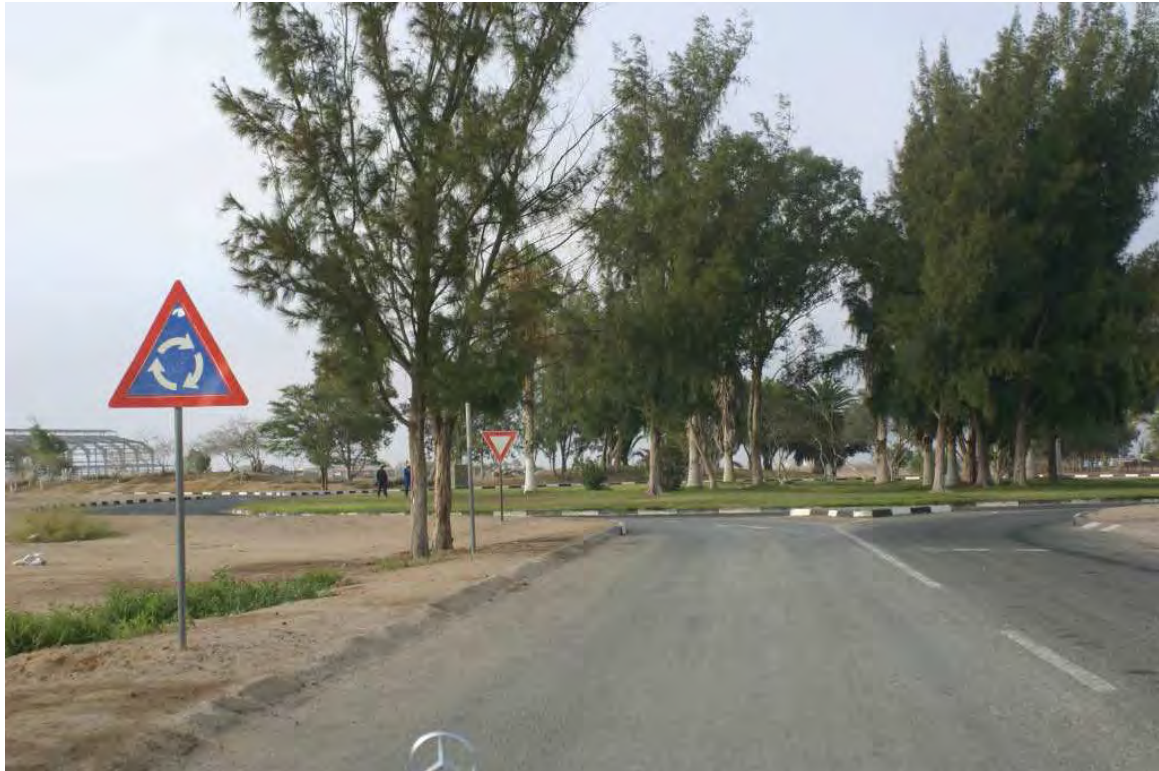
Exhibit 2 continued.

Note the outdated circle warning sign with blue background.

The circle is not legible from this approach due to no signs on the central island to guide drivers.

Pedestrian sidewalks are in poor condition. Bus stops are located to the left at the entrance to Arandis and pedestrians walk along the edge of the traffic circle to get to the bus stops.

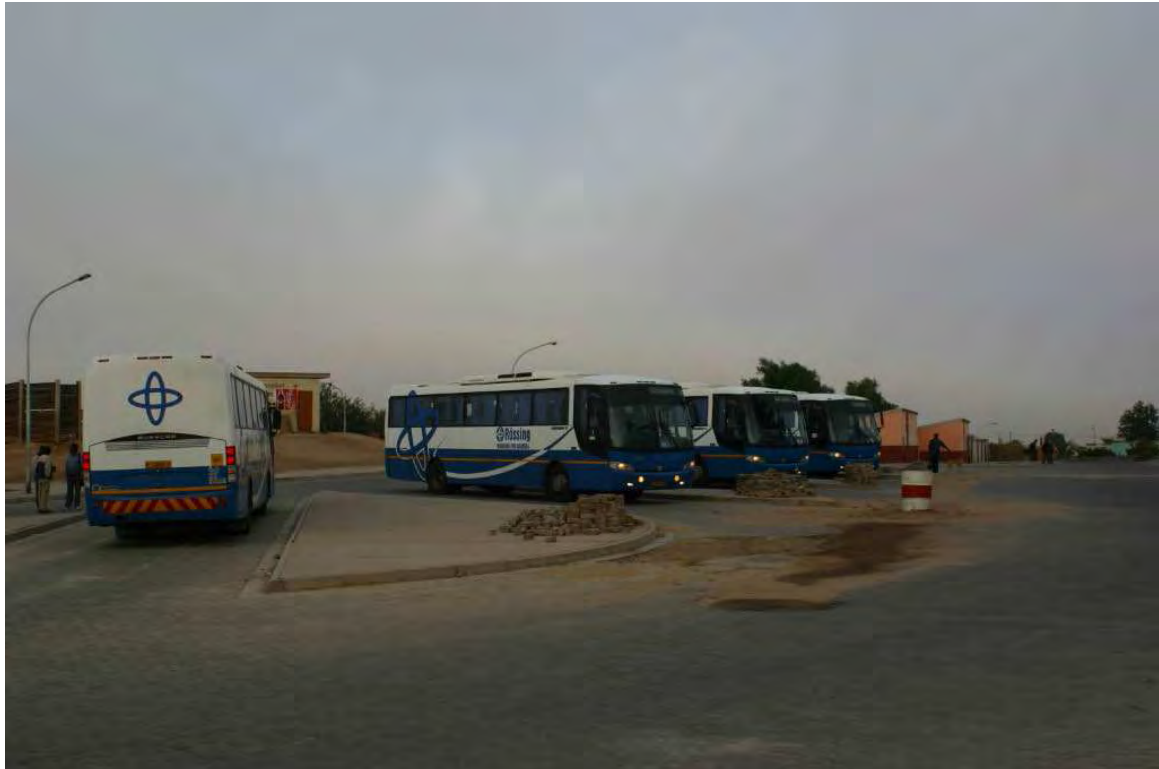
Islands should be demarcated by means of hazard markers: even if the area is provided with high mast lighting, drivers turning into the area may not see the raised island and damage their vehicles.

The islands should be linked to the sidewalks by means of pedestrian crossings.

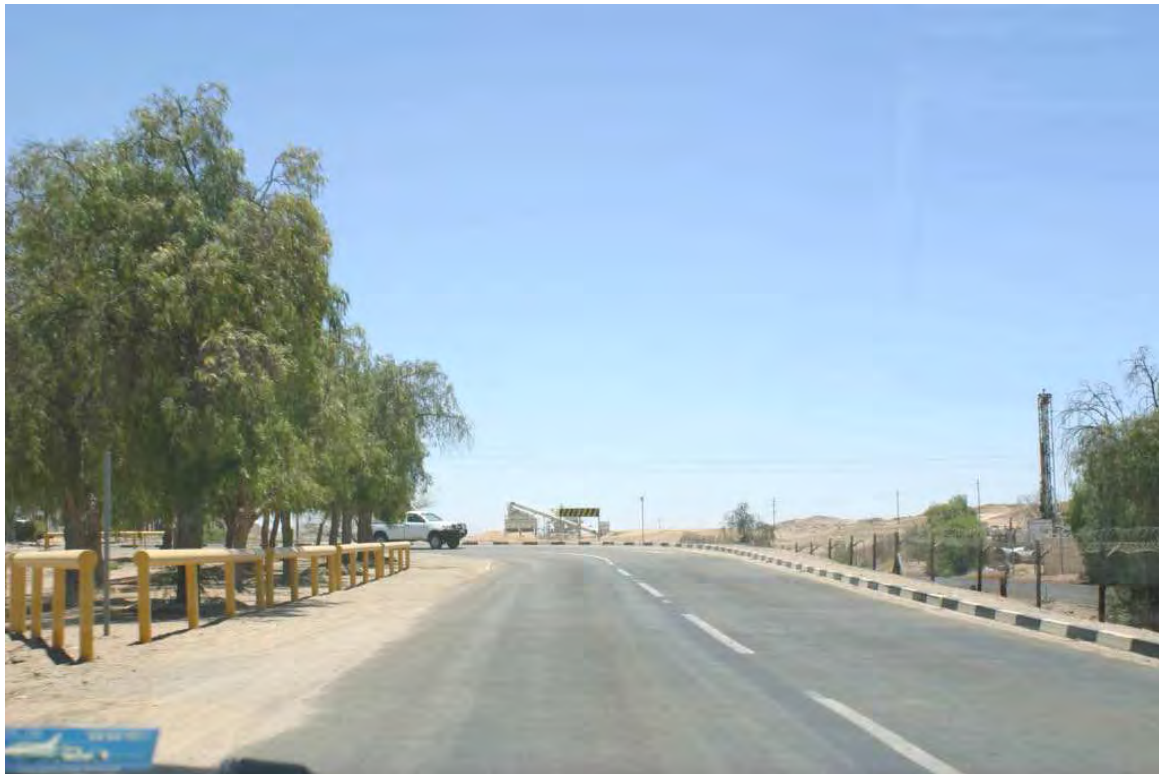
Exhibit 3

The mine road curves to the left over the railway line: direction from the mine towards the entrance gate. The curve is substandard compared to the rest of the alignment. Sharp curve warning signs are required on the approach of the curve. The sharp curve chevron is outdated. The barriers on the left are not of an approved road side barrier design. Vehicles hitting the blunt ends can sustain severe damage.

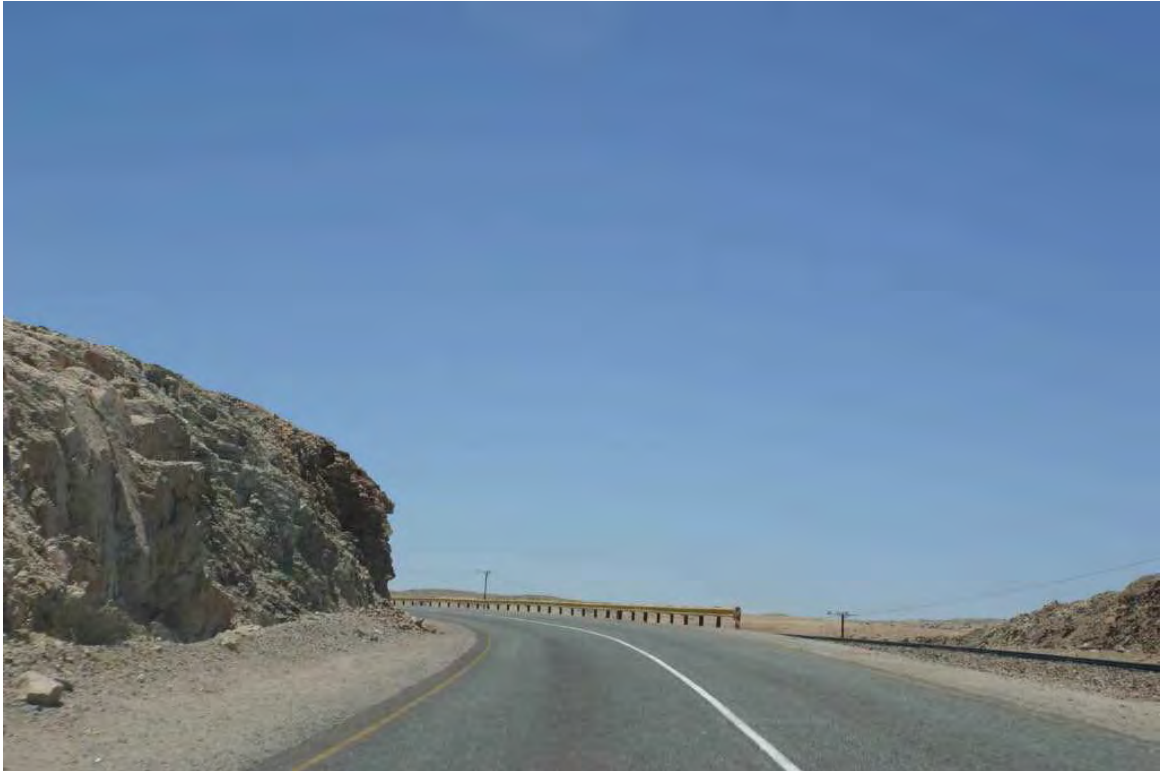
Exhibit 4

Barrier lines provided where adequate passing sight distance cannot be provided.  
Clearance width to the cutting is inadequate.

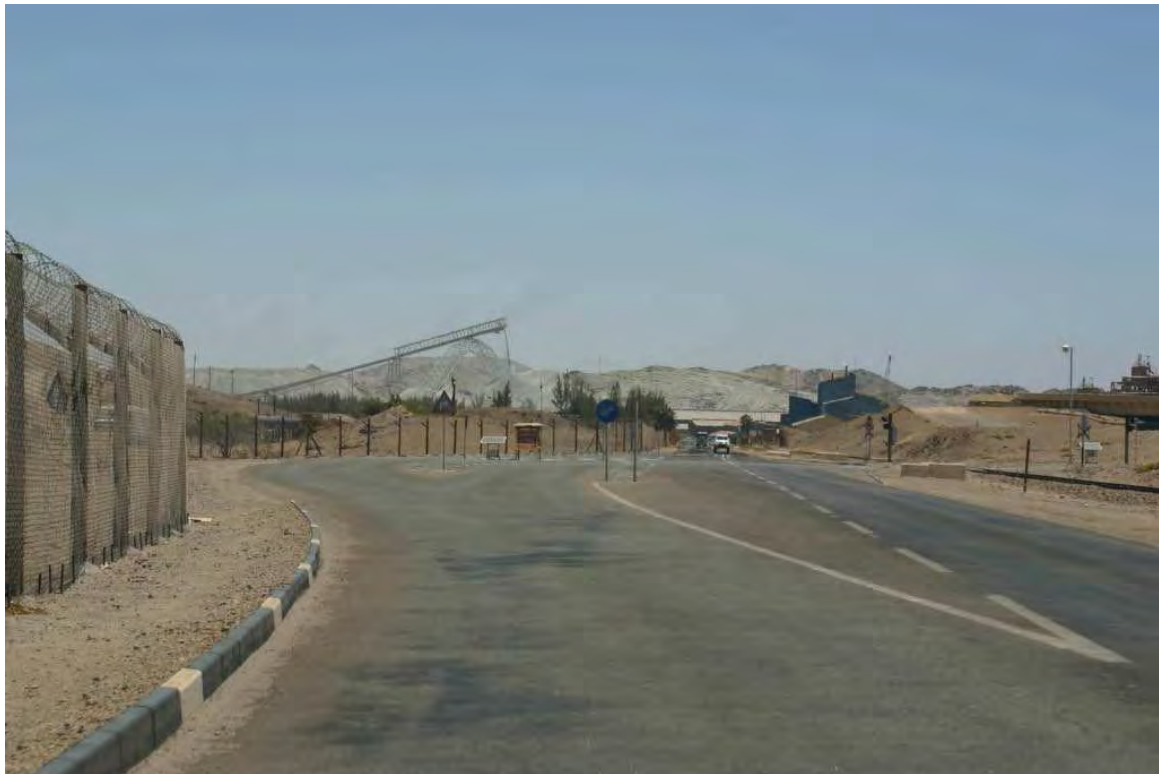
Facilities for pedestrians such as side walks and crossings are not clearly demarcated.

It is suggested that the left lane of the main road be painted out to clarify the required movements.

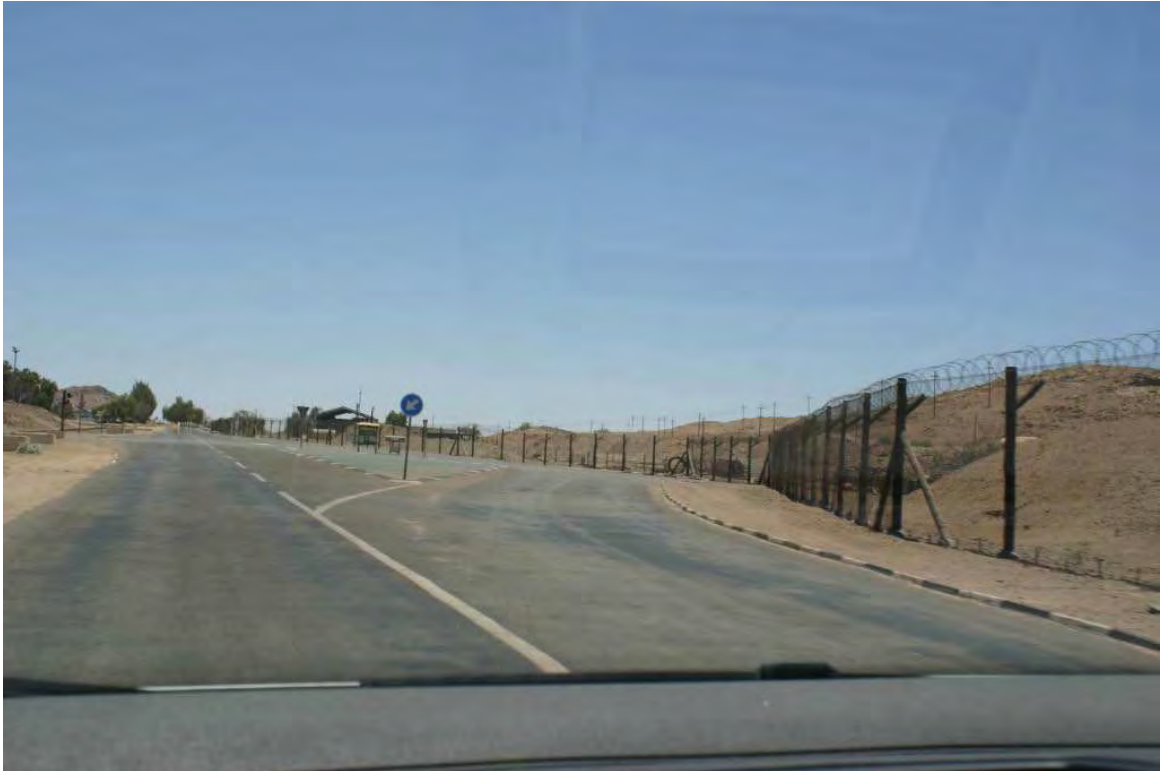
Exhibit 6 continued

It is suggested that the section of lane that is not to be used be painted out. The broken dividing line may be interpreted as allowing passing. Facilities for pedestrians such as side walks and crossings are not clearly demarcated.

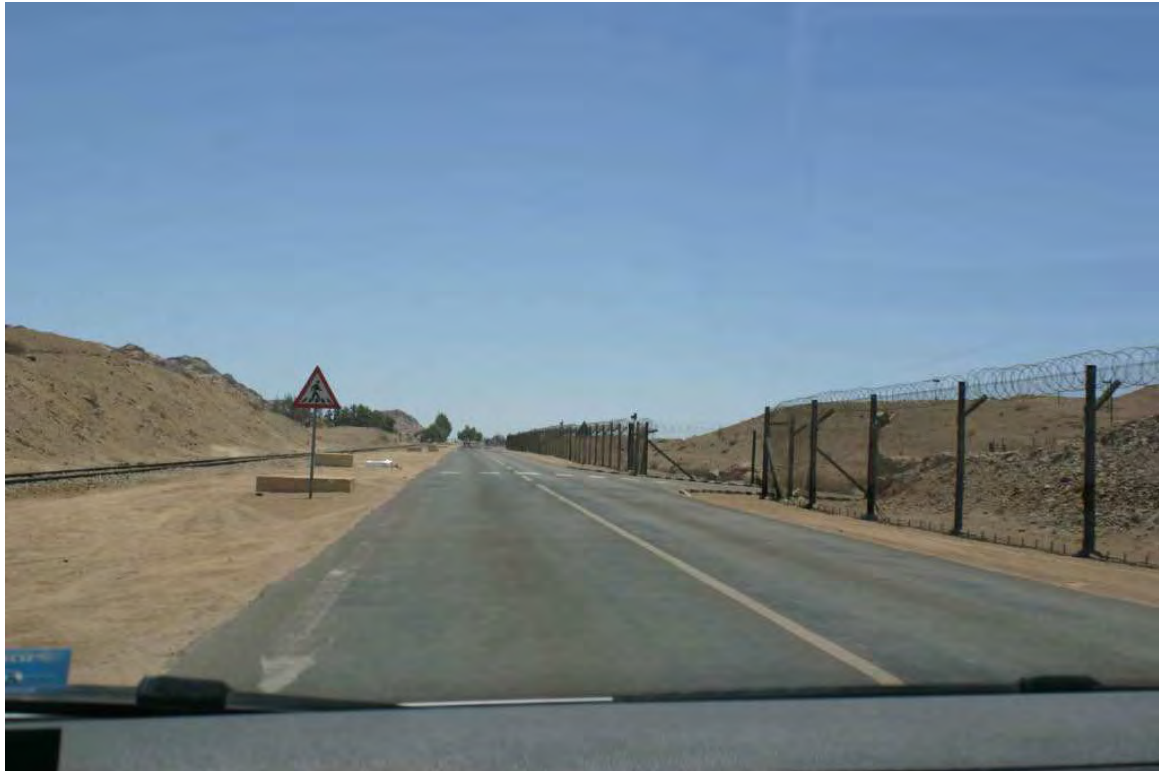
Note the manholes on the left, which is both trip hazards for pedestrians and collision hazards for vehicles, as they occur in the clear width of the road. These manholes should be marked with hazard markers.

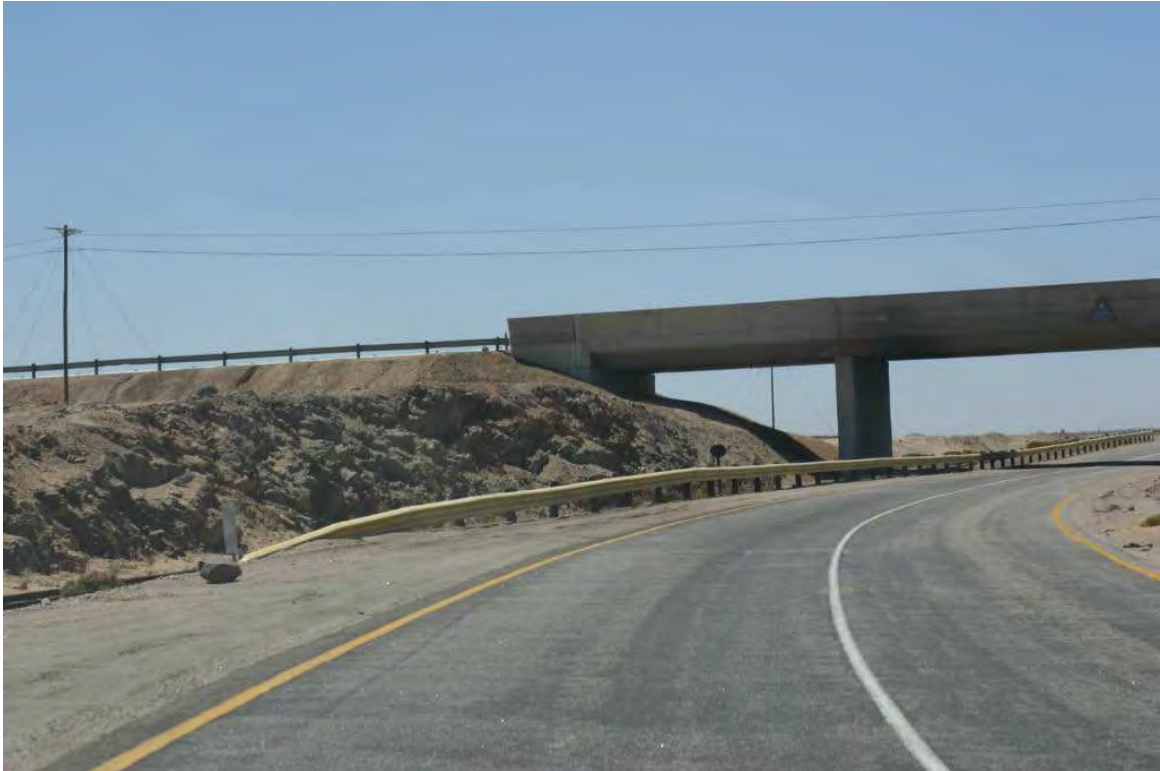
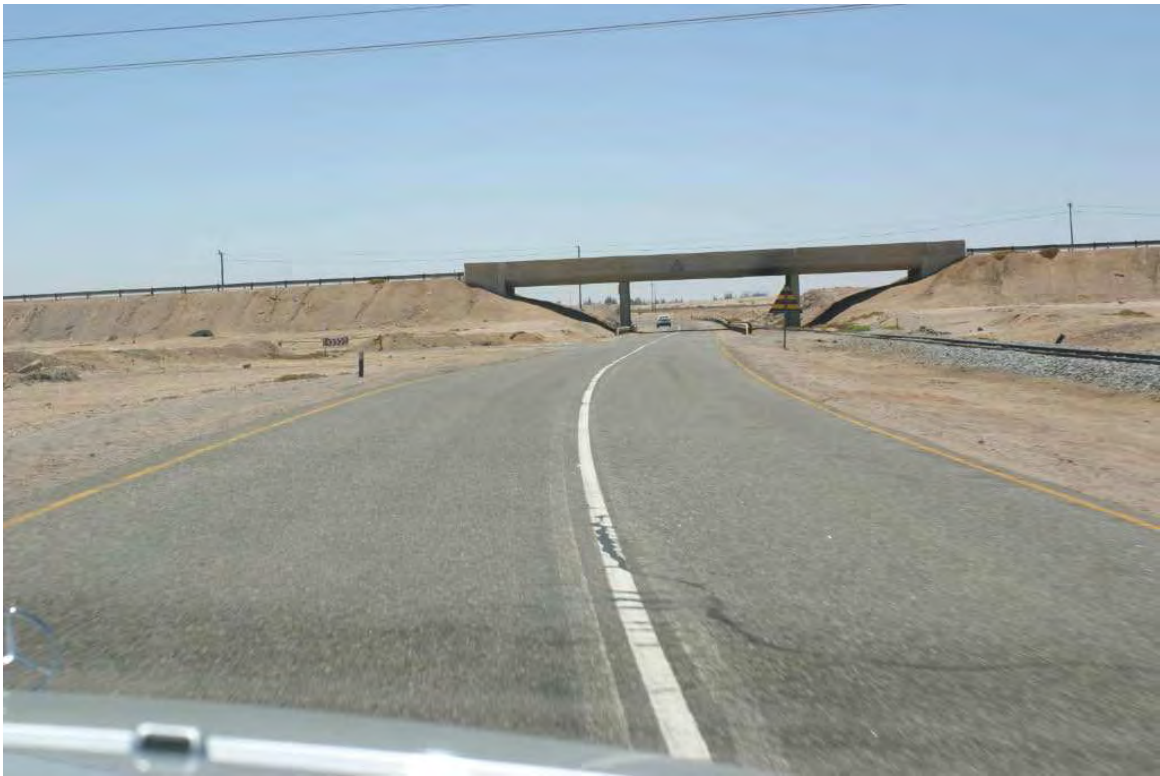
Hazard marker sign is faded and lacks reflectorization.  
Height restriction sign on the bridge is outdated and faded.

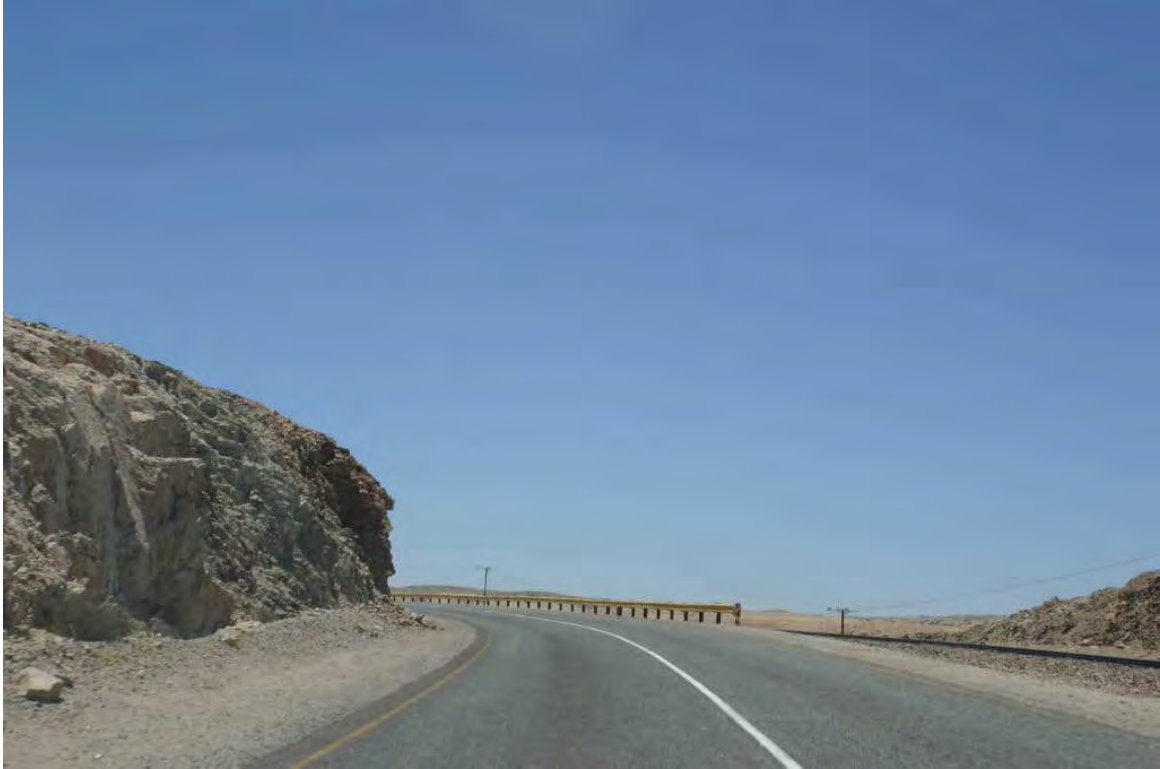
Exhibit 10

A barrier line is provided where sight distance is inadequate due to cutting on the left.  
The safe clear width is not sufficient due to the cut face.  
Guard rail is provided between the road and the railway line on the curve.

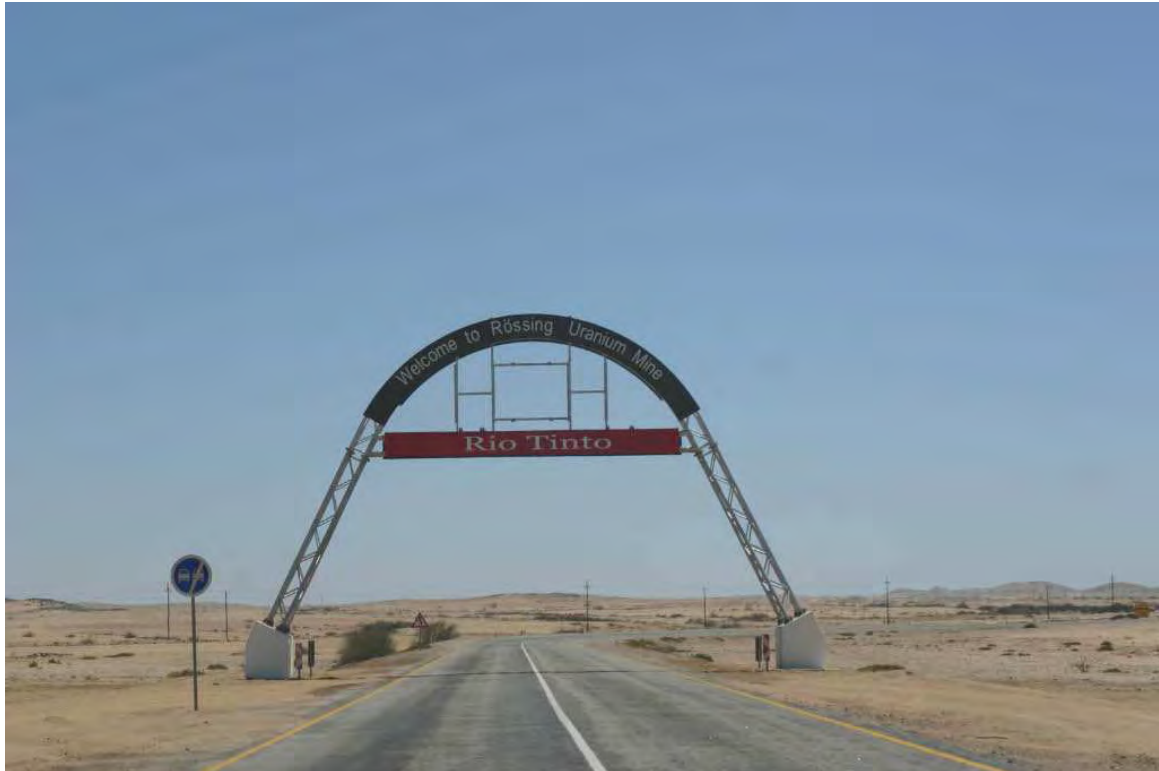
Exhibit 11.

Rio Tinto arch: gateway to mine access road from the Arandis side.  
The hazard markers on the right hand side are pointing in the wrong direction.  
The no overtaking sign is outdated and faded.  
The S curve ahead warning sign should be a sharp curve to the right sign.

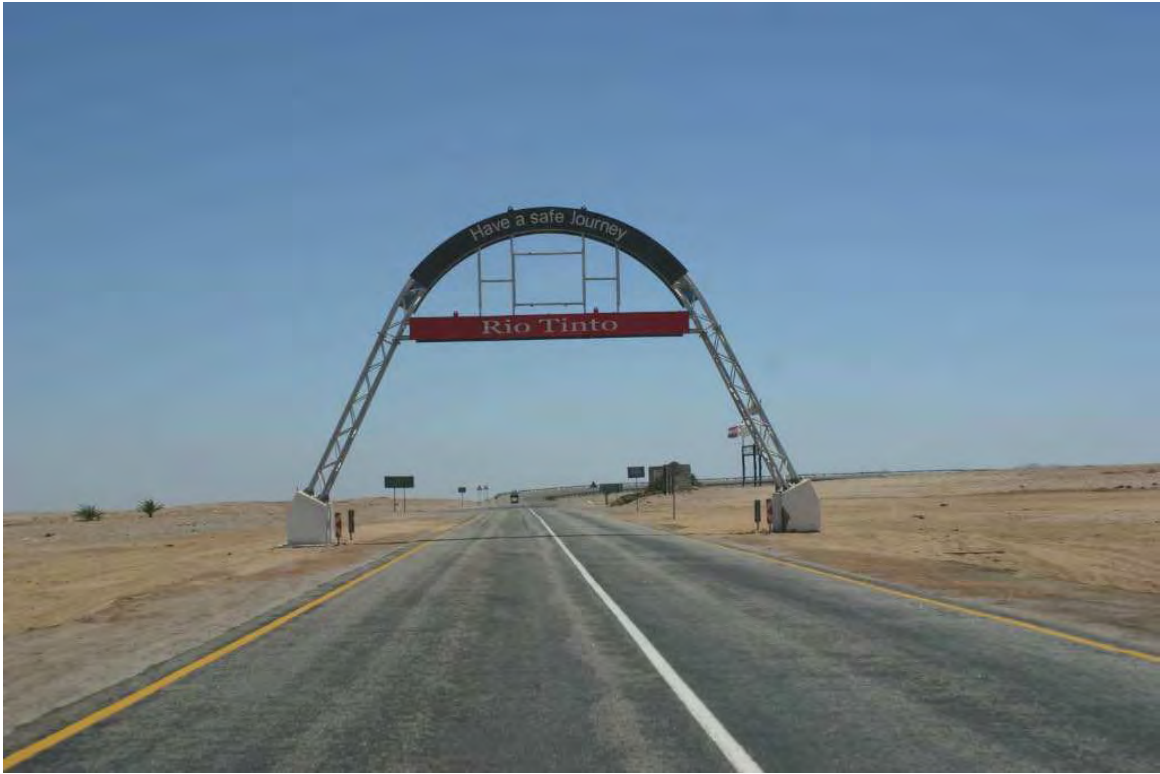
Rio Tinto arch from the mine's side:  
Hazard marker on the left hand side pointing the wrong direction

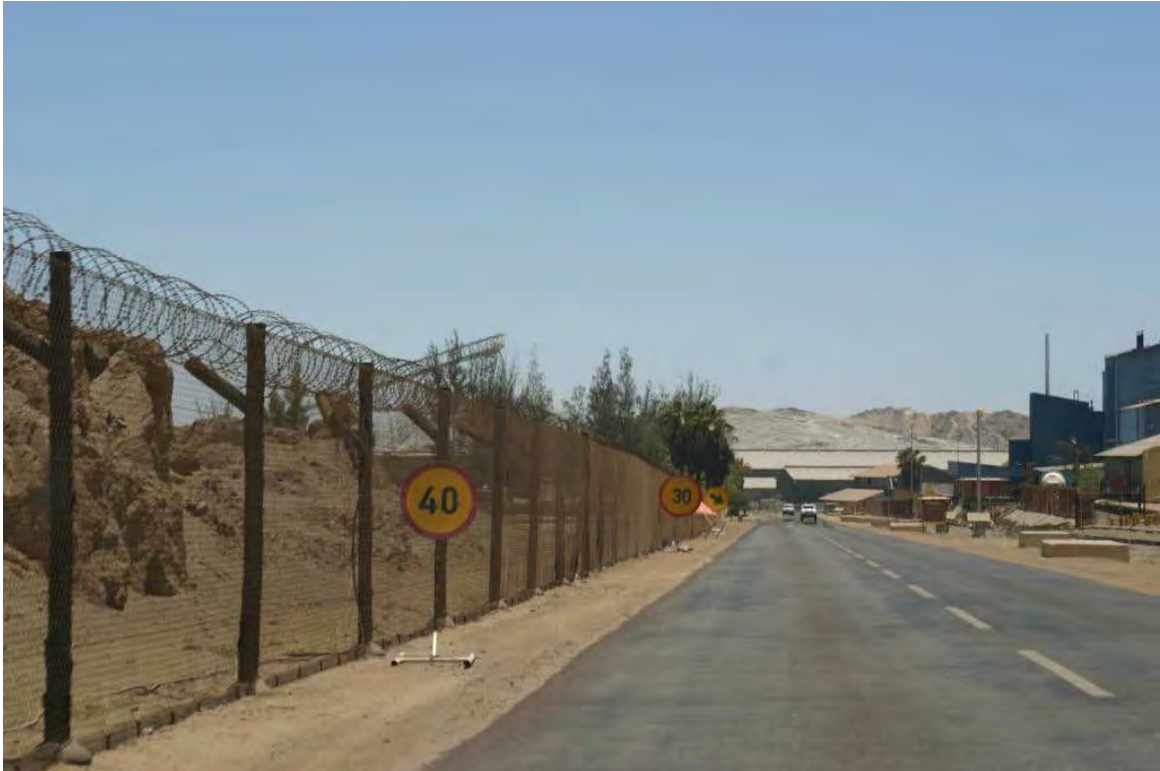
Temporary signs observed were not functional and did not appear to relate to actual construction taking place.

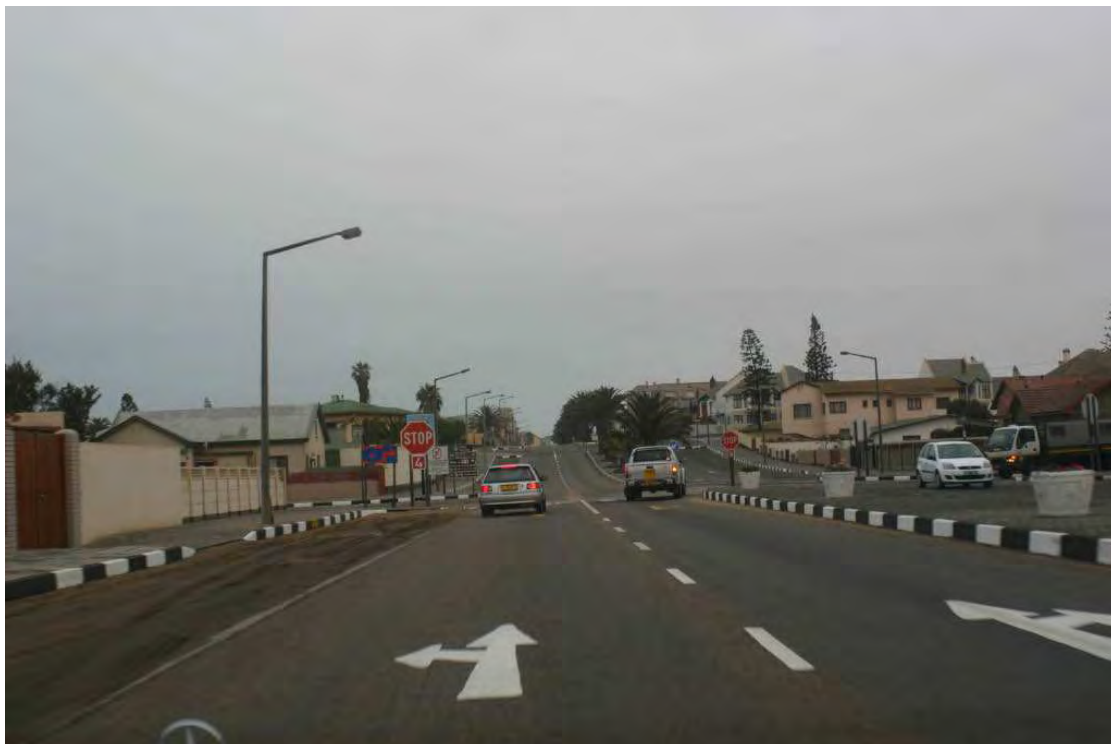
Flower pots on the median is considered dangerous hazards for secondary collisions.

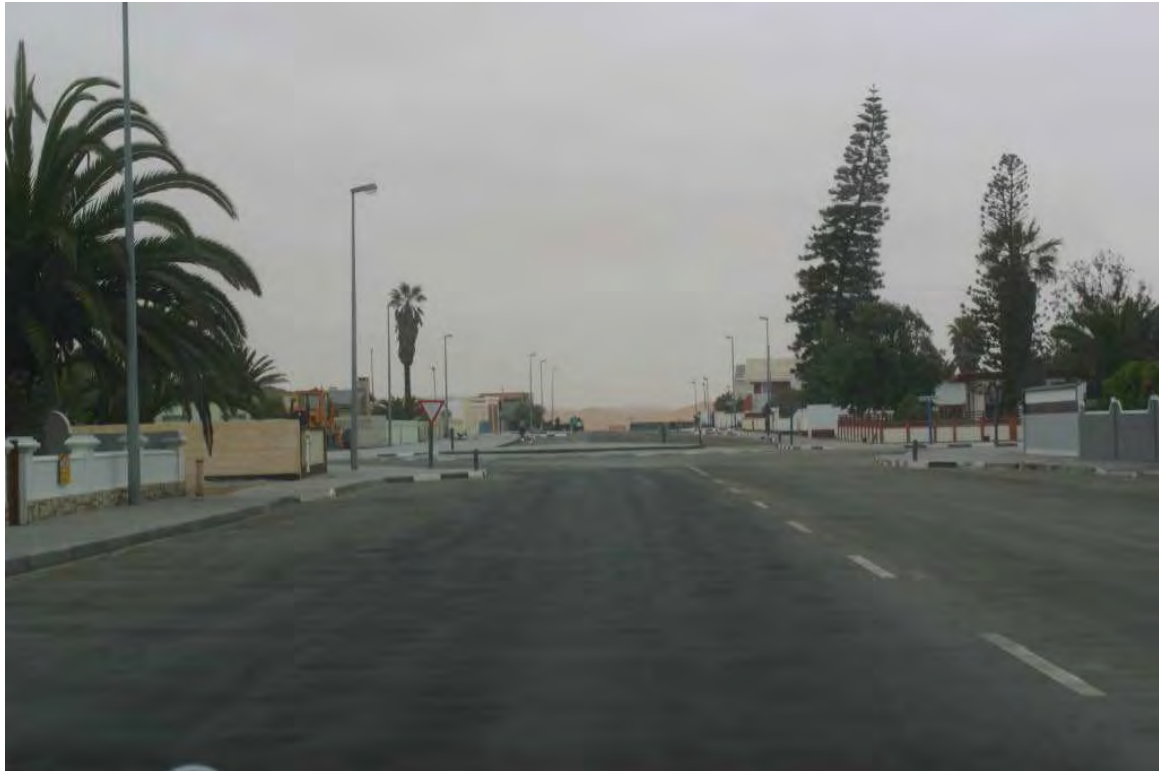
No deflection, splitter islands or signs on the central island may lead an unfamiliar driver to drive into the raised island.

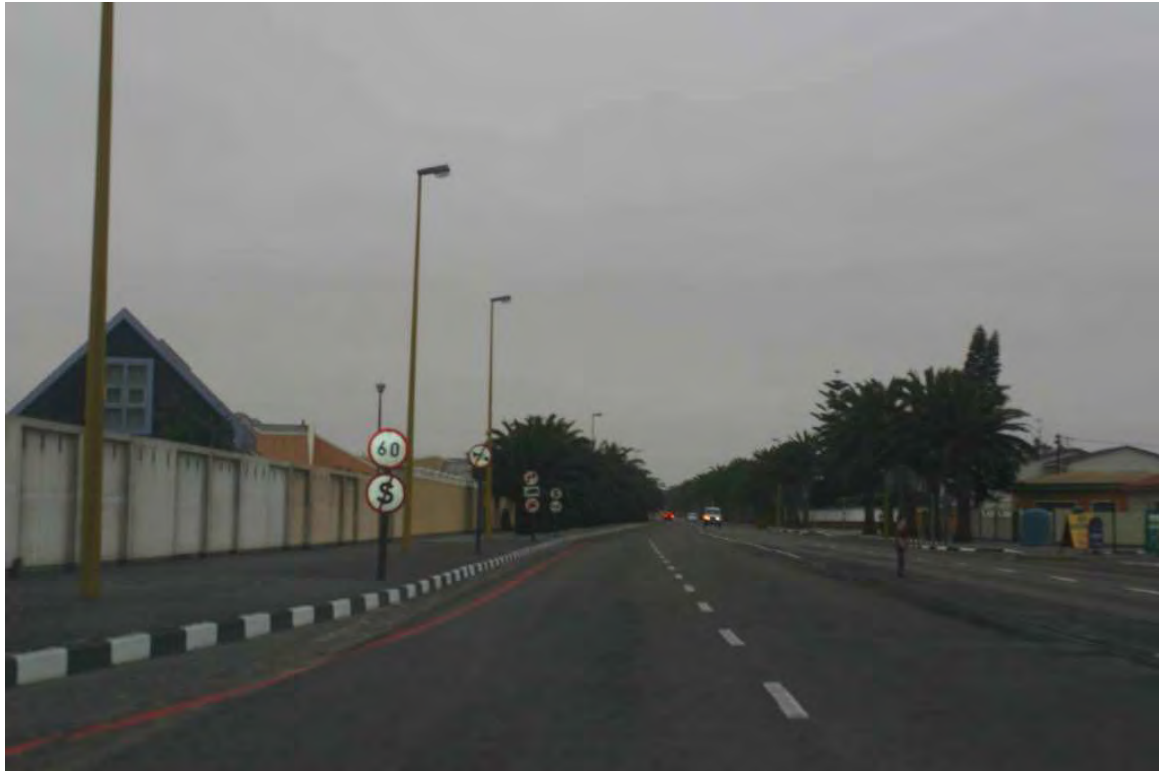
A high density of road traffic signs was observed on the road leading to Usakos. Multiple regulatory signs on a post should be avoided, as drivers may observe selectively. The no stopping sign is a duplication of the red pavement marking.
