# **Traffic Impact Assessment Rio Tinto Rössing Uranium Limited**

## **FINAL REPORT MARCH 2010**

Road Safety Audit Report: Swakopmund to Arandis: Surfaced road B2

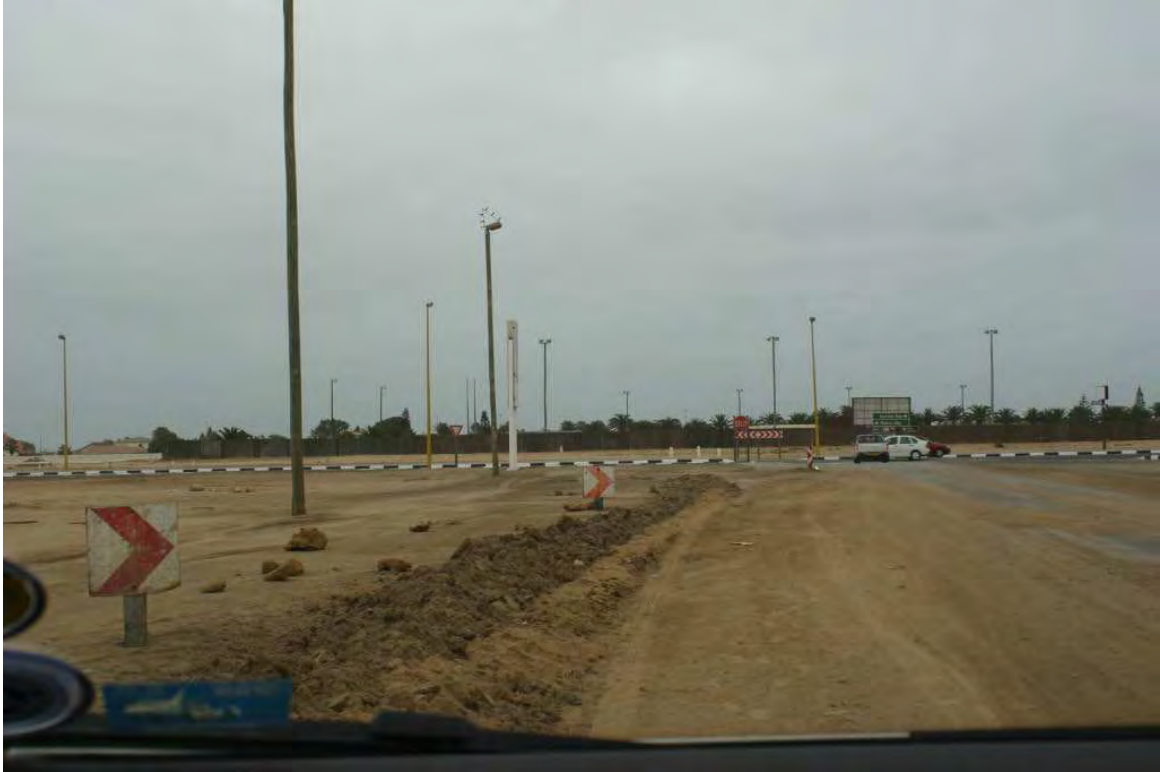
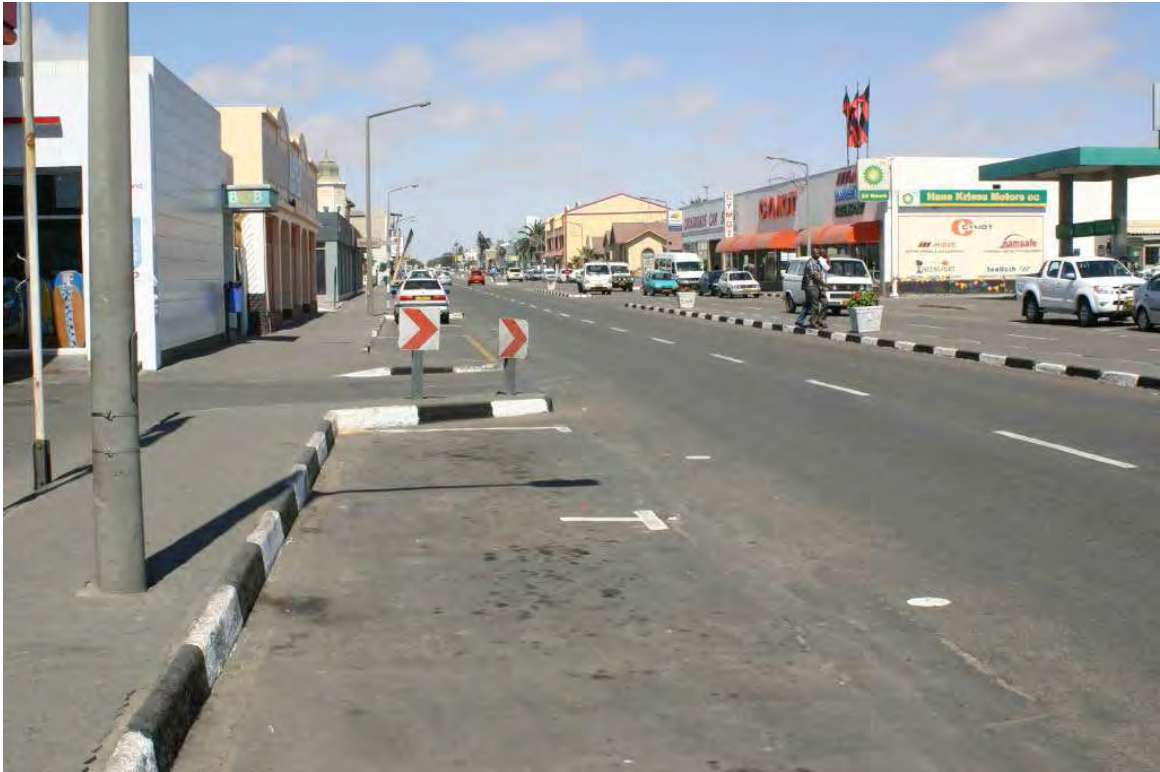
Sharp curve chevrons are used as hazard markers.

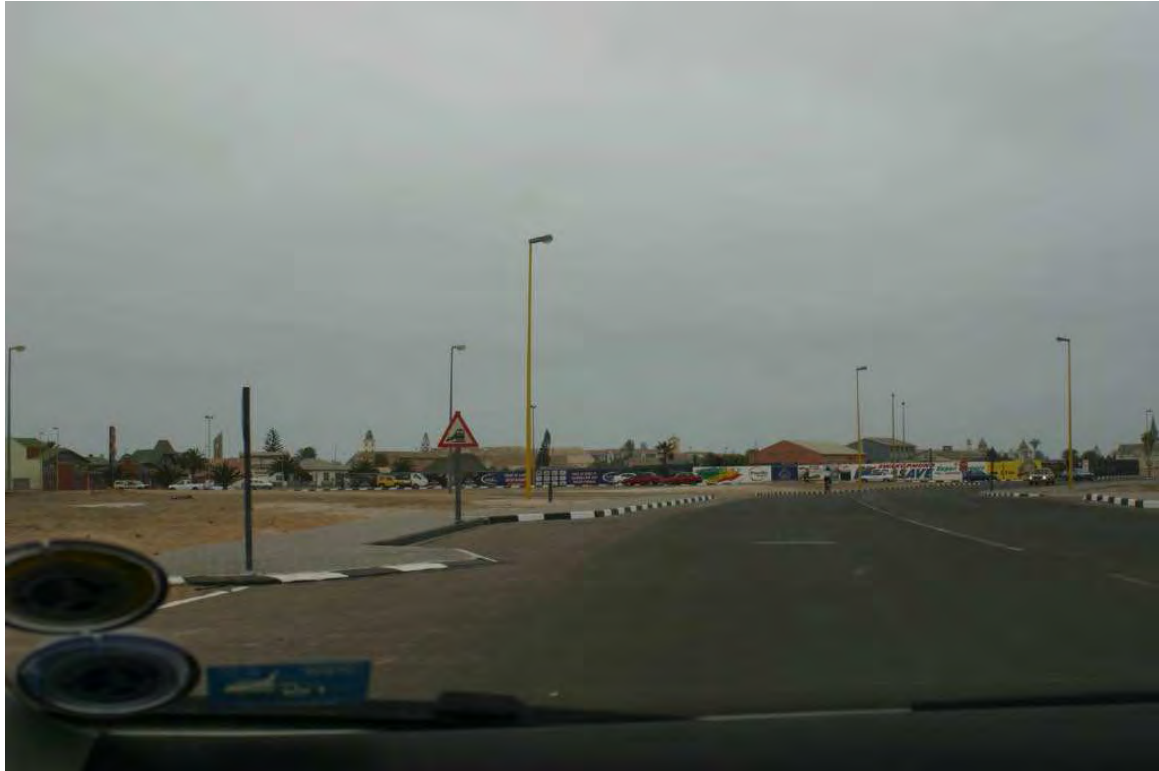
Exhibit 15.

This train crossing warning sign was observed where not railway line was evident.  
Note the excessively wide lanes that will lead to overtaking.

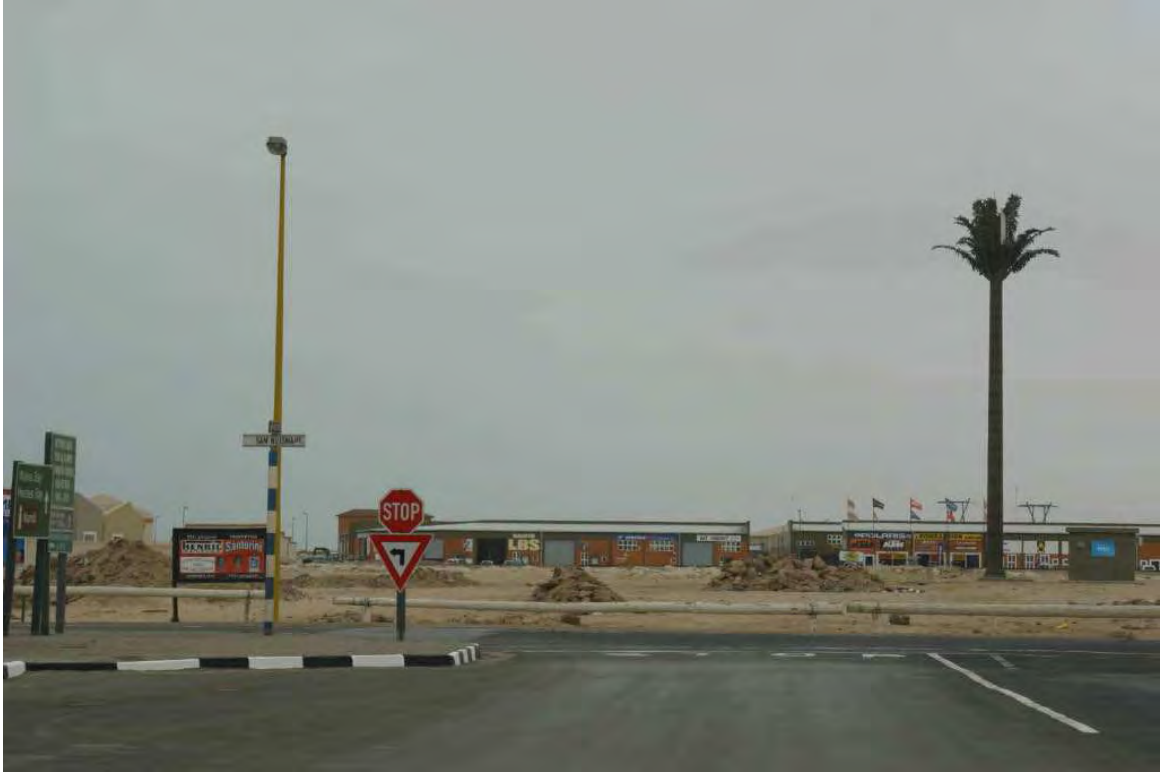
Exhibit 16.

Missing signs: T junction Chevron required at this major junction.

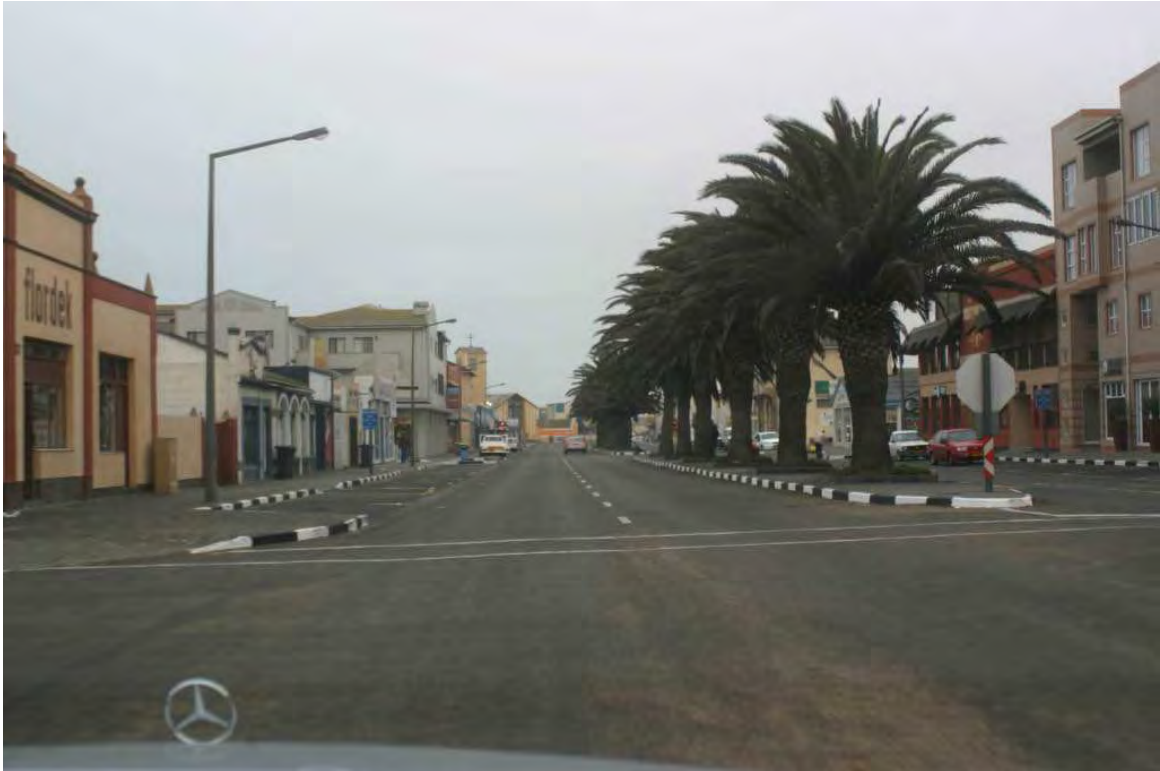
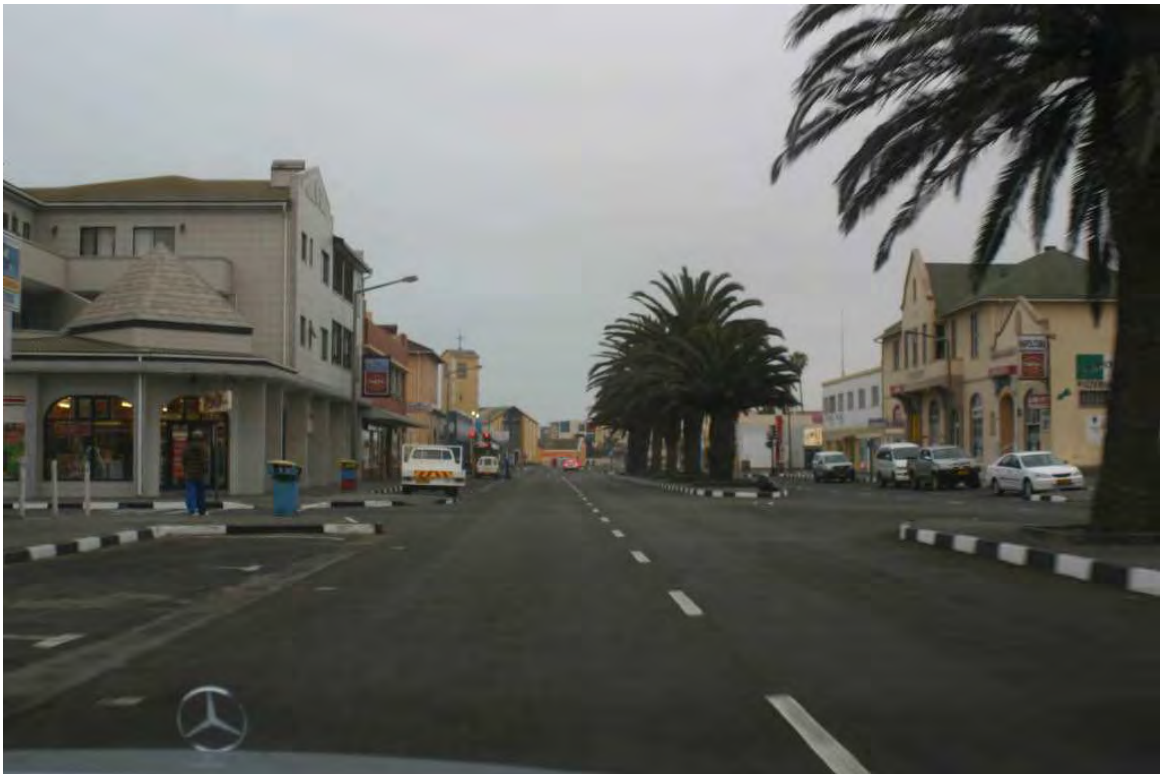
Exhibit 16.

Missing hazard markers and or Keep Left signs at approach ends of median islands or splitter islands.

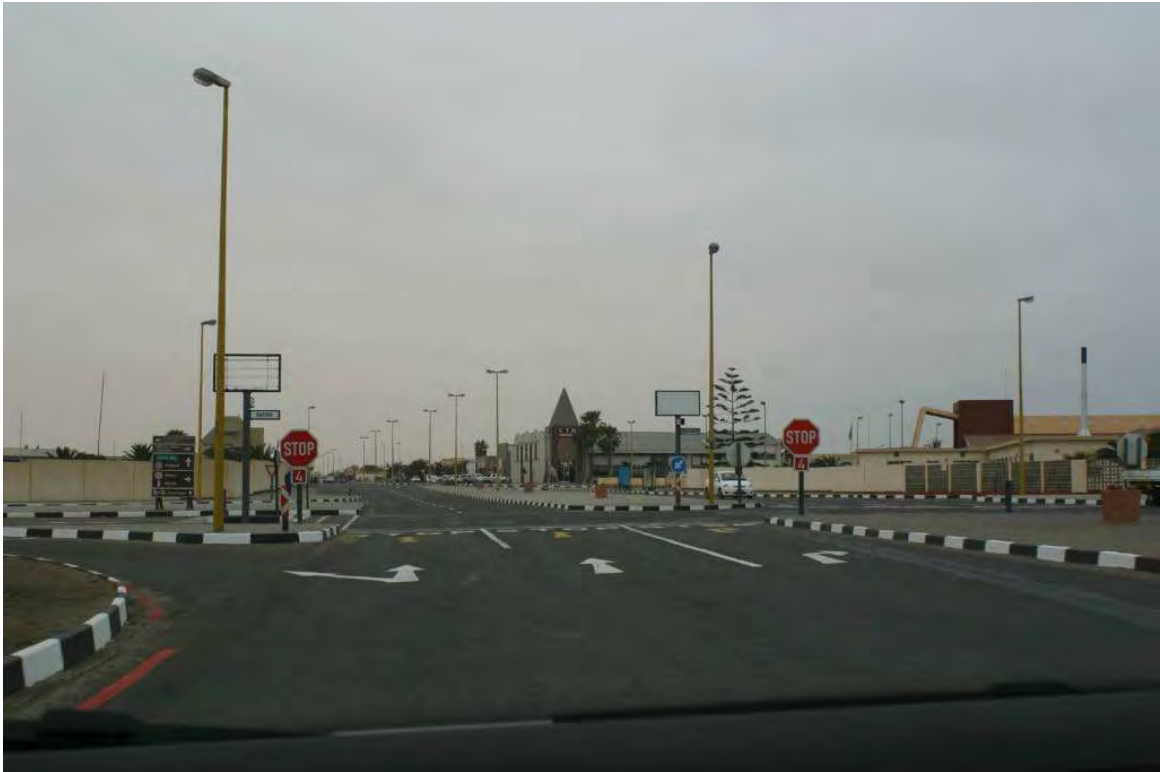
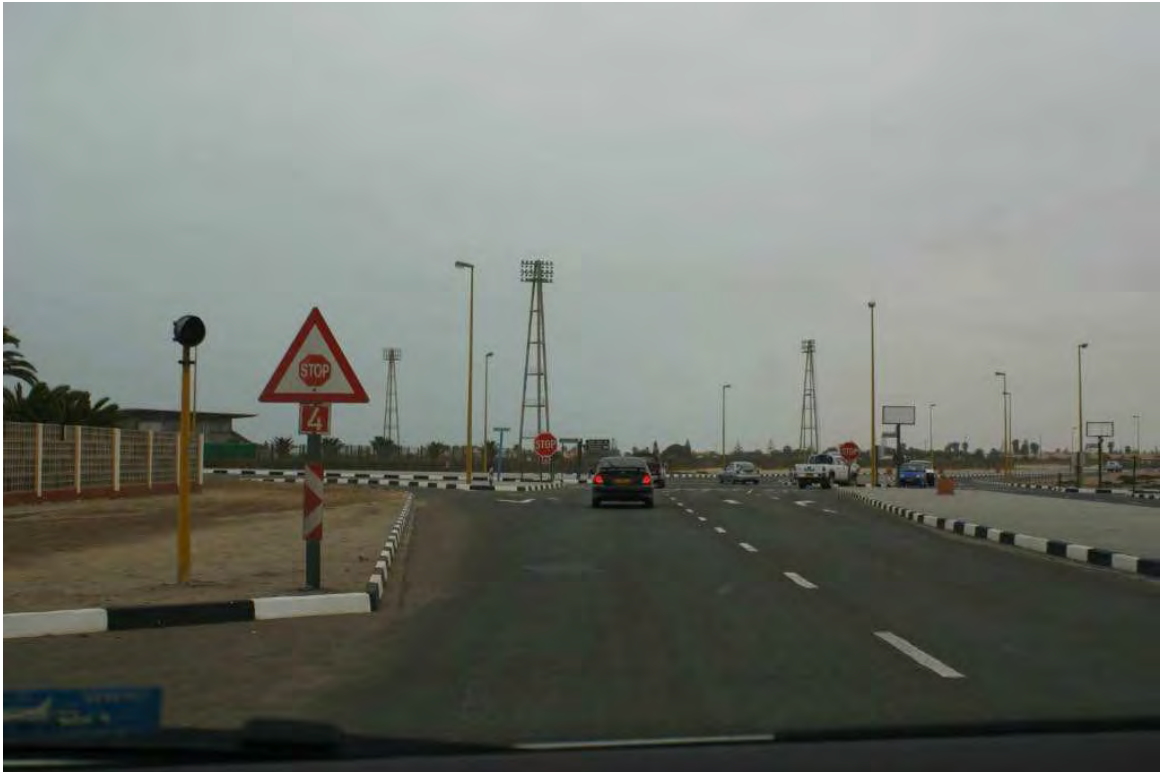
Exhibit 16 continued

Missing hazard markers on splitter islands: there should be markers pointing left and right.

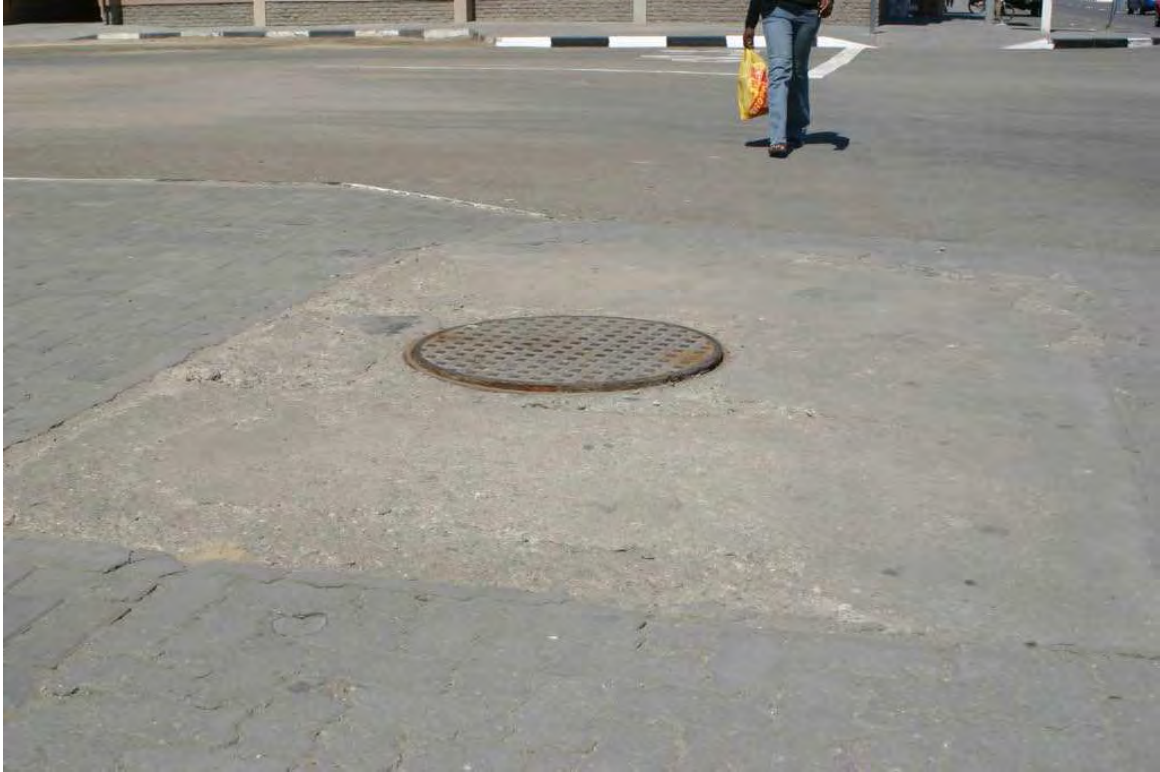
Trip hazards in the town centre.
