# **Traffic Impact Assessment Rio Tinto Rössing Uranium Limited**

## **FINAL REPORT MARCH 2010**

Road Safety Audit Report: Swakopmund to Arandis: Surfaced road B2

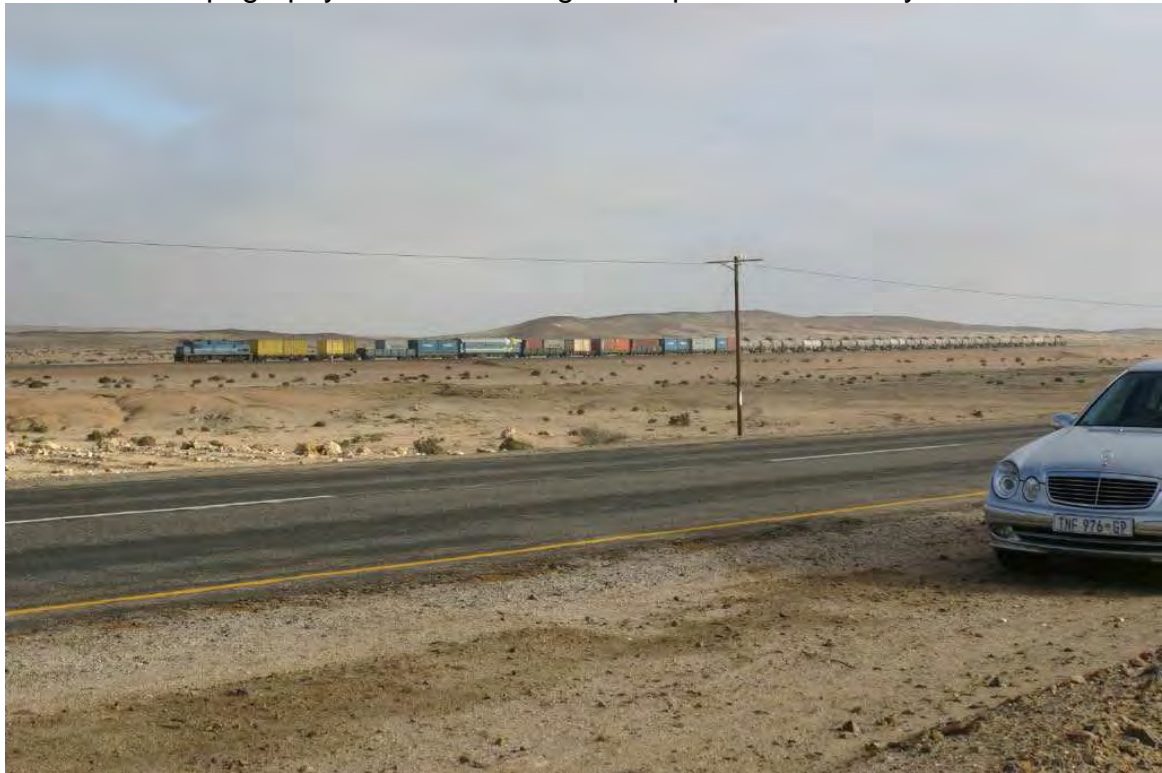
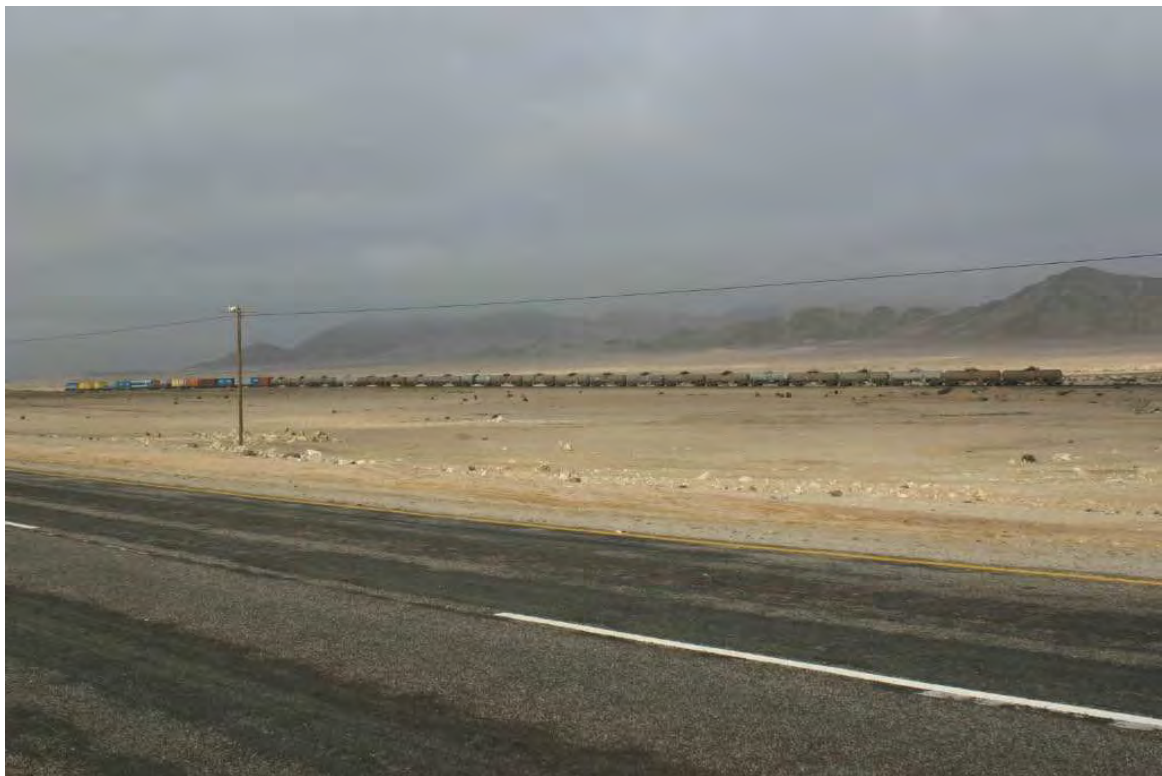
Exhibit 1

General flat topography and smooth alignment parallel to railway line.

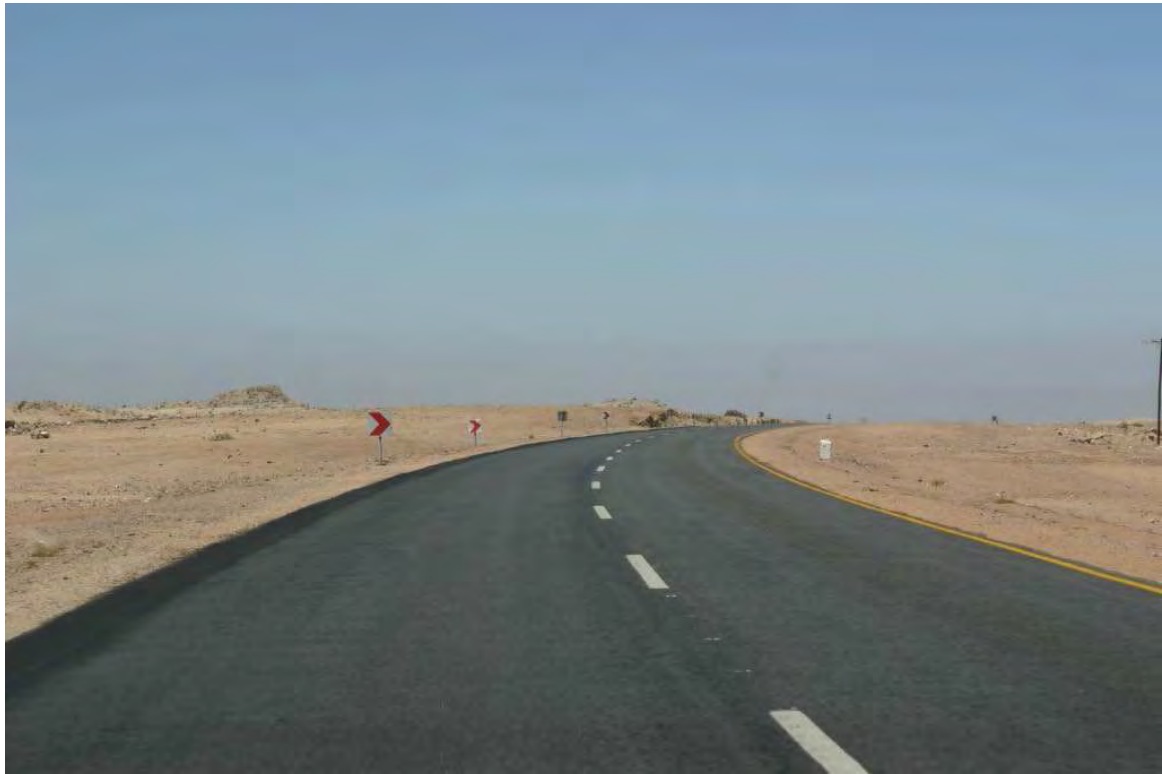
### Exhibit 3

Overtaking sight distance affected by horizontal and vertical alignment: in this case the road falls away over a vertical curve in the direction of travel, while the traffic from the opposite direction would not have adequate sight distance if travelling behind a heavy vehicle unless it moves into the opposing lane to see past the vehicle.

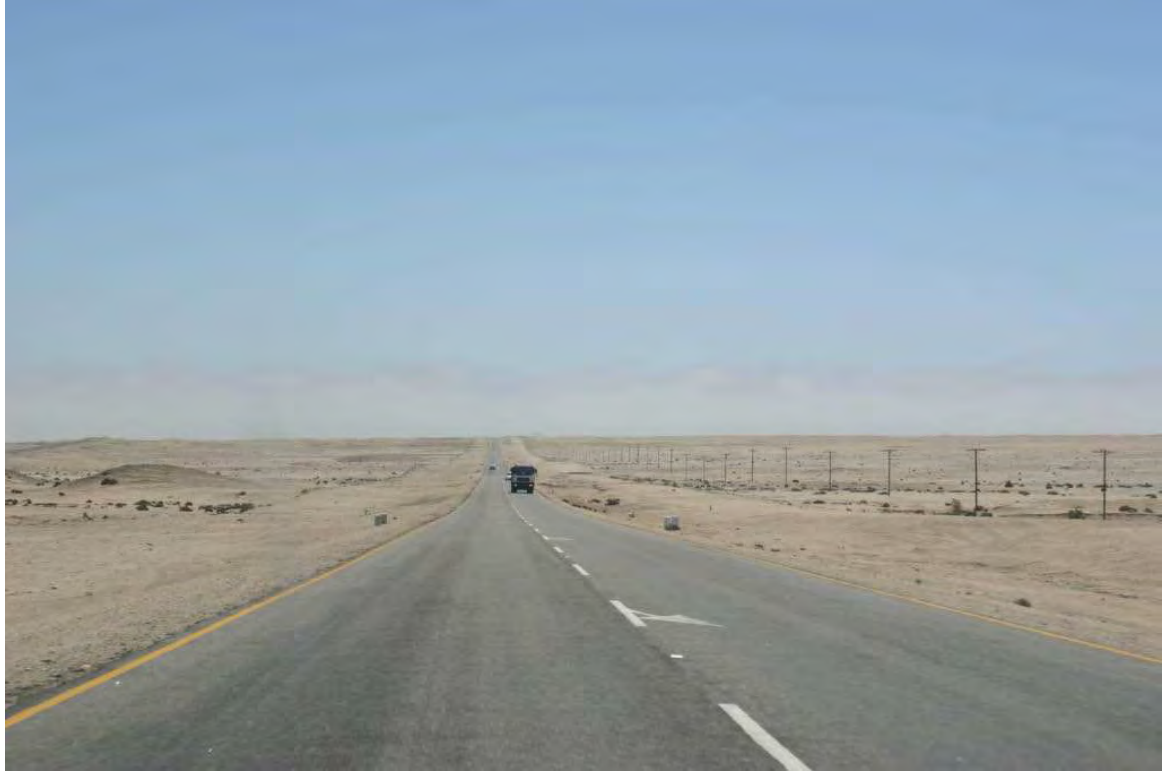
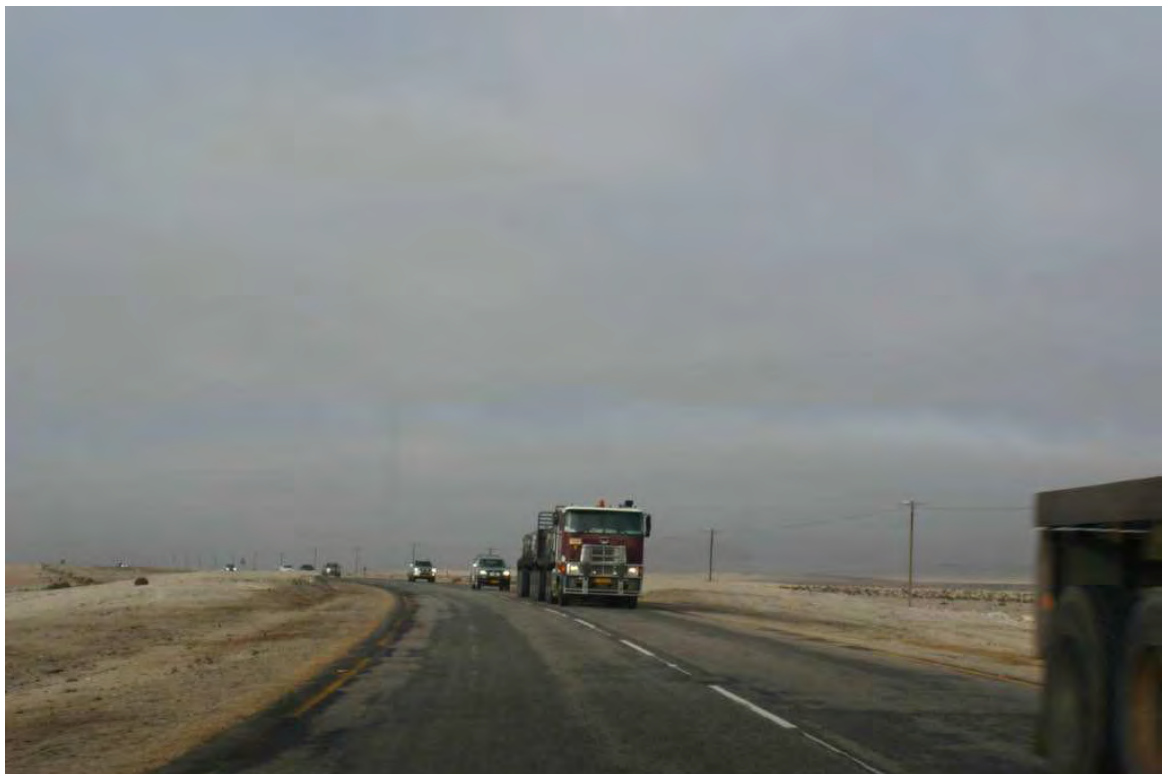
Exhibit 4

Narrow cross section is compensated for by a wide recovery area, but is problematic in curves. See patching on inside of curve in second photo.

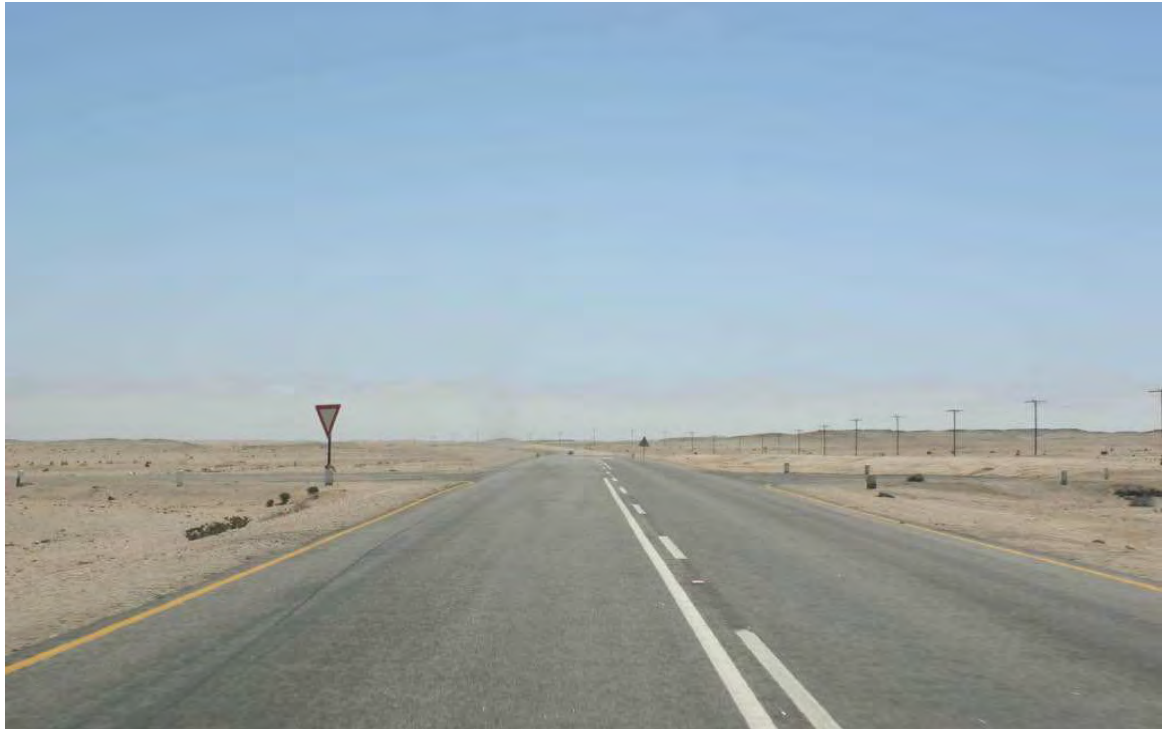
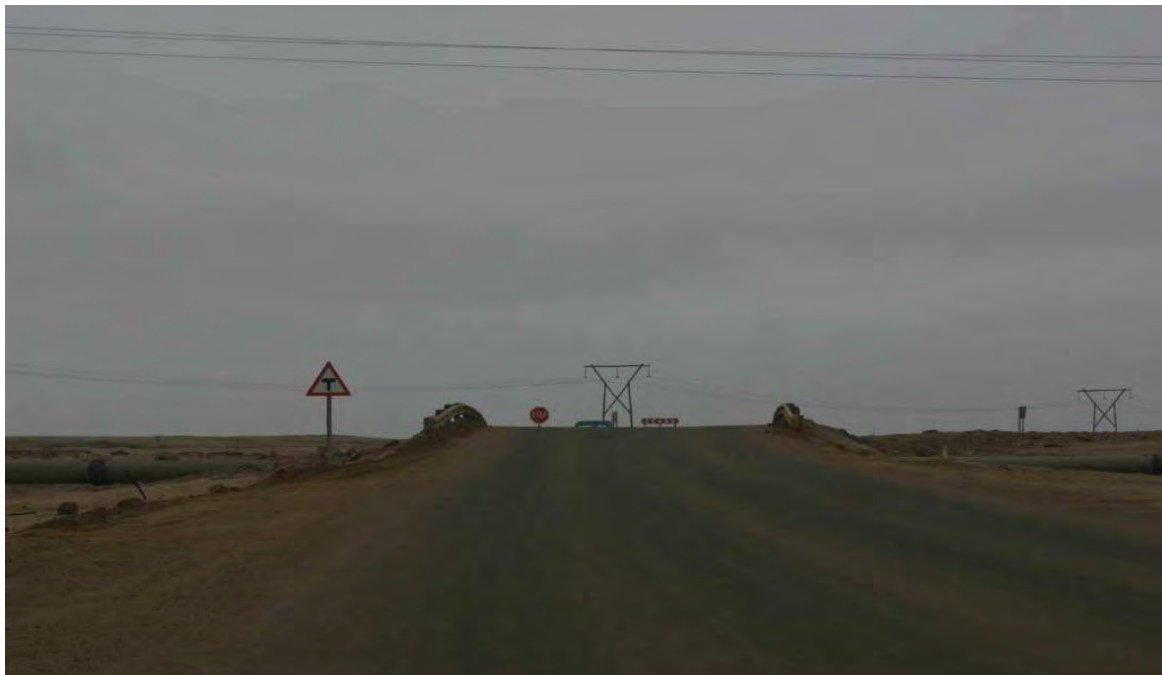
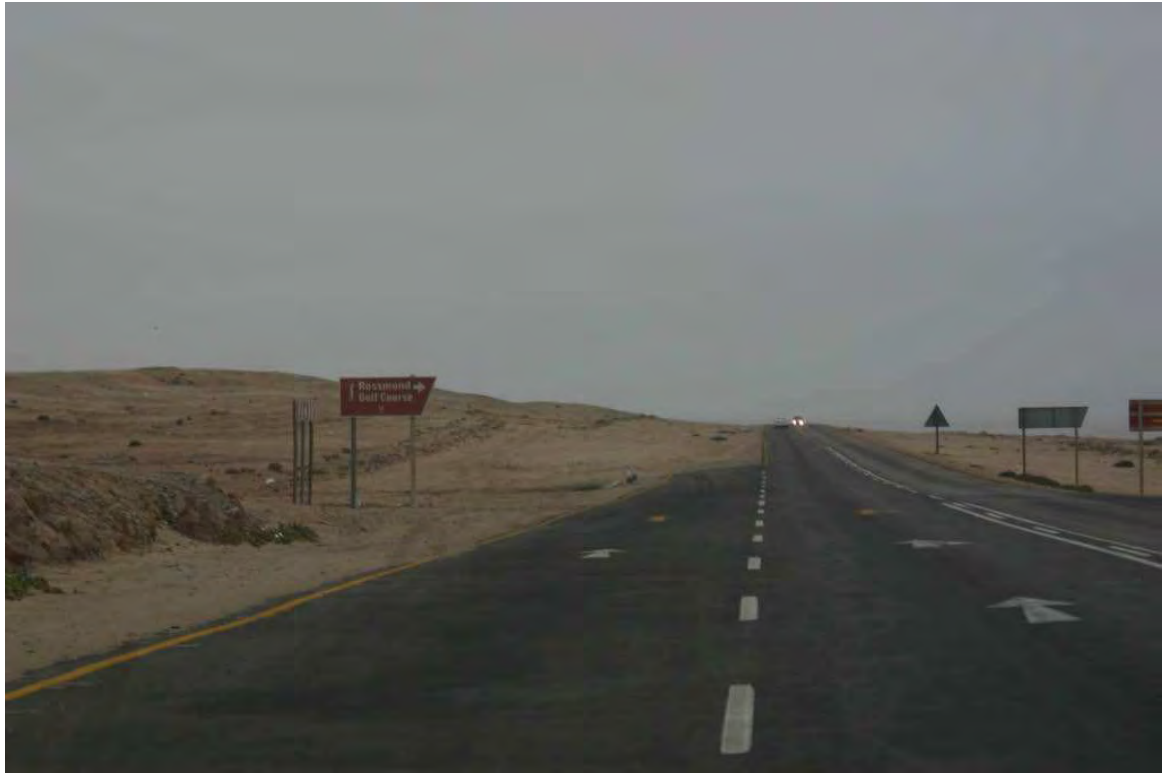
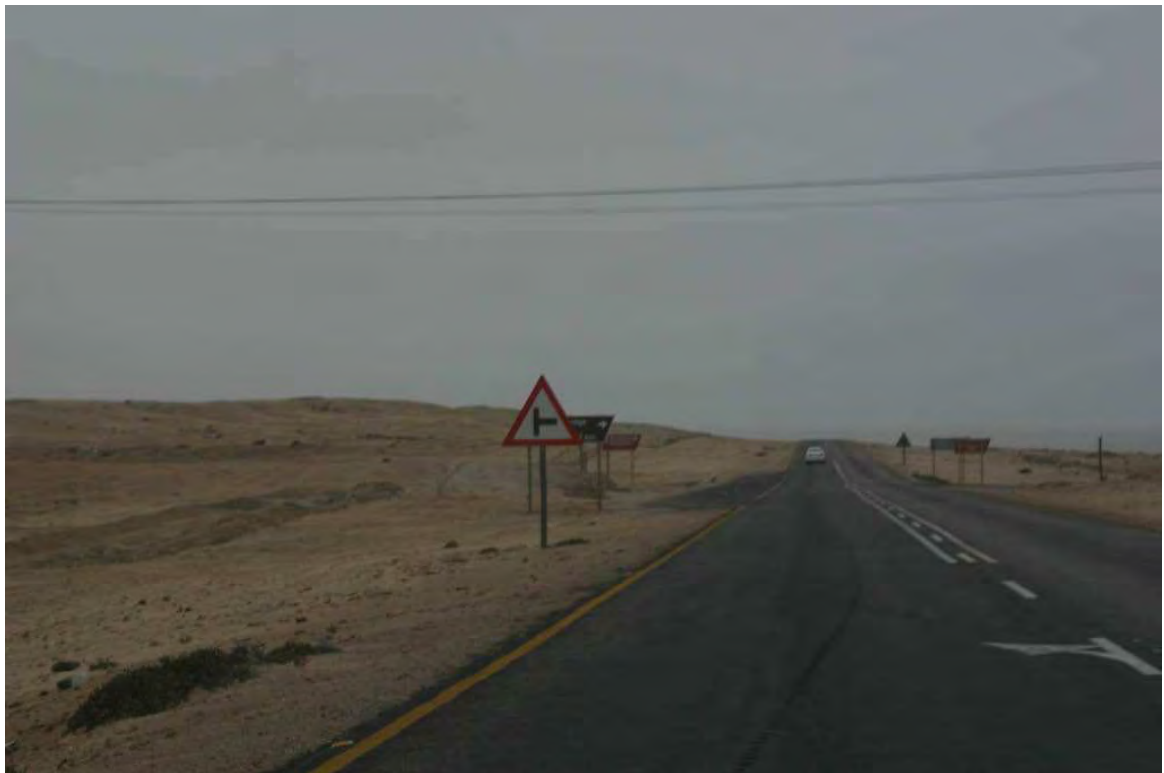
### Exhibit 5: Intersections on the B2

Lack of auxiliary lanes at minor intersections or junctions leaves turning vehicles without any protection from high speed through vehicles. Where auxiliary lanes have been provided, the merges are not well defined. The practice of allowing through movement on both lanes in the widened area is less safe than having a dedicated protected right turn slot. The side approach must have adequate sight distance to the stop line.

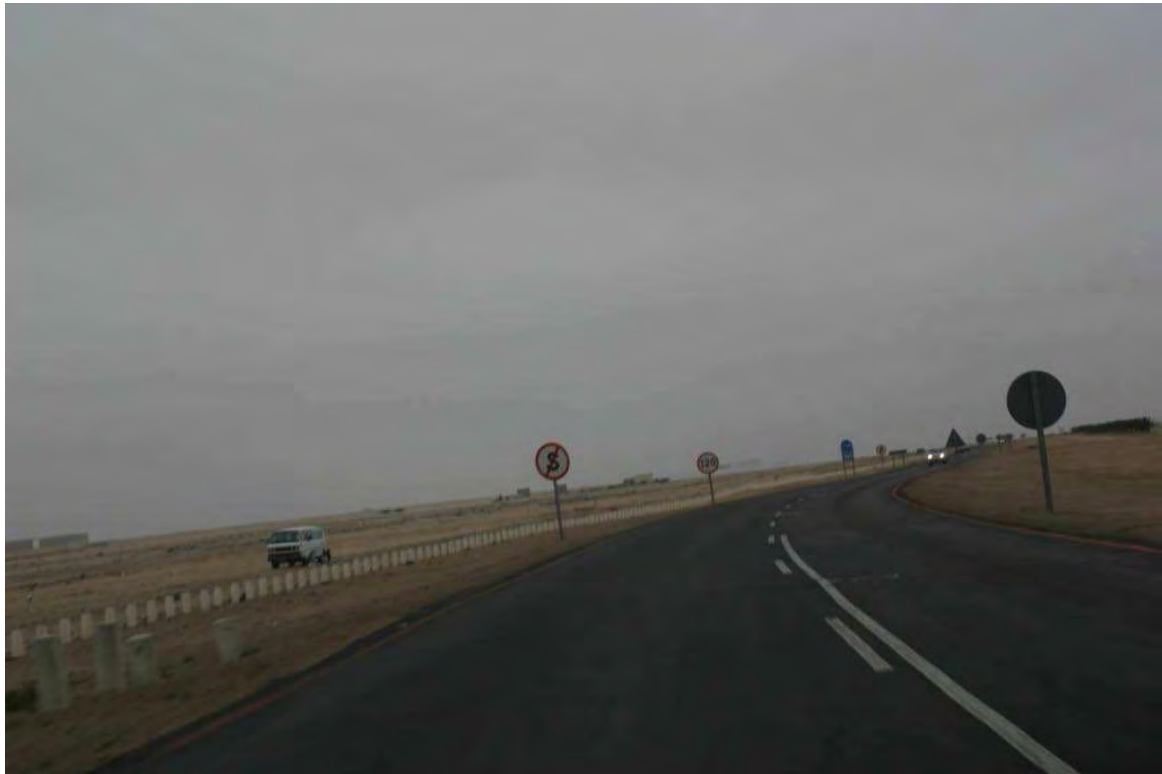
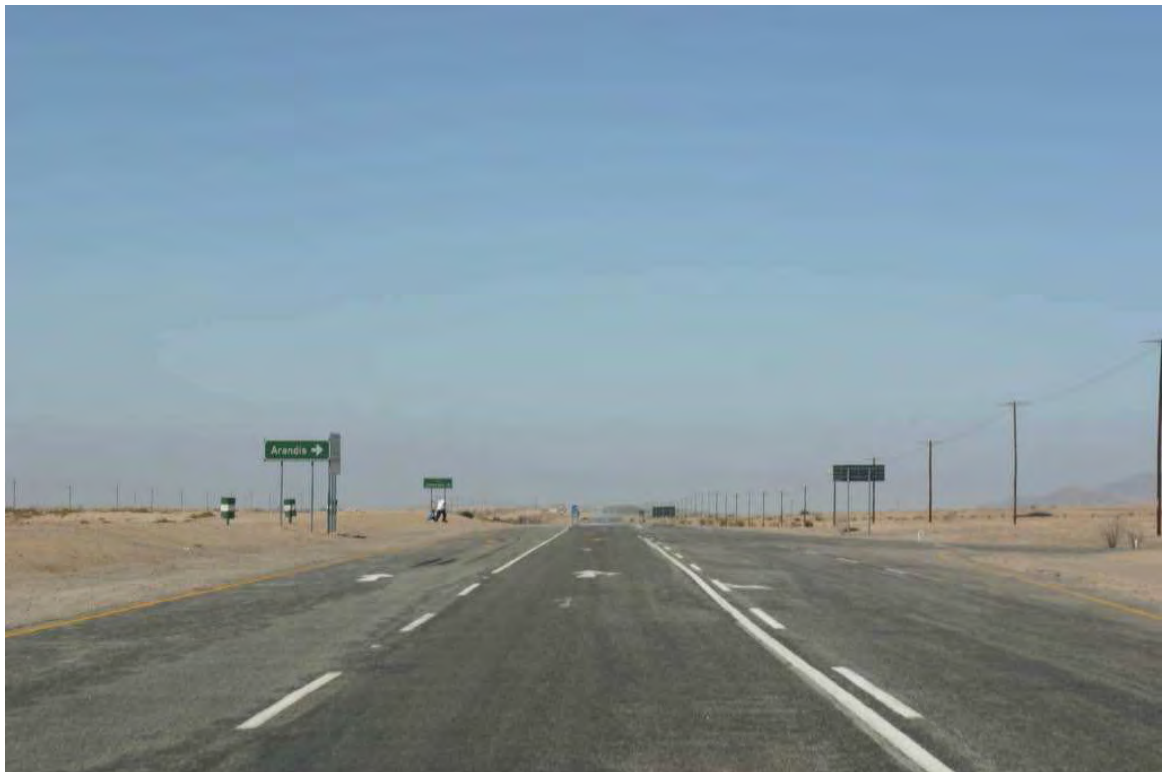
Exhibit 8

Hitch hikers at Nelson Mandela Drive, Swakopmund and Arandis T -junction. In the first case, the road was cordoned off. Facilities should be provided where it is safe for pedestrians and drivers.

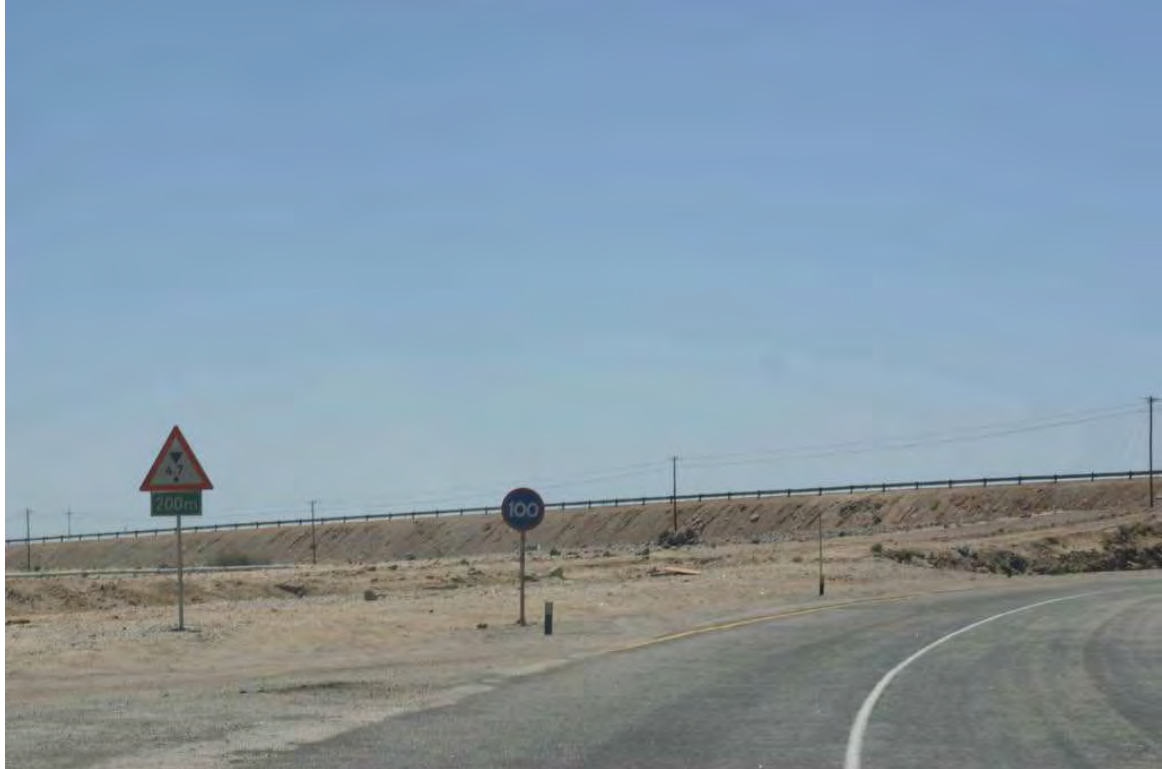
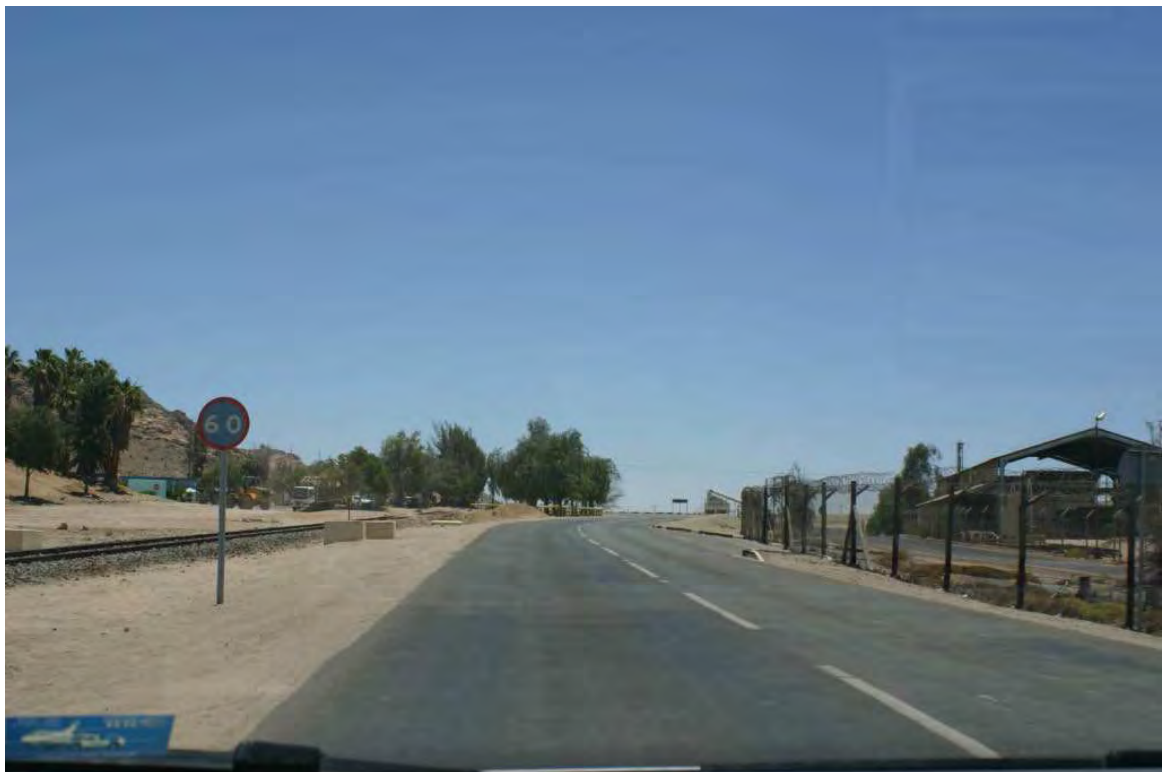
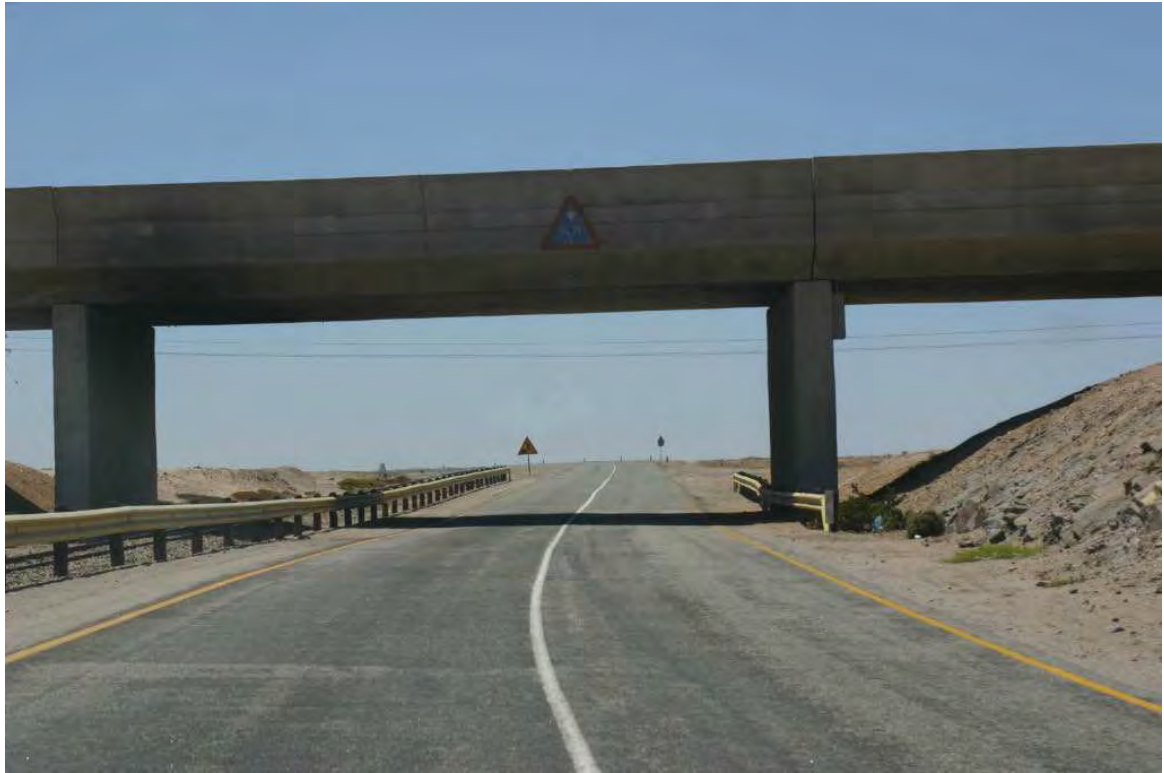
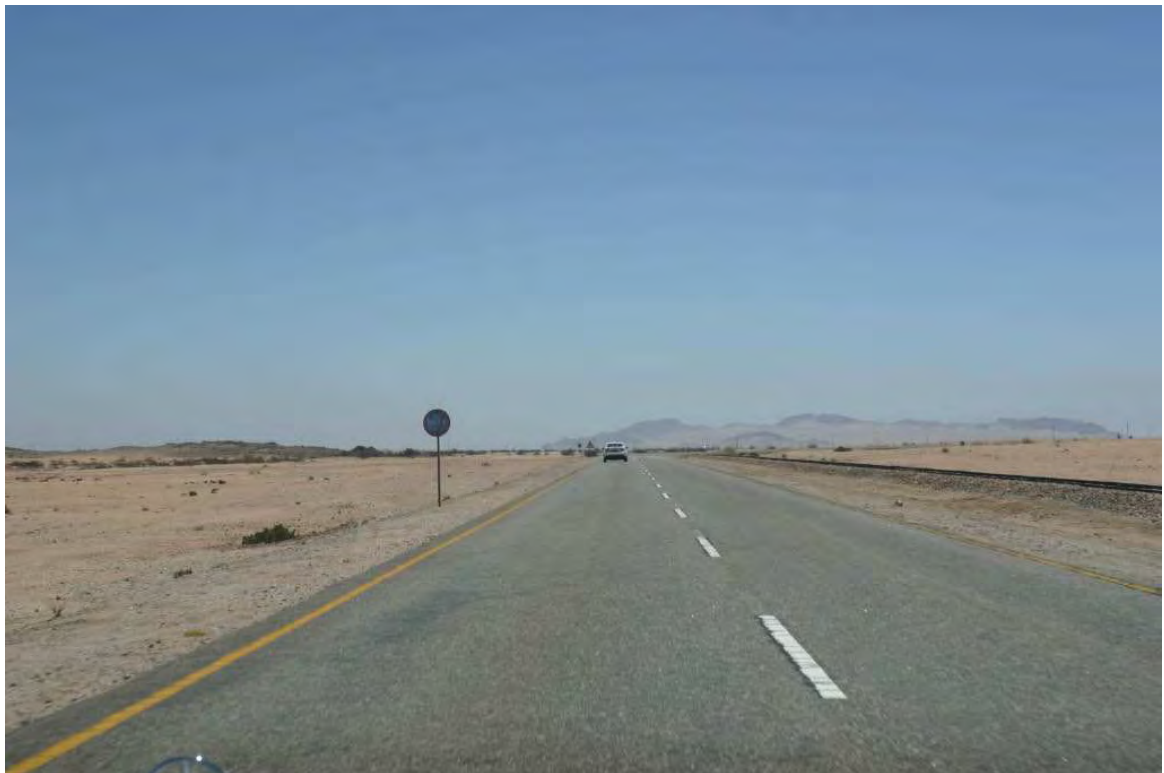
Exhibit 9

Old style road signs with blue background is not in conformance with the SADC Road and Traffic Signs Manual. These signs have no legal standing.

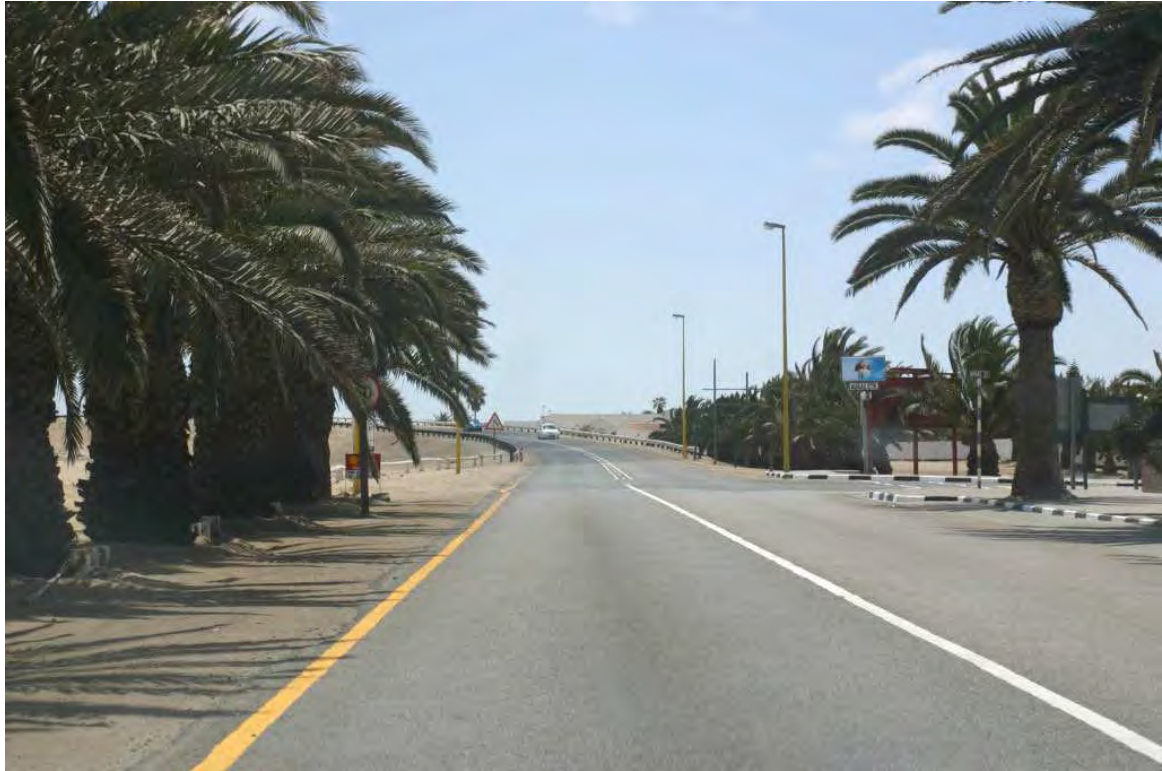
Exhibit 10

Obstruction of signs by vegetation. This is primarily an urban problem.

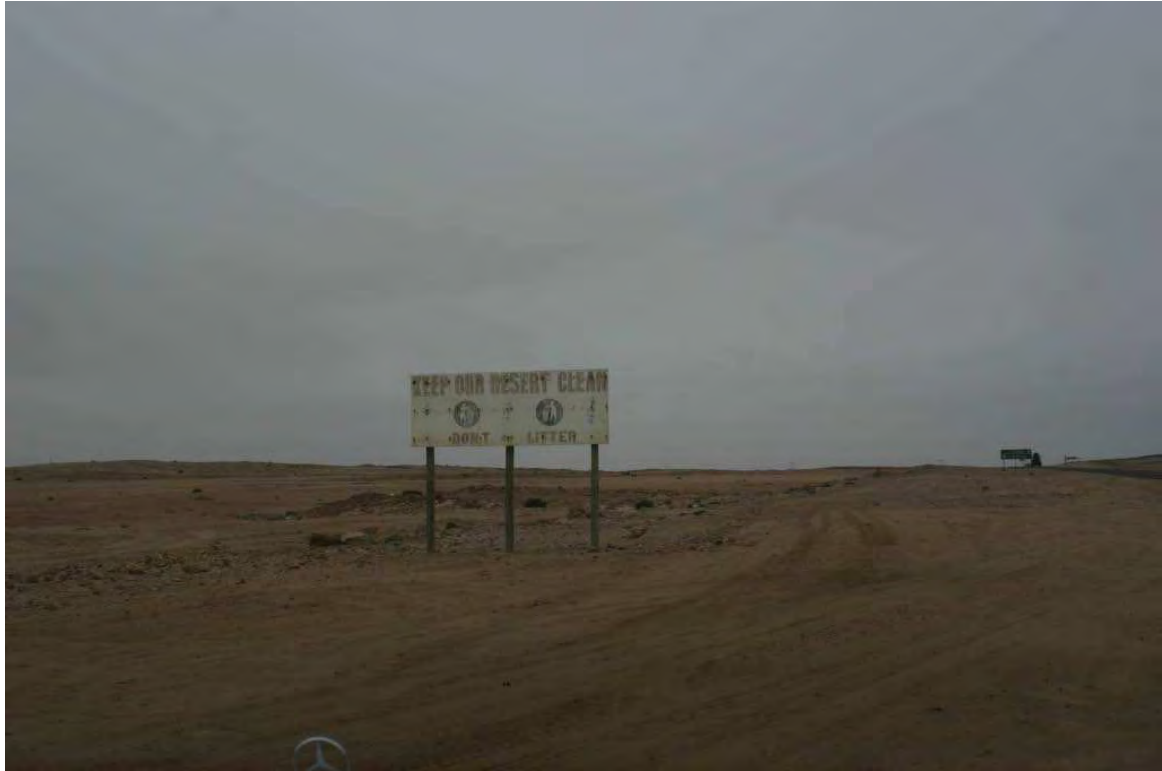
Exhibit 11

Legibility of signs: this information sign cannot be read from a moving vehicle.]

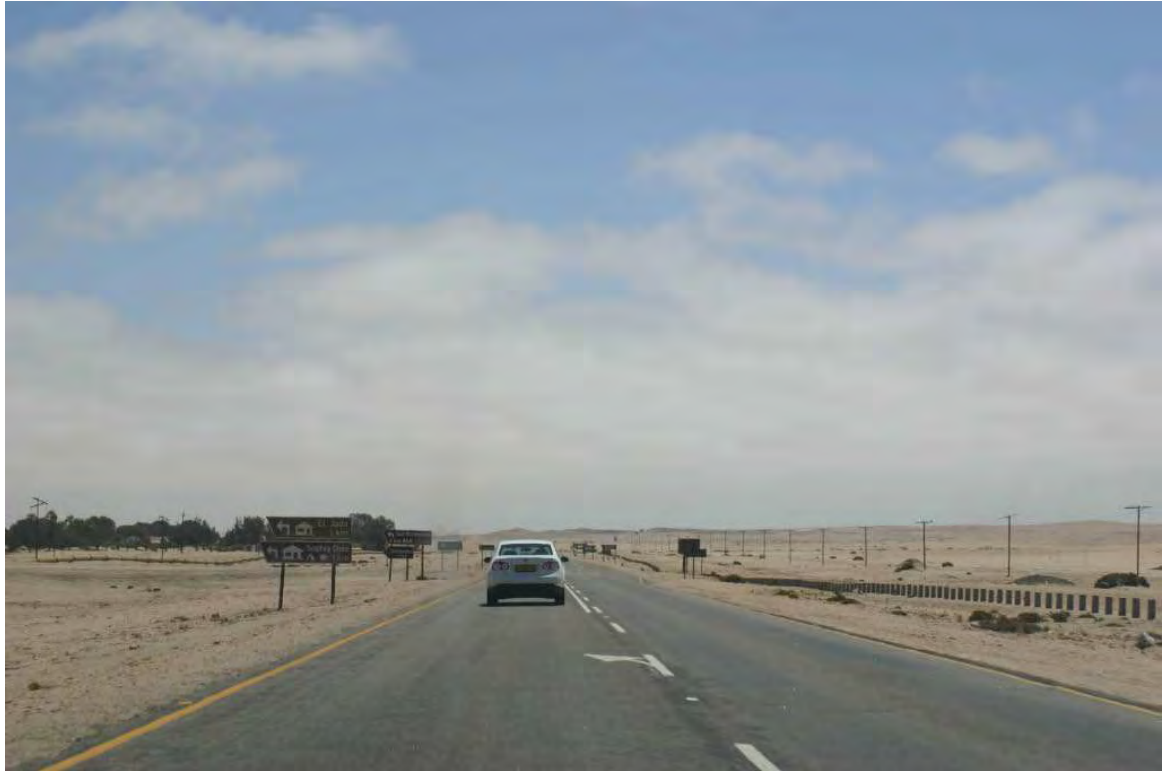
Exhibit 12

Too much information in the form of facilities signs on the B2.

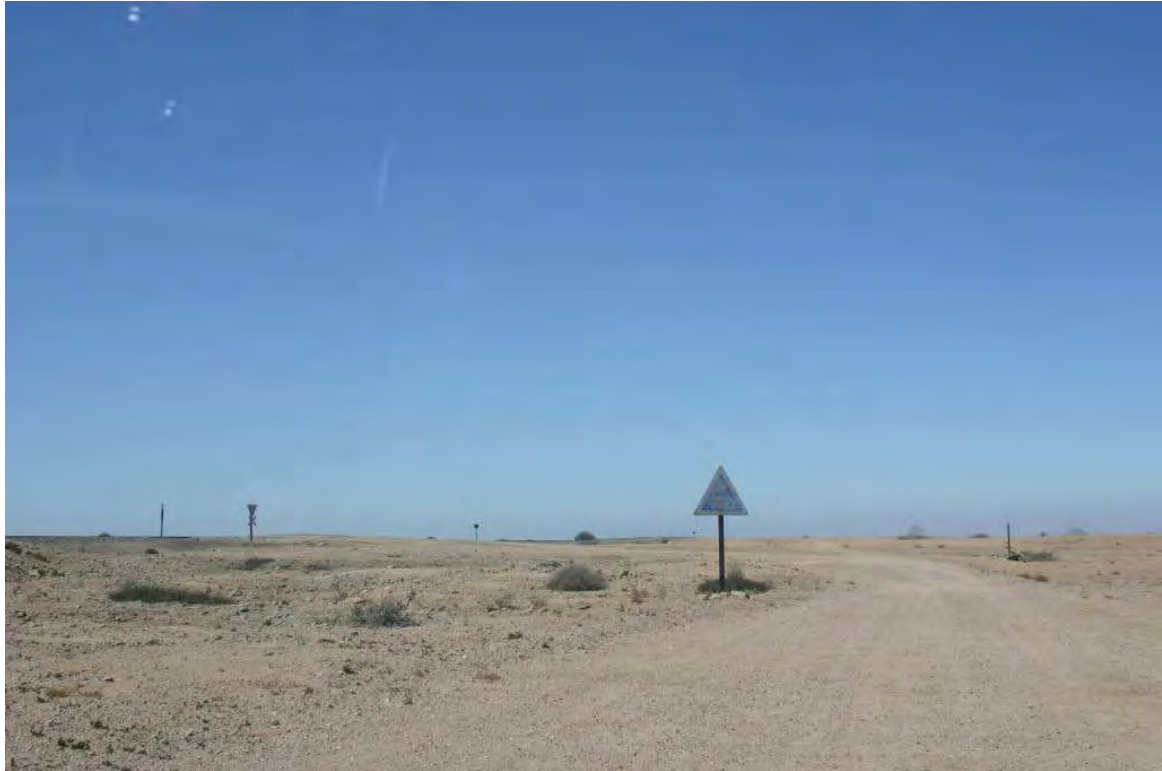
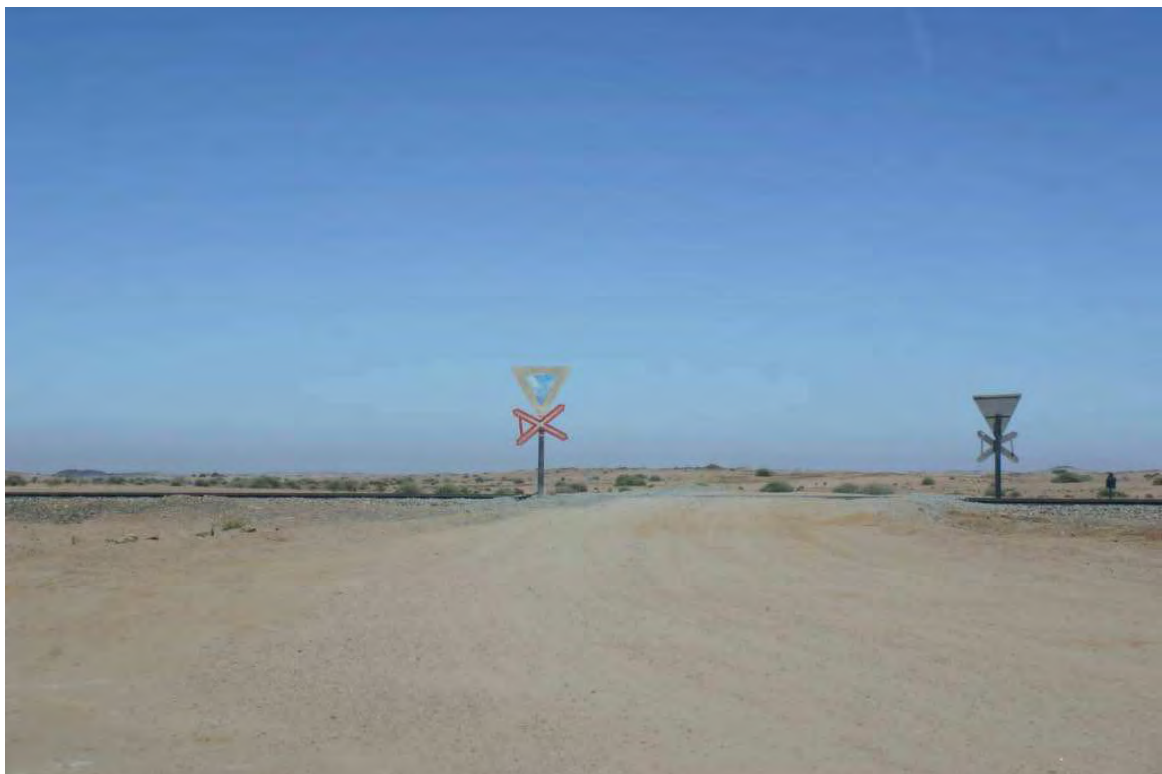
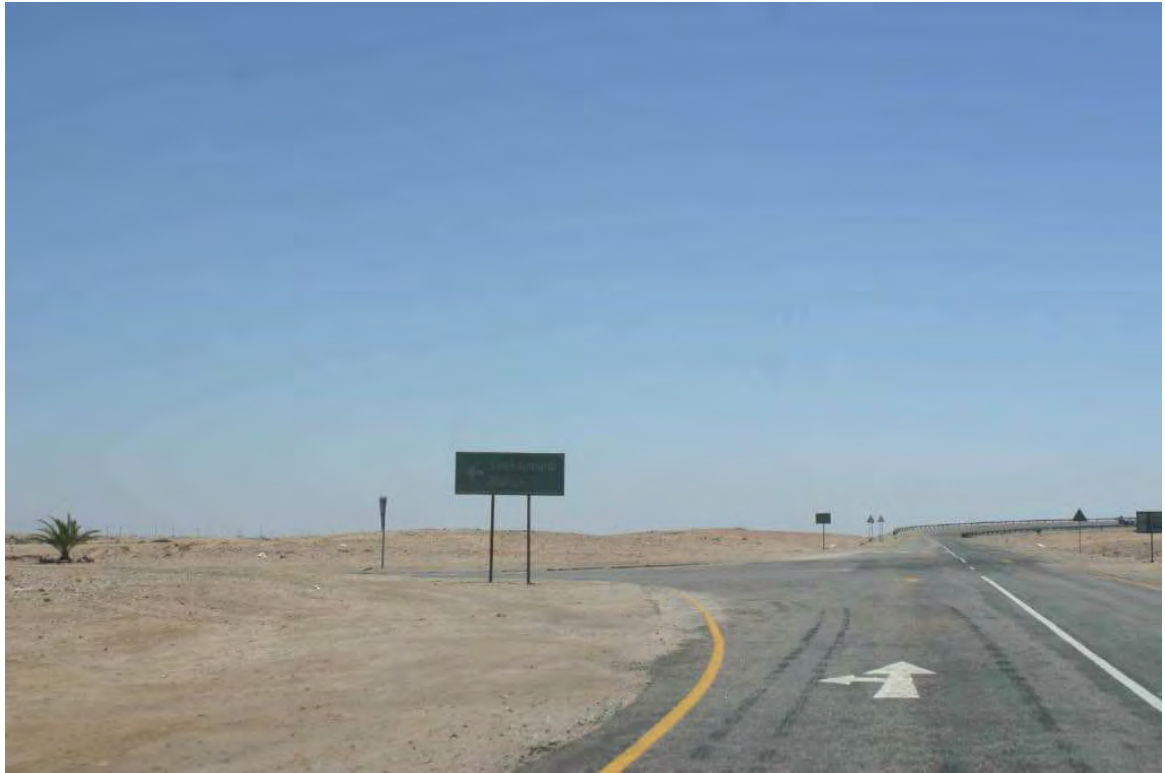
Exhibit 13

Faded road traffic signs on the B2 and road approaching the B2.

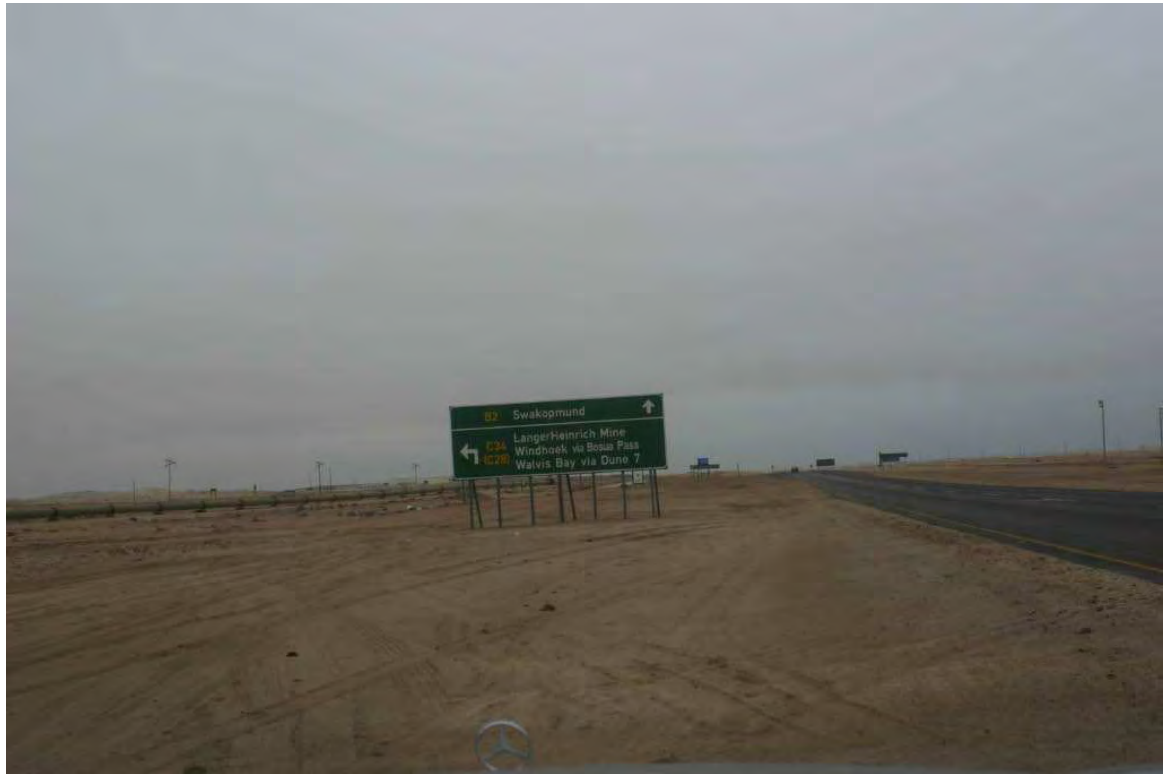
### Exhibit 16

The alternative road to Walvisbay via the "Salt" road is indicated on this direction sign. This may not be apparent to unfamiliar drivers, but known to local users.

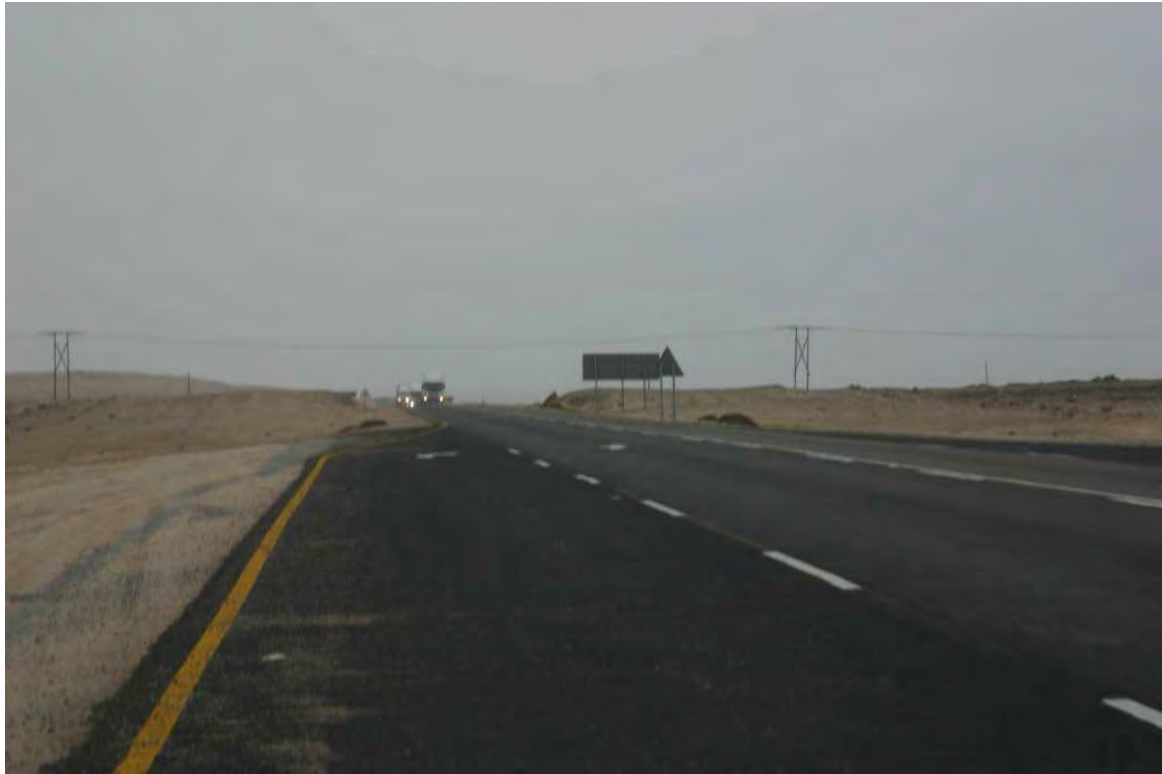
### Exhibit 19

The merge at the end of the auxiliary lane is marked on the edge of the roadway, leaving no recovery area. It is current practice to paint the merge some distance from the edge of the roadway to allow some encroachment of the merge limit without leaving the roadway.

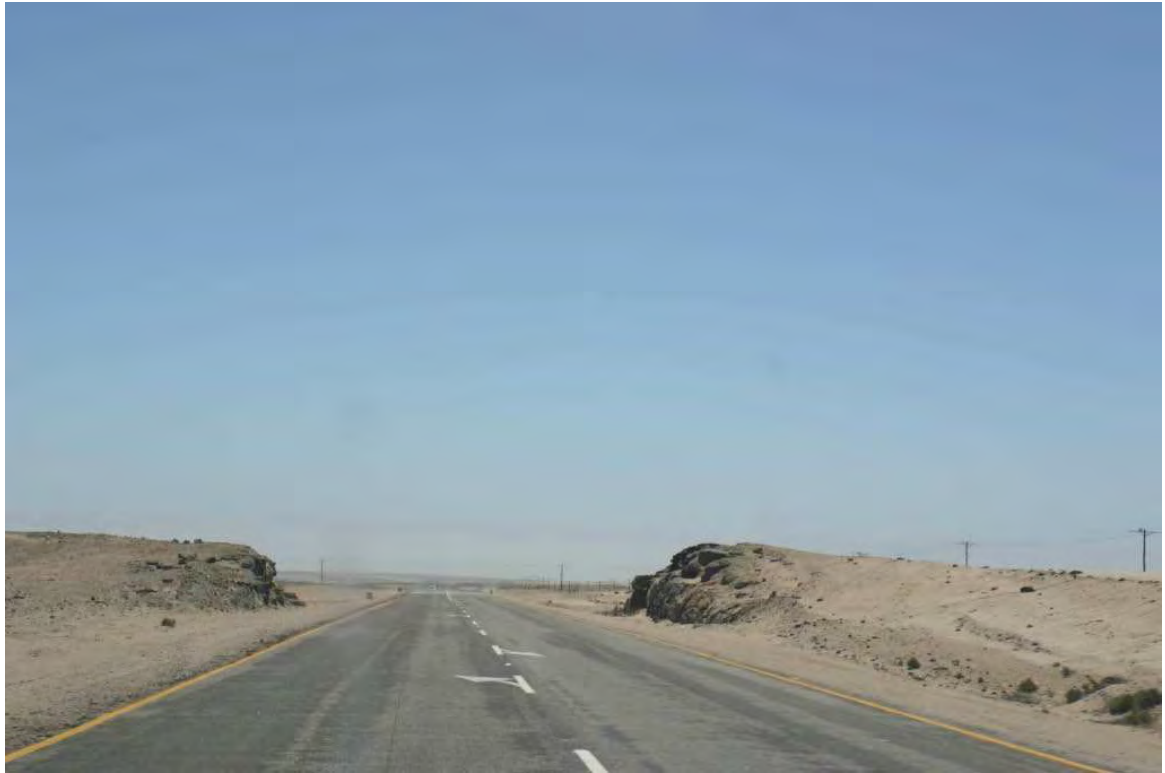
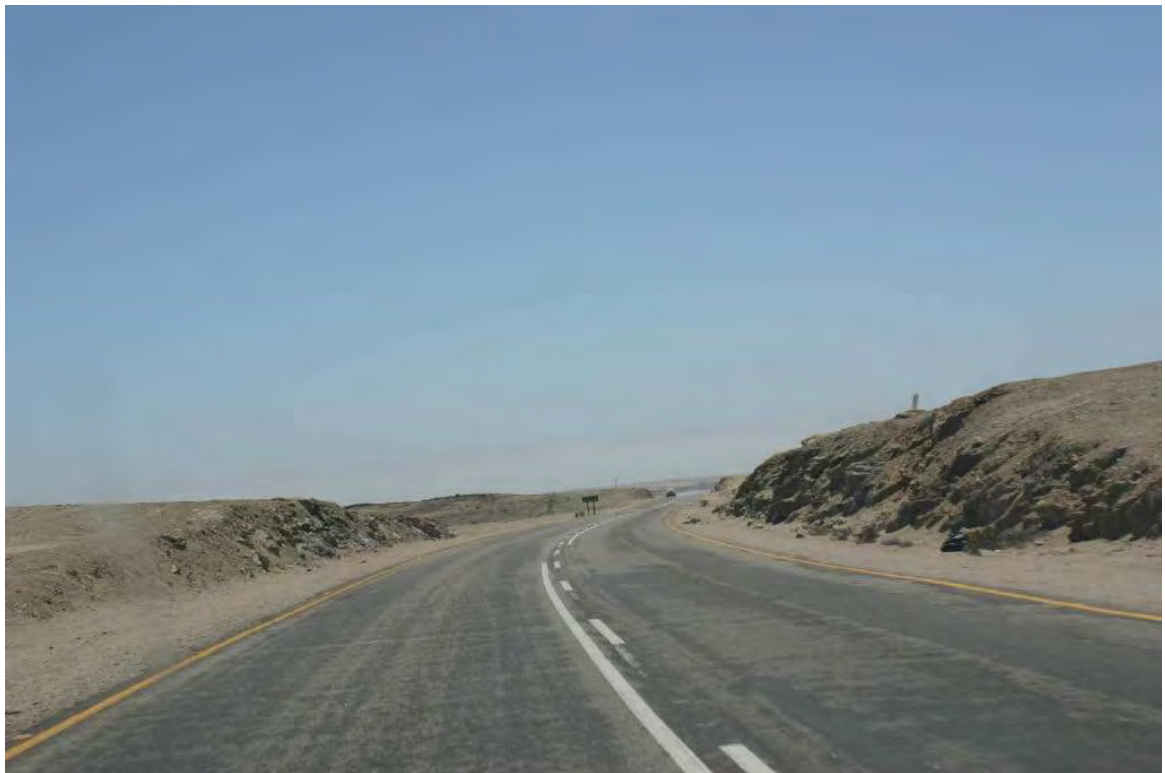
Exhibit 20

Clear zones are affected by local narrow rock cuttings inhibit recovery and pose hazards.
