# **Traffic Impact Assessment Rio Tinto Rössing Uranium Limited**

## **FINAL REPORT MARCH 2010**

Road Safety Audit Report: Swakopmund to Arandis: Surfaced road B2

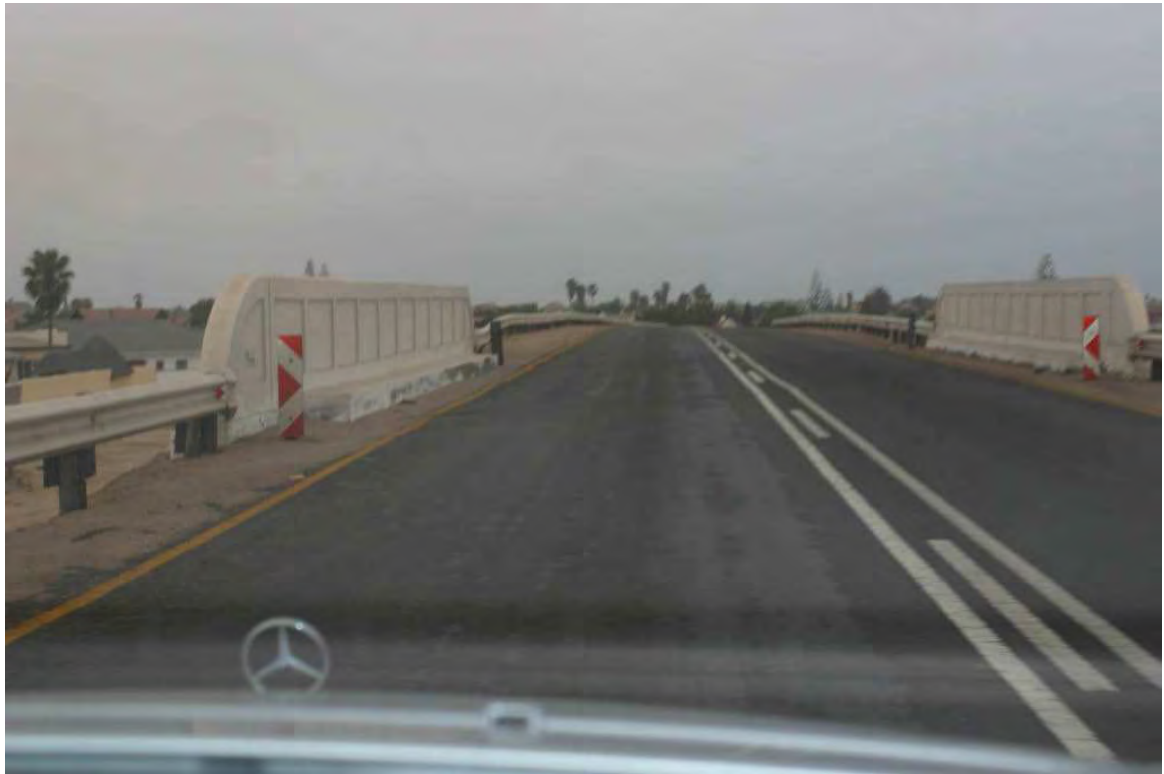
Exhibit 23

Guard rails should tie in with bridge balustrades as an strong anchorage. Unconnected guard rails can deflect and guide the errand vehicle into the balustrade.

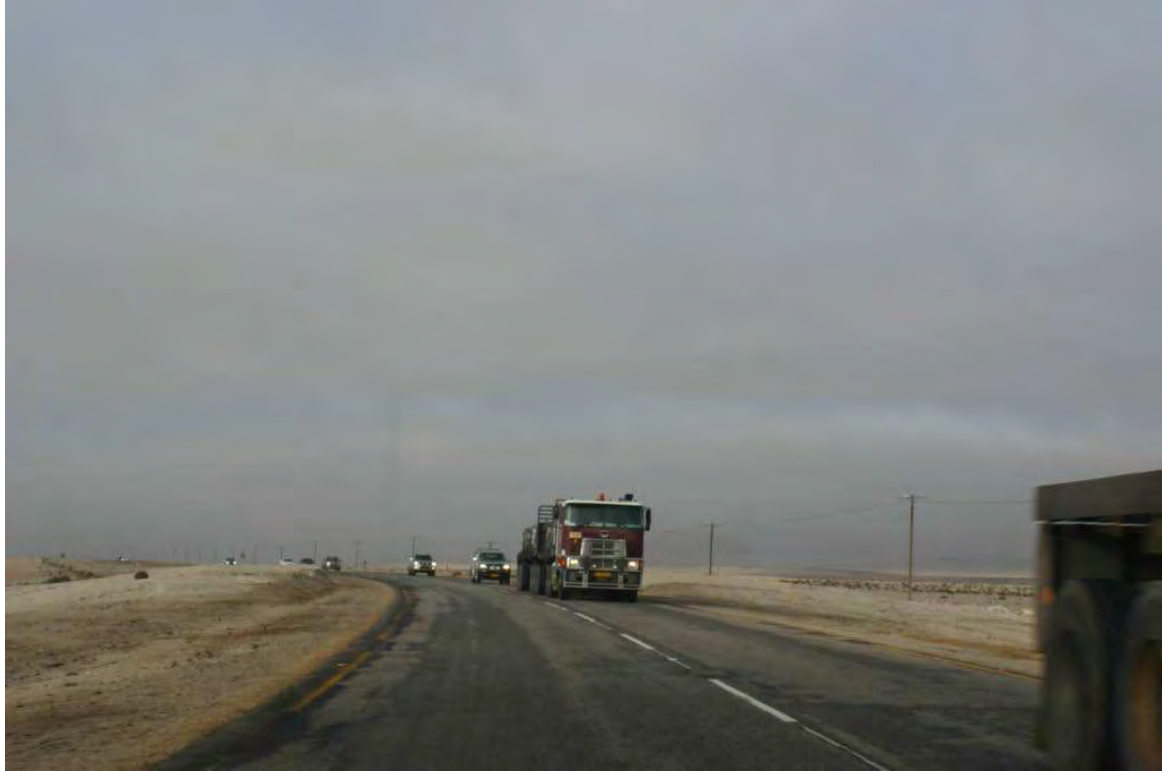
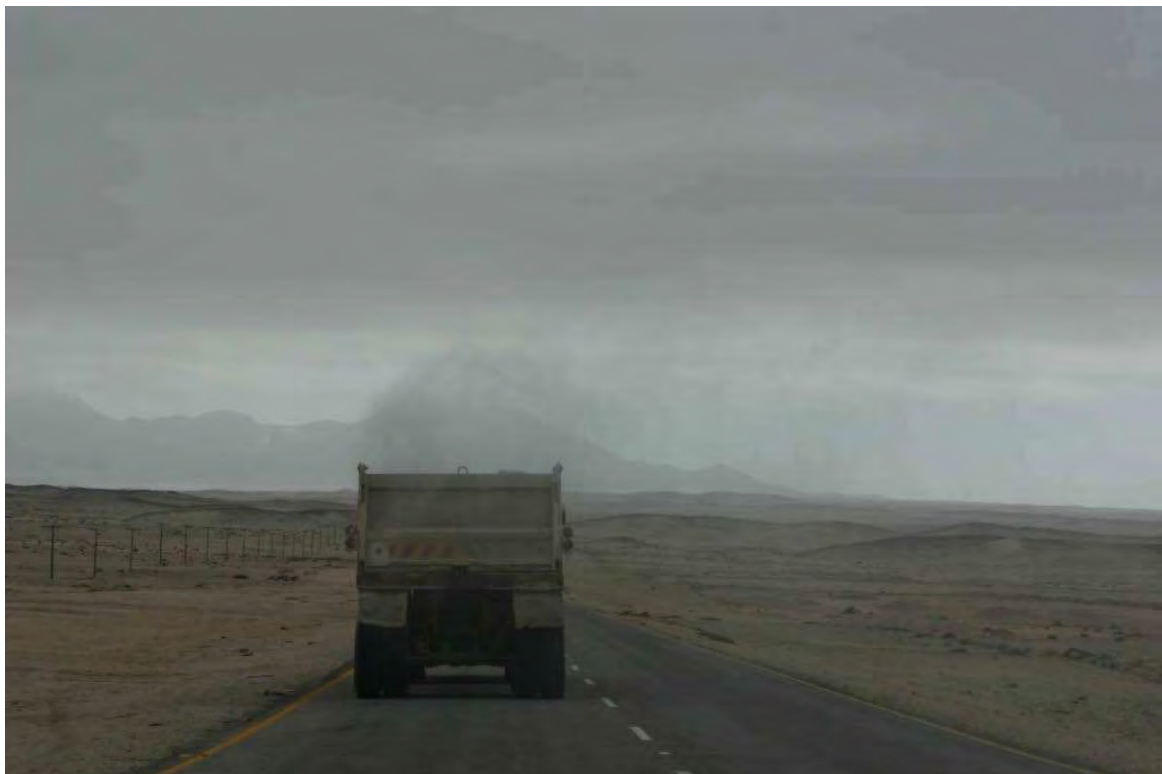
Exhibit 25

Passing opportunities are dictated by heavy vehicle speeds and platooning. Provision of passing opportunities improves safety and reduces frustration.

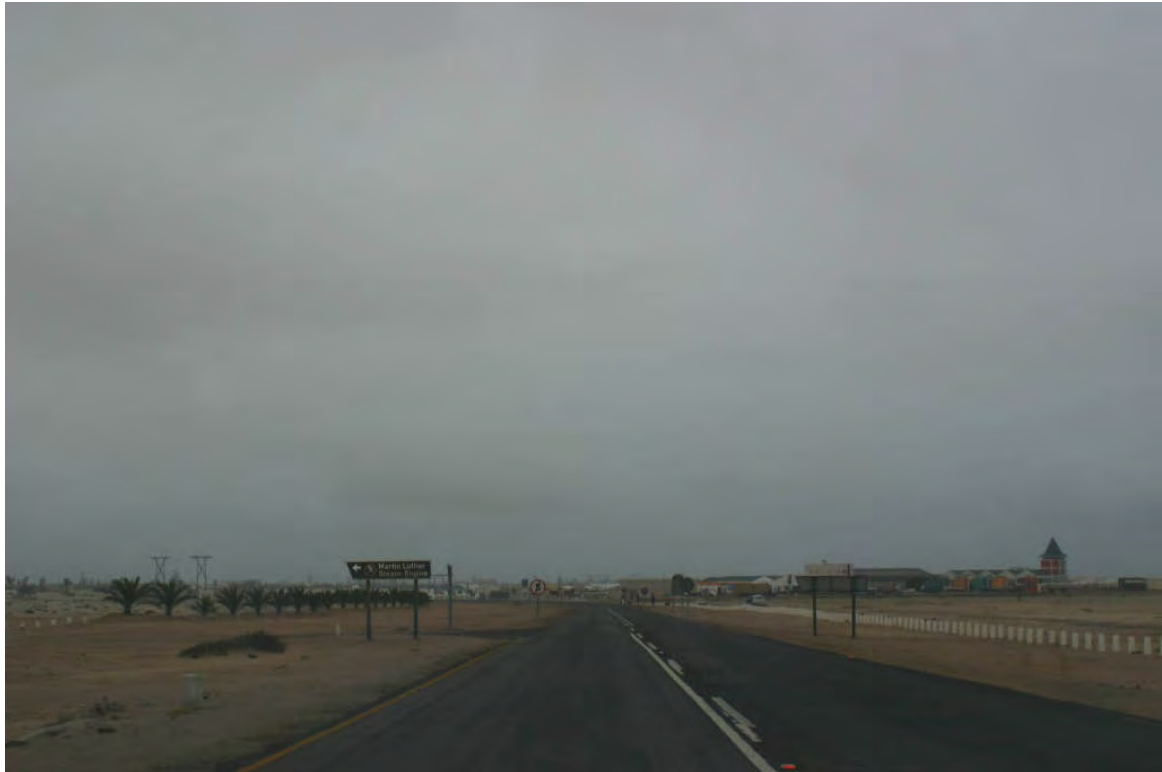
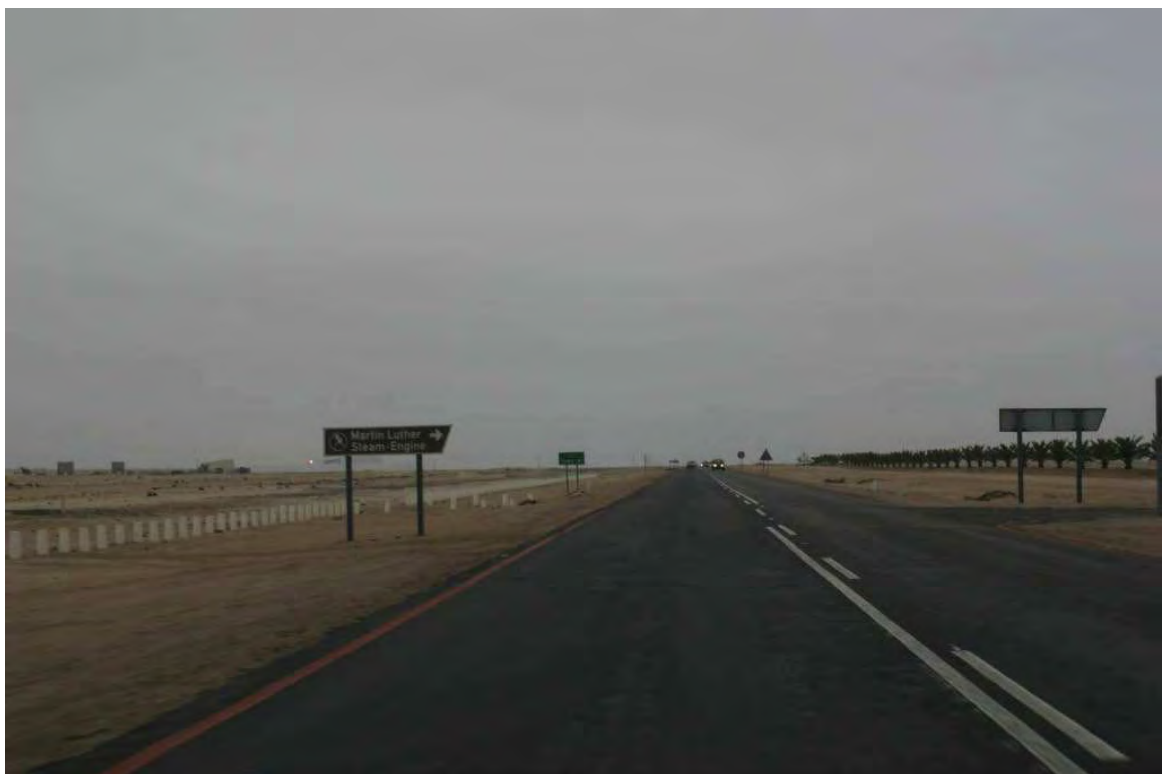
Exhibit 26

Formal access to the Martin Luther Train tourism facility off the B2

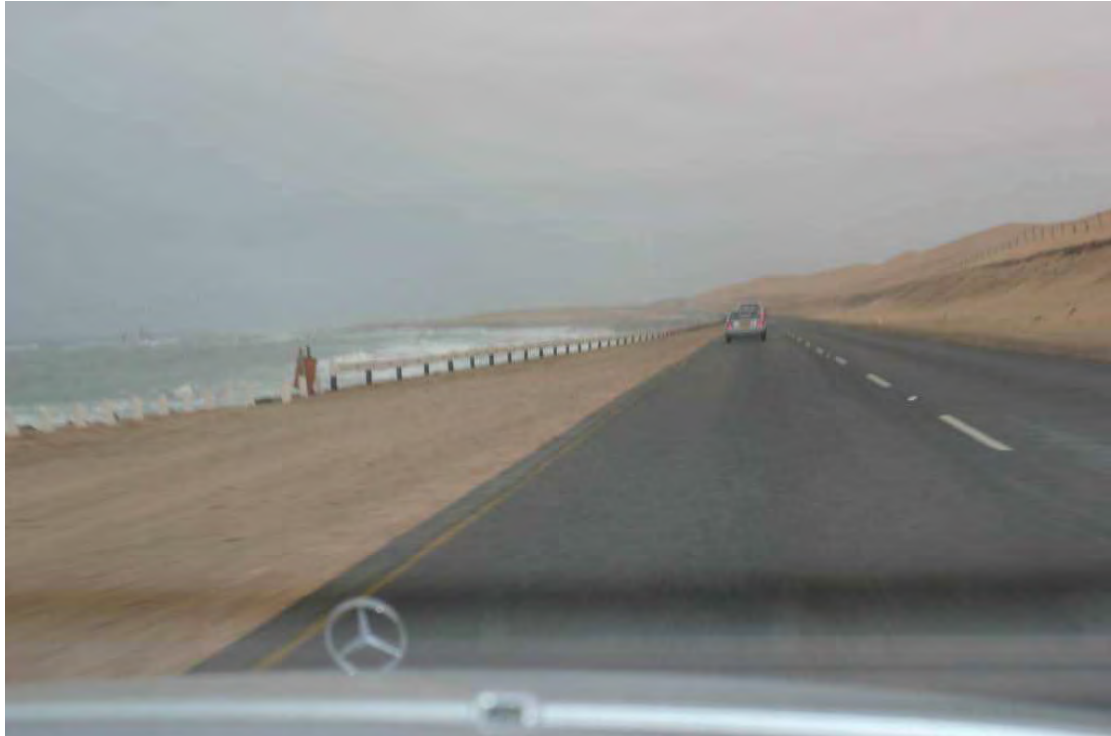
Exhibit 1

General flat topography and smooth alignment parallel to the shore line.

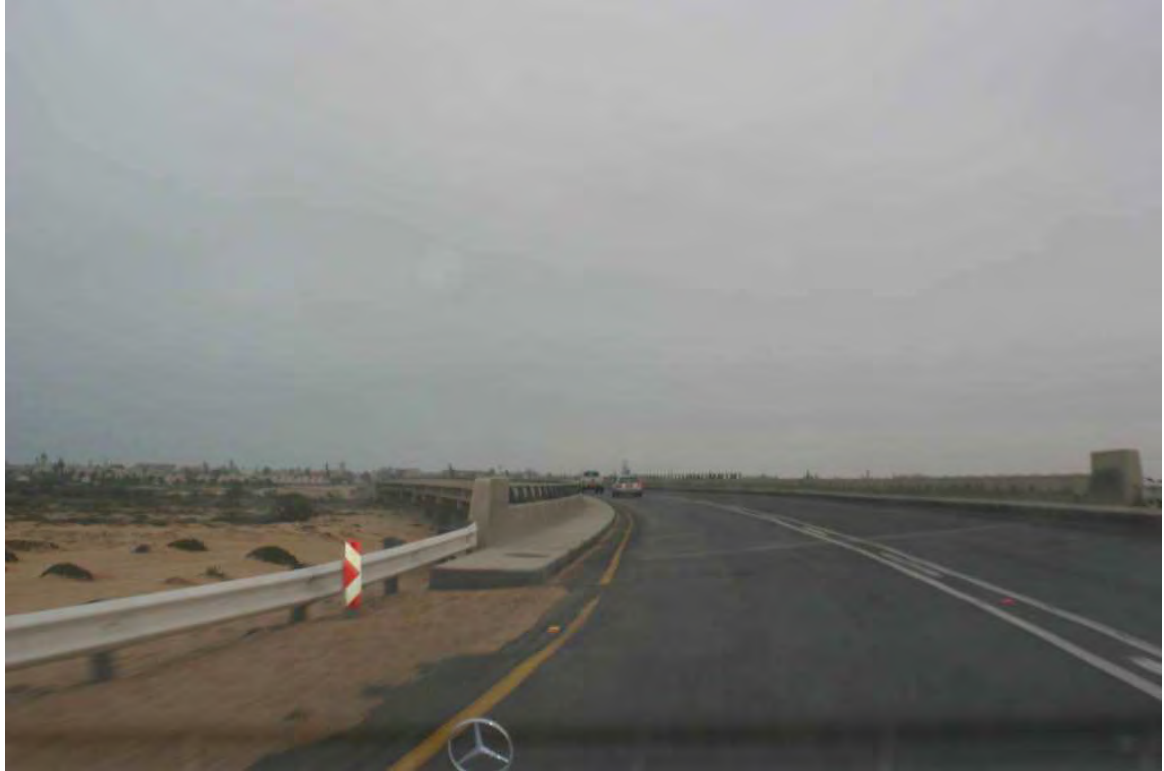
Exhibit 2

Entry into Swakopmund on curve serves as speed reduction measure.

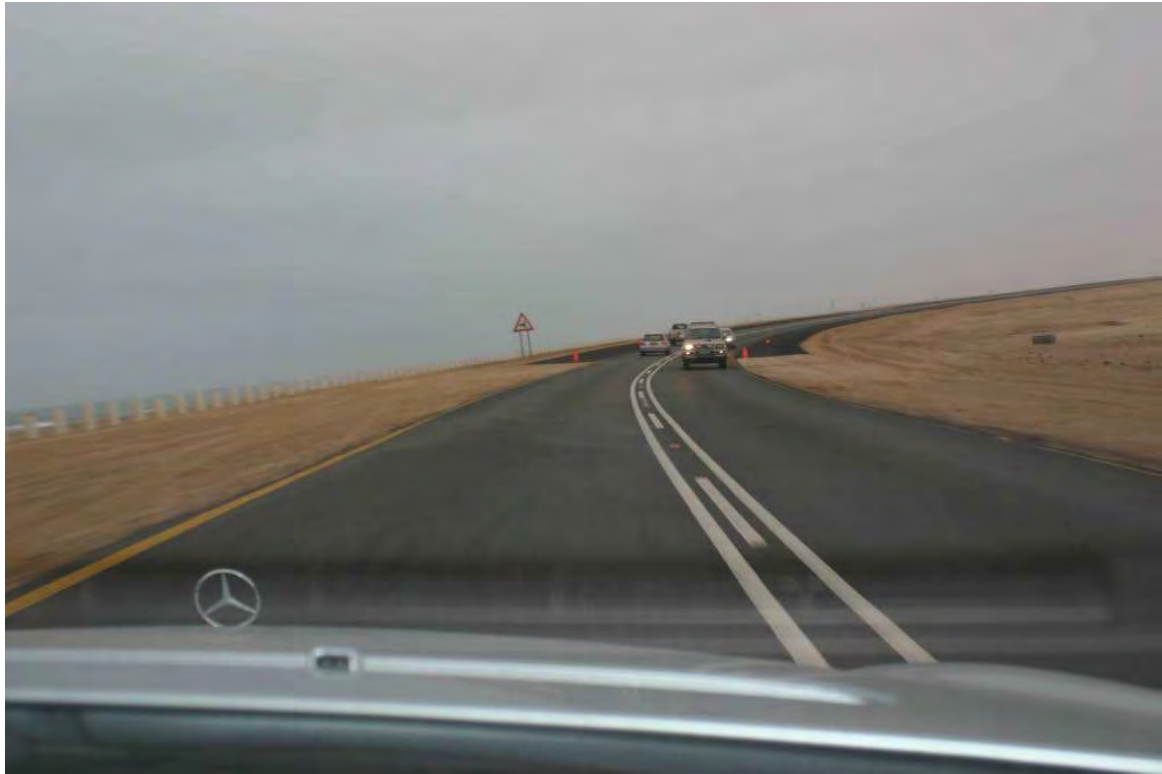
Exhibit 3

Overtaking sight distance affected by horizontal alignment: the traffic from the opposite direction would not have adequate sight distance if travelling behind a heavy vehicle unless it moves into the opposing lane to see past the vehicle.

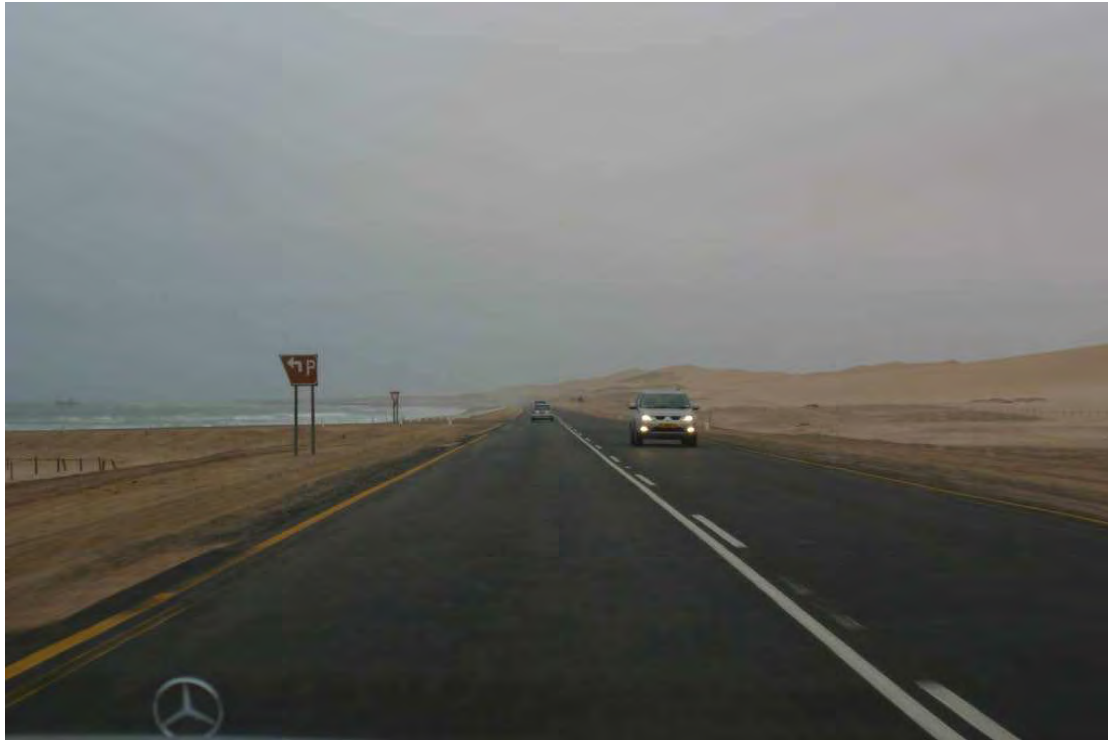
Lack of auxiliary lanes at minor intersections or junctions leaves turning vehicles without any protection from high speed through vehicles and reduces capacity.

Lack of shoulders and kerbs at intersections lead to sand on the roadway.

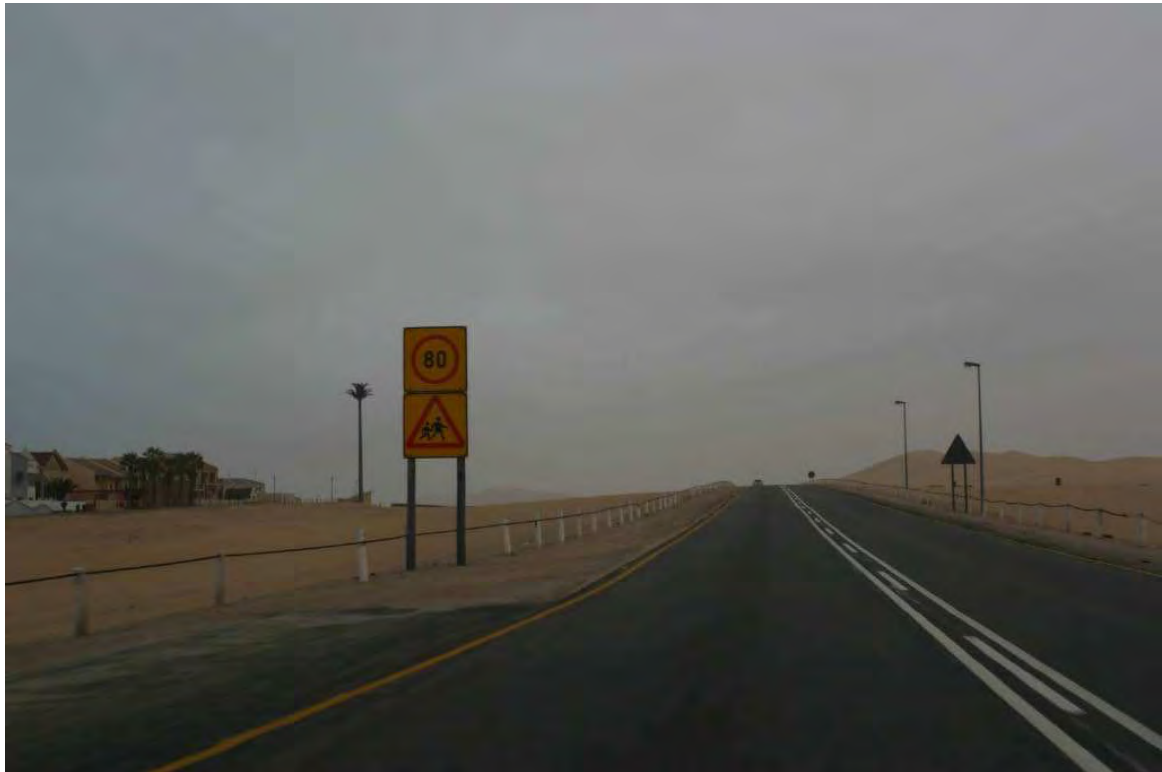
### Exhibit 6

Holiday pedestrian traffic cross route B2 just on the other side of this vertical curve, as recreational facilities were provided on the inland side of the road, while the residential development is on die seaward side of the road. A temporary warning sign for children crossing will soon lose its credibility due to constant display.

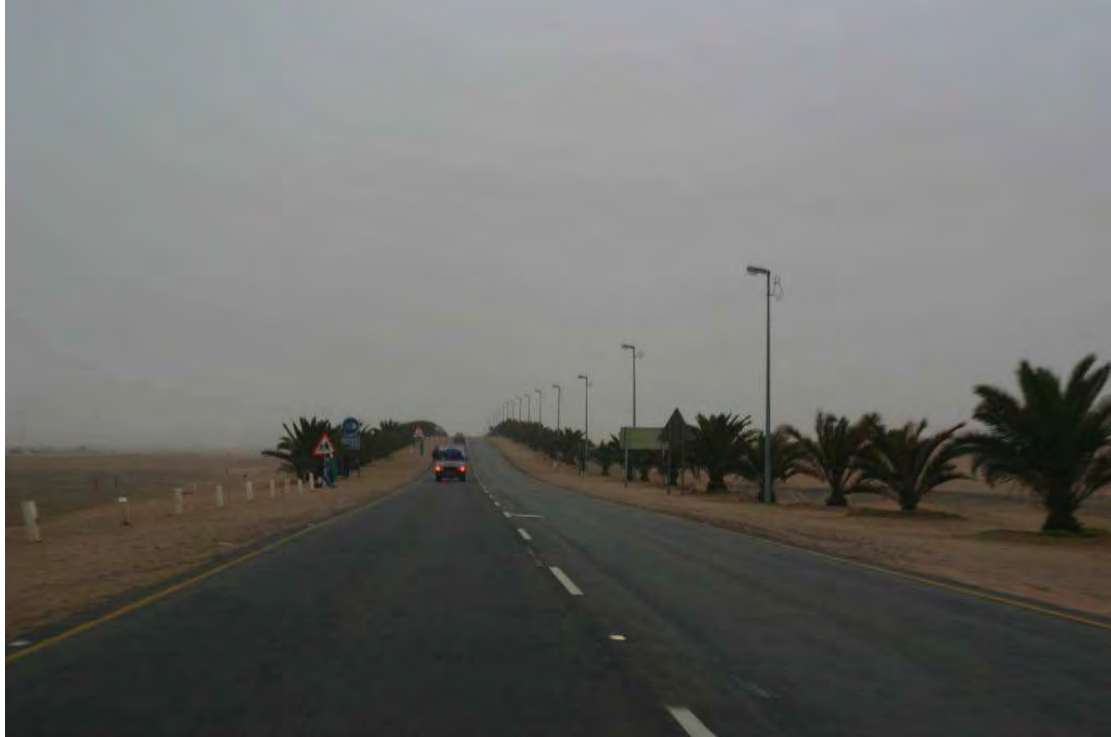
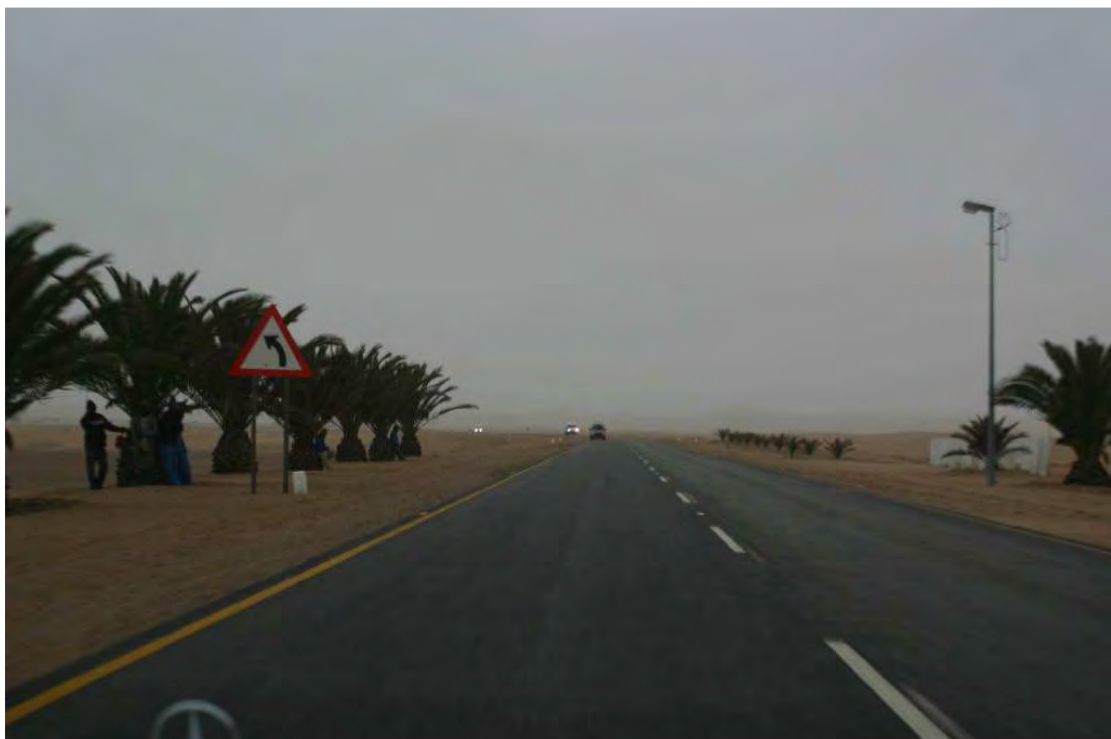
Exhibit 7

Pedestrians cross route B2 on the outskirts of Walvisbay. The road is in fill. The area is also used as pick up point for hitch hikers to Swakopmund.

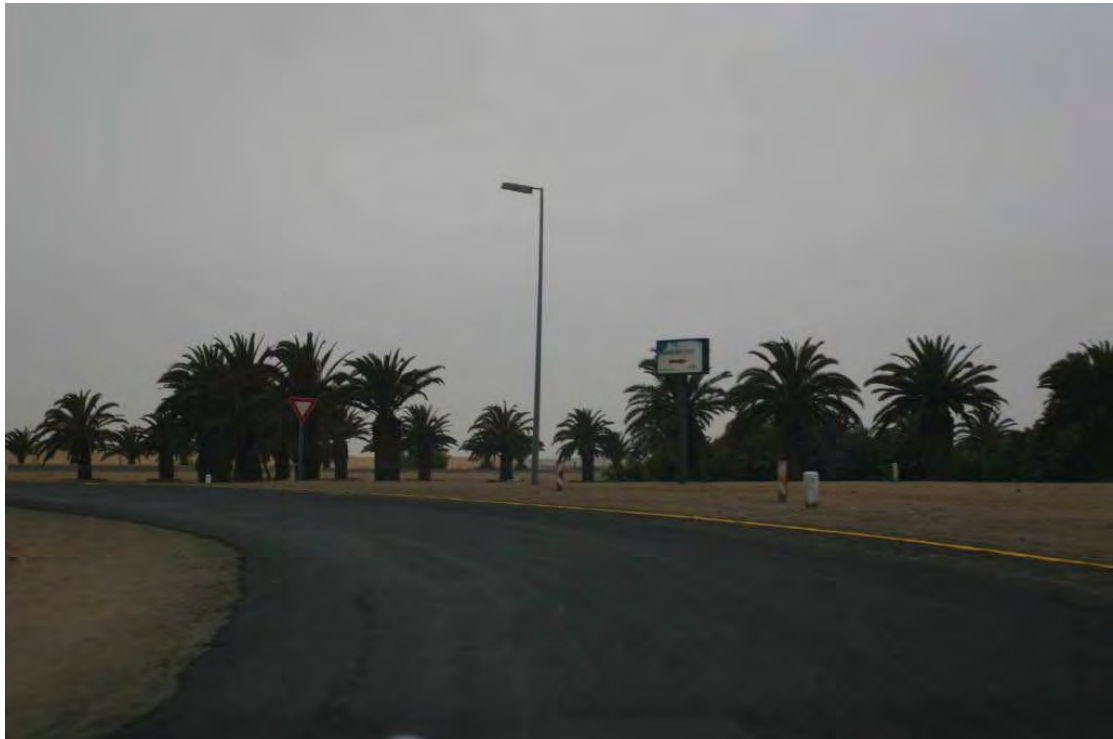
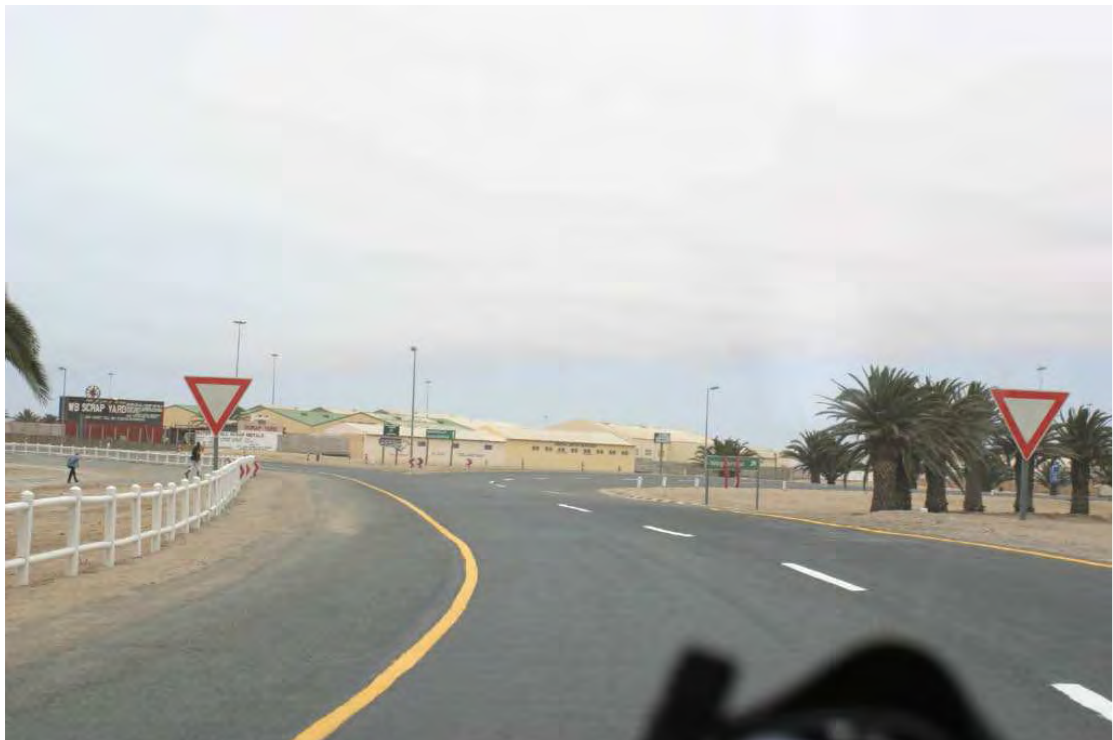
### Exhibit 8

Roundabouts or traffic circles in Walvisbay do not conform to modern design principles. The basic assumption is that vehicles accept gaps in the circulating flow, not merging at will. The entry design in Walvisbay is more of a slip road leading to high speed and acute angles so that traffic cannot be observed from the right.

The acute entry angle requires a yield sign that must be placed so far on the splitter island that it may be seen to apply to the circulating traffic.

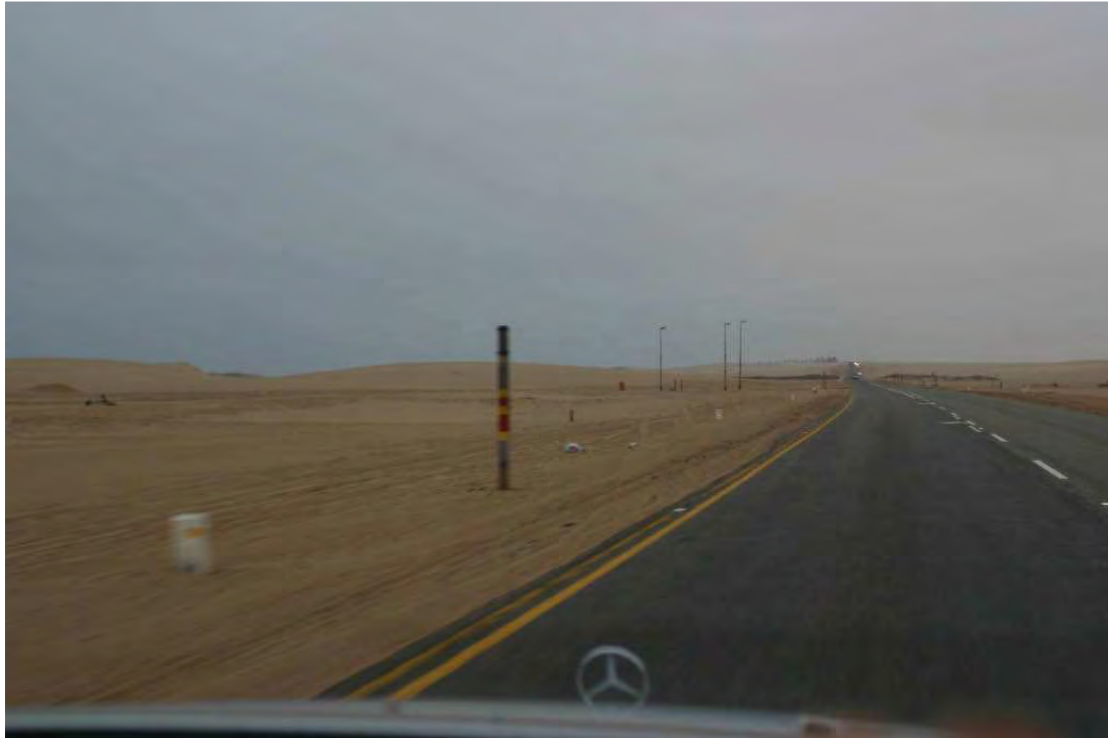
### Exhibit 9

Intersections and junctions onto route B2 are mainly at right angles. The provision of auxiliary lanes (turning or deceleration lanes) are not consistent. Turning vehicles obstruct through vehicles.

This photo shows a poorly defined intersection, where future development will take place.

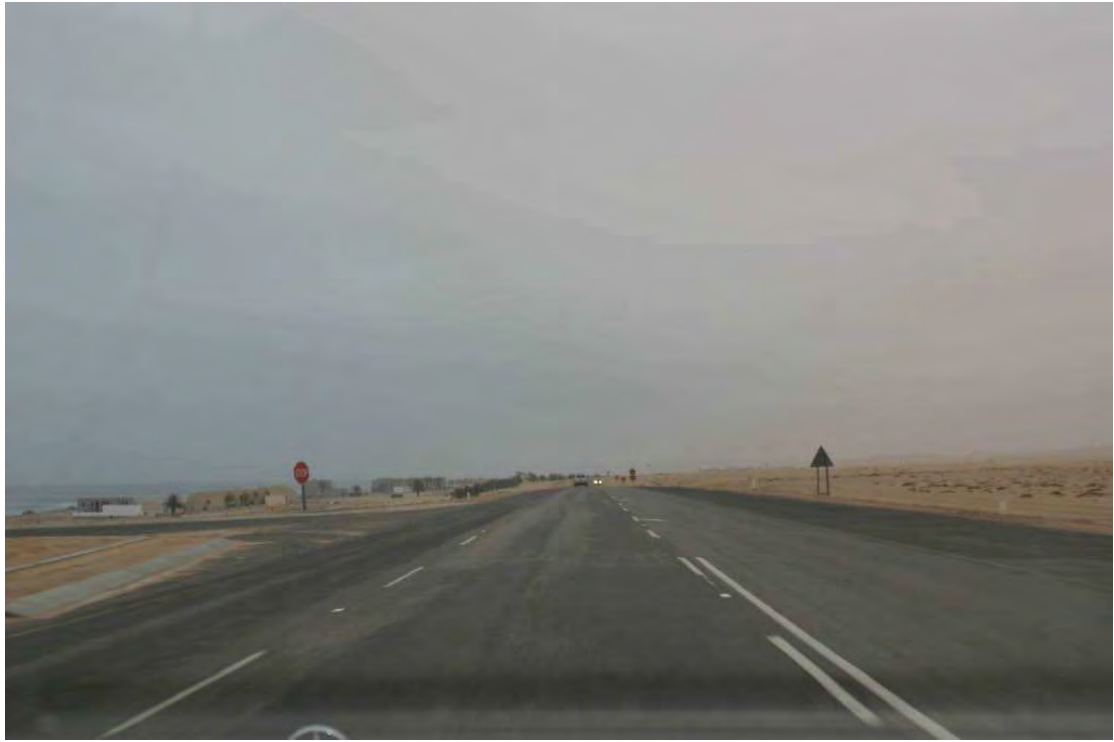
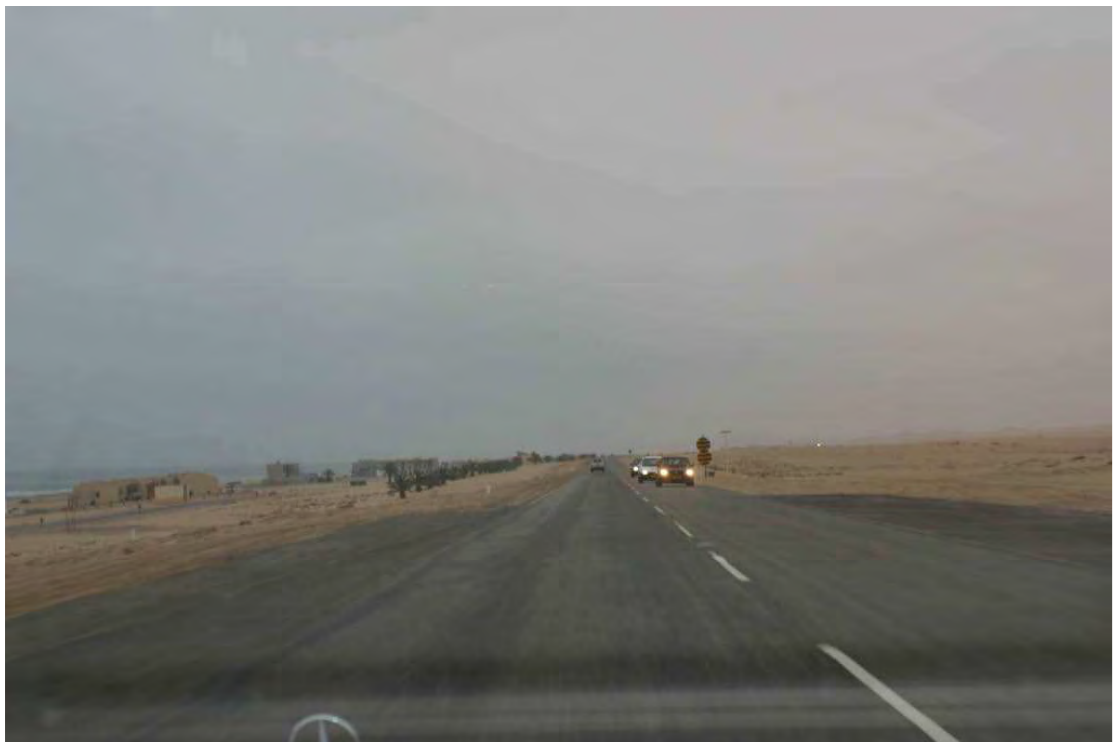
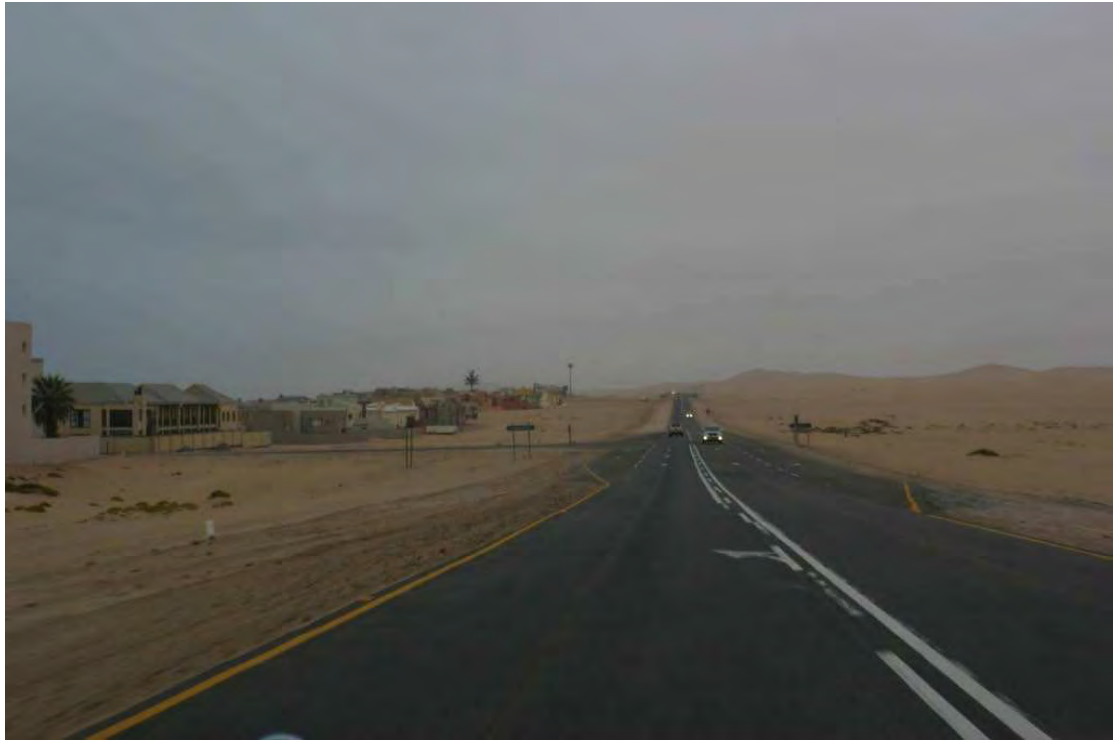
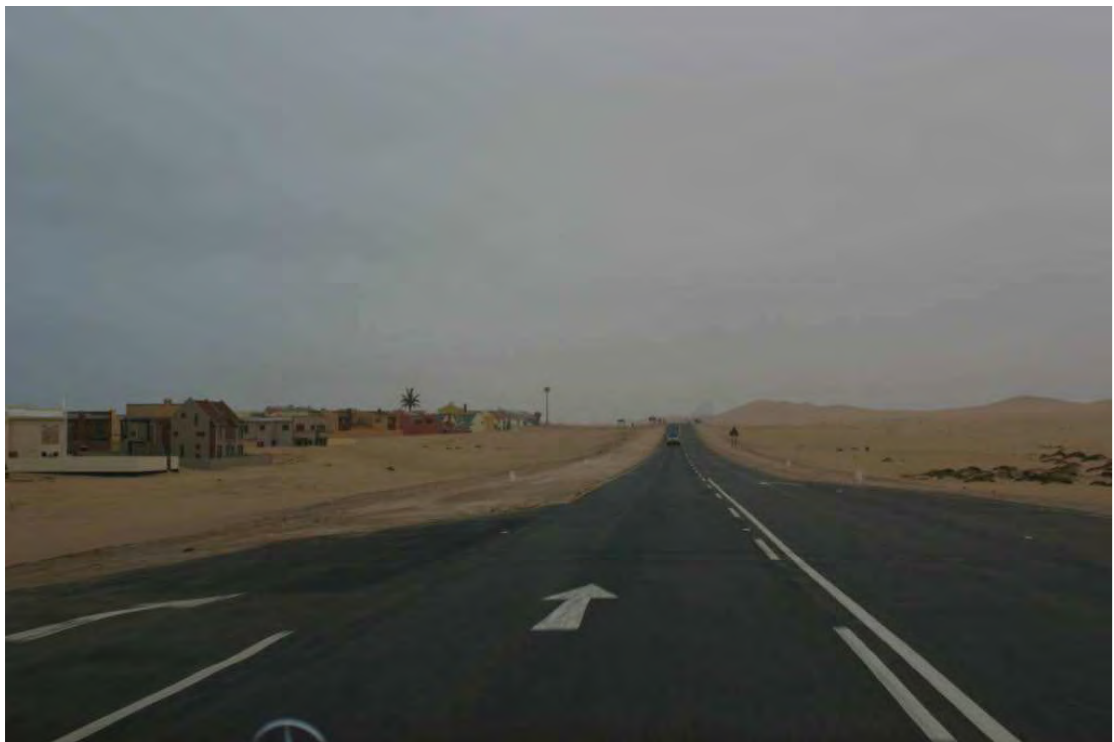
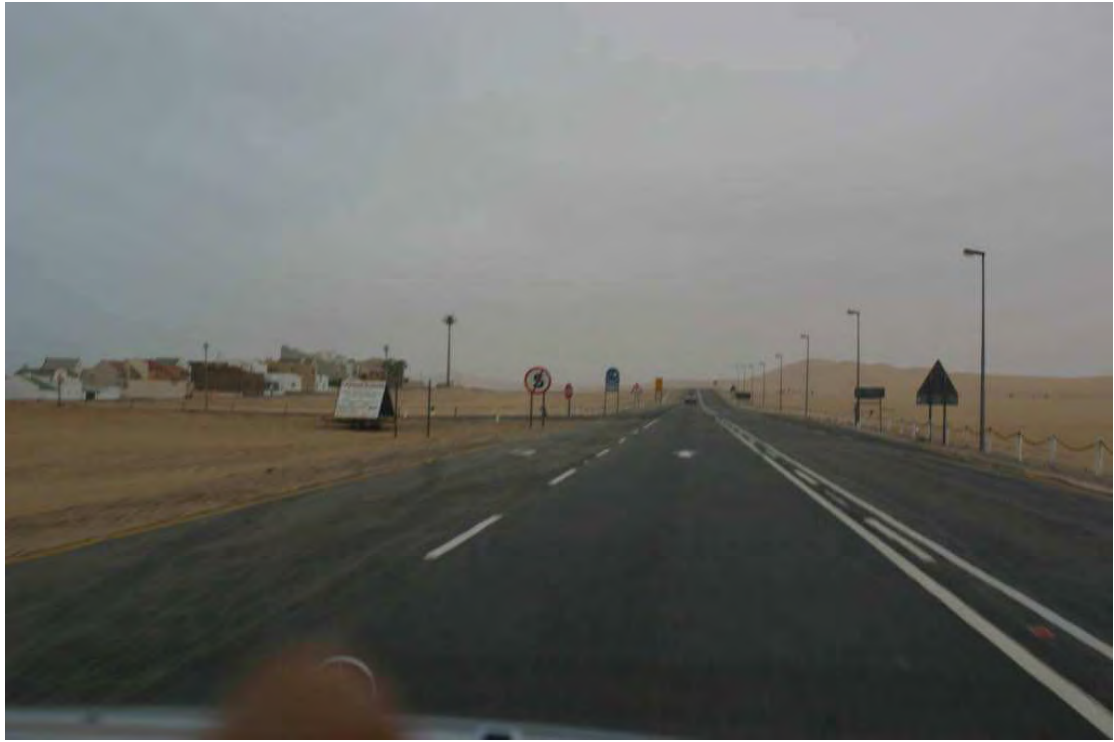
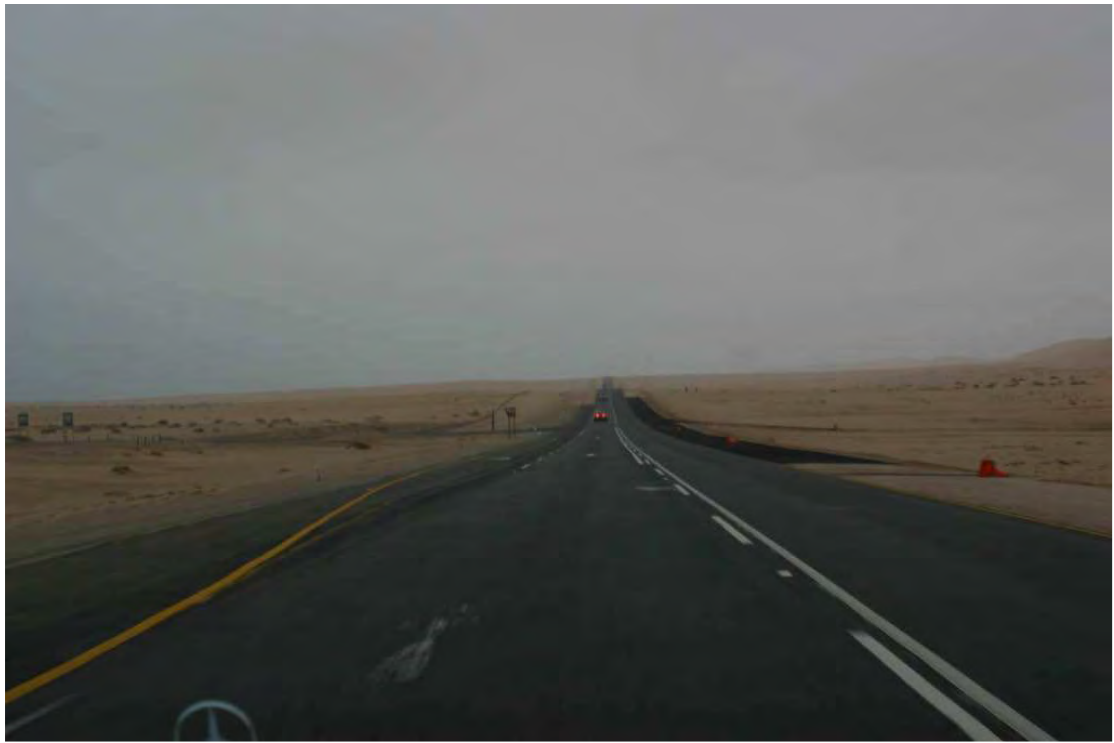
The next photos show intersections or junctions at Langstrand, with varying lengths of auxiliary lanes and tapers to end the auxiliary lanes. Road markings are not to SADC RTSM guidelines in the case of the new junction. It is important for safe operations to complete road markings as soon as possible after construction, as drivers must be able to interpret the junction. Note the lack of yellow edge lines in the second junction and sudden merge at the end of the acceleration lane. A safe area should be painted out so that late mergers do not drive on the gravel shoulder, but on a painted island.

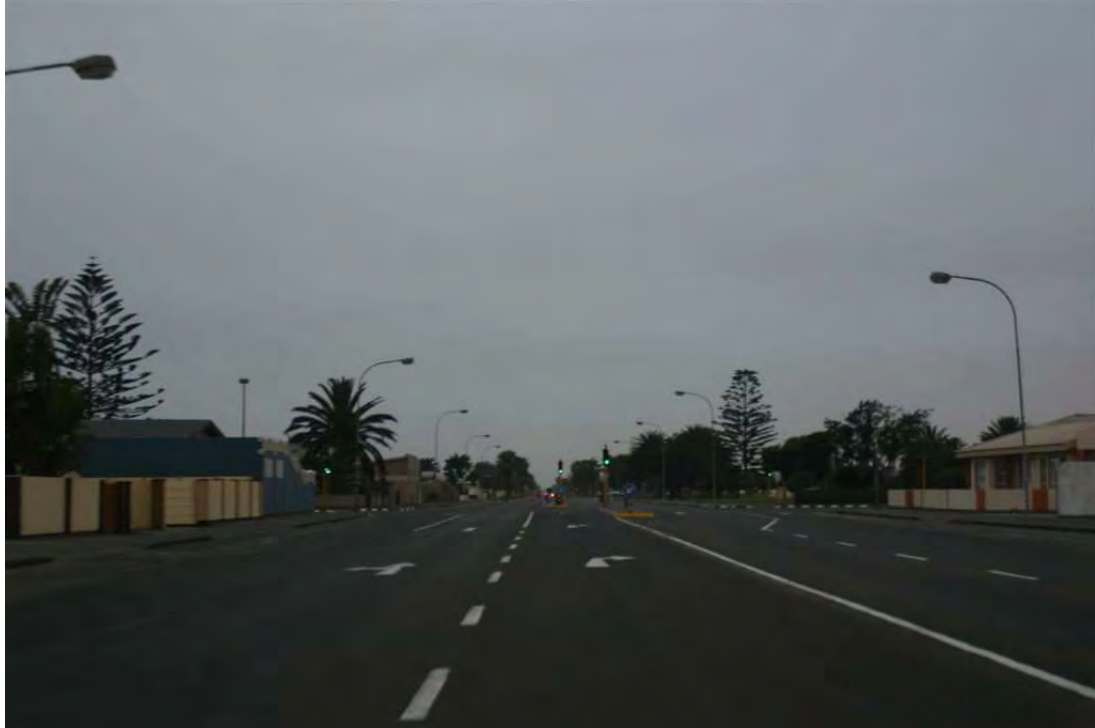
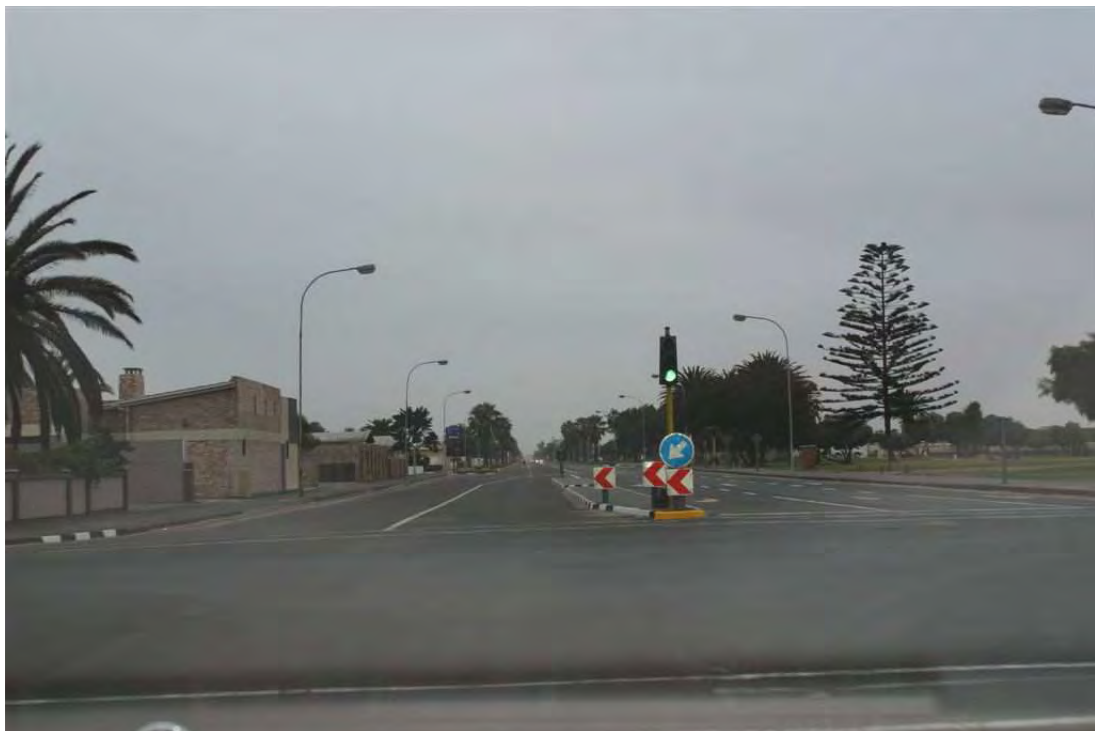
Exhibit 11

Traffic signal installations in Walvisbay are in reasonable conformance with The SADC RTSM. Signal heads should be upgraded with backing boards.

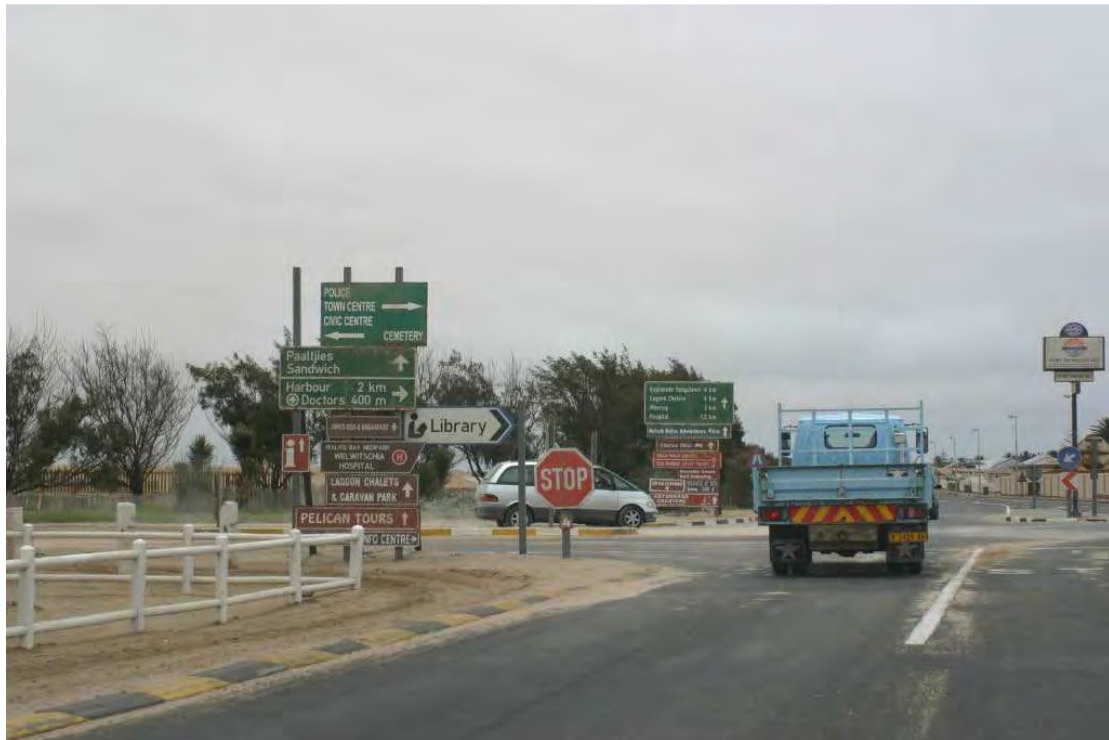
Note sand on roadway.

The height of the signs does not conform to requirements of the SADC RTSM in terms of clearance. For pedestrians

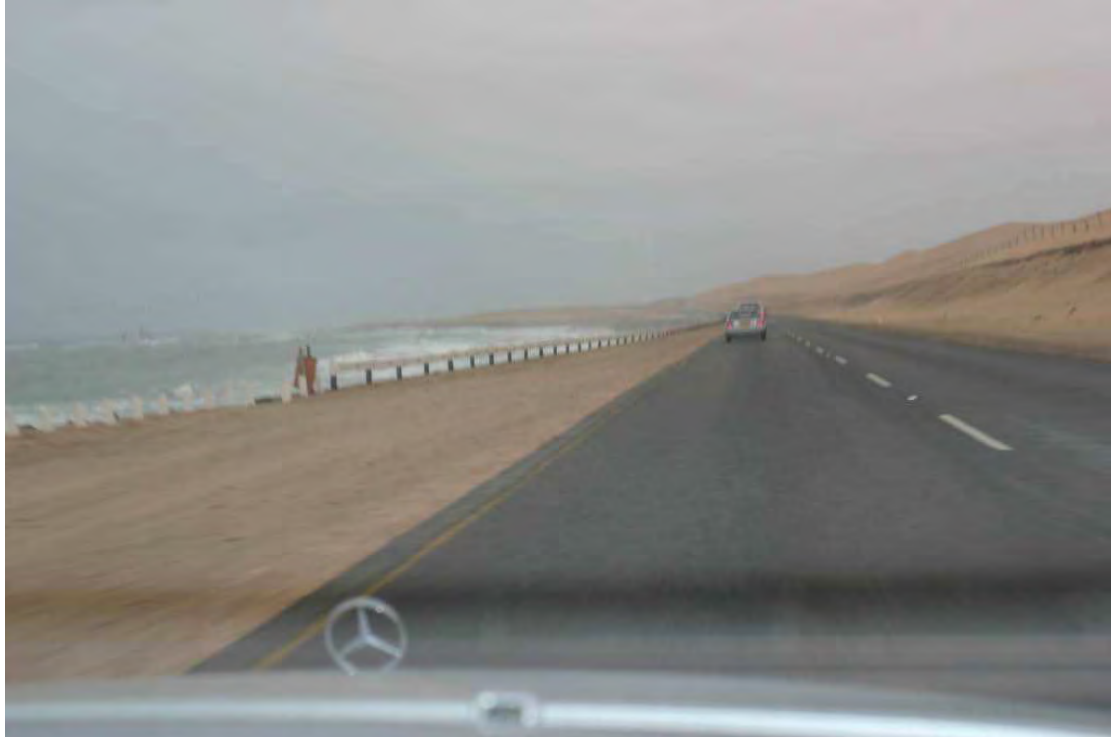
Guard rails are provided at the sections where the road is close to the beach, but not in a consistent way.

End wings are not acceptable end treatments.

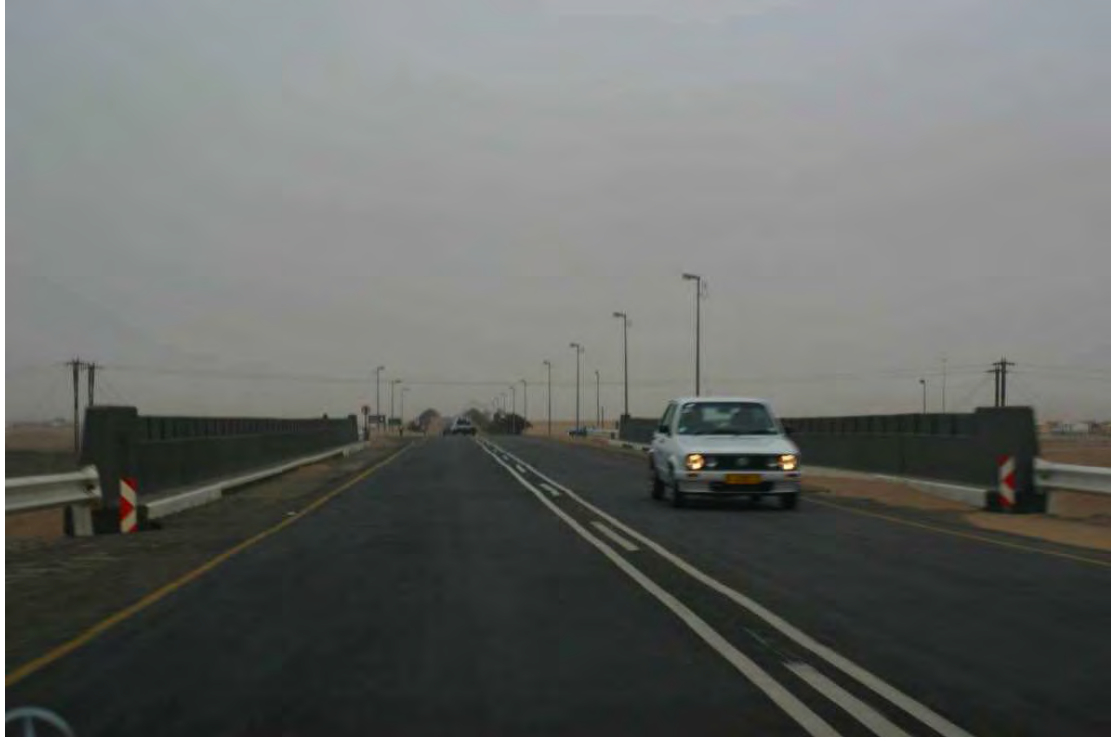
Exhibit 17

Guard rails should be connected to the bridge abutments to provide strong anchorage.
