# **Traffic Impact Assessment Rio Tinto Rössing Uranium Limited**

## **FINAL REPORT MARCH 2010**

Road Safety Audit Report: Swakopmund to Arandis: Surfaced road B2

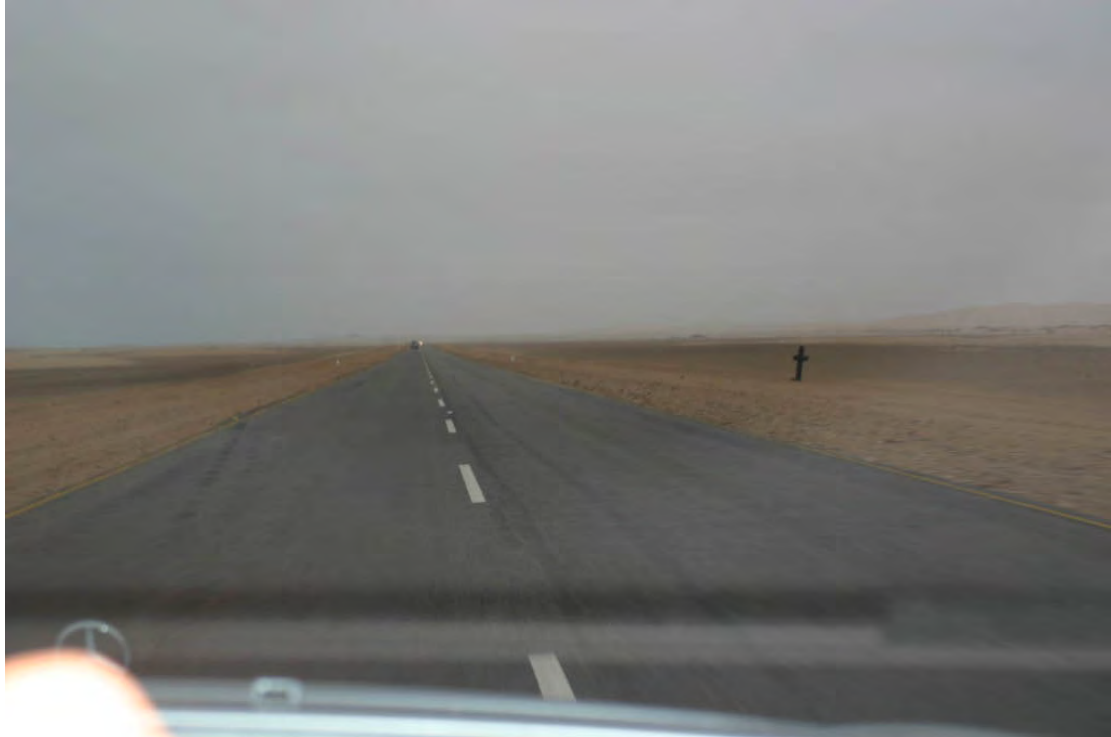
Exhibit 18

The dry and harsh climate along the route contributes to little vegetation to obscure signs.

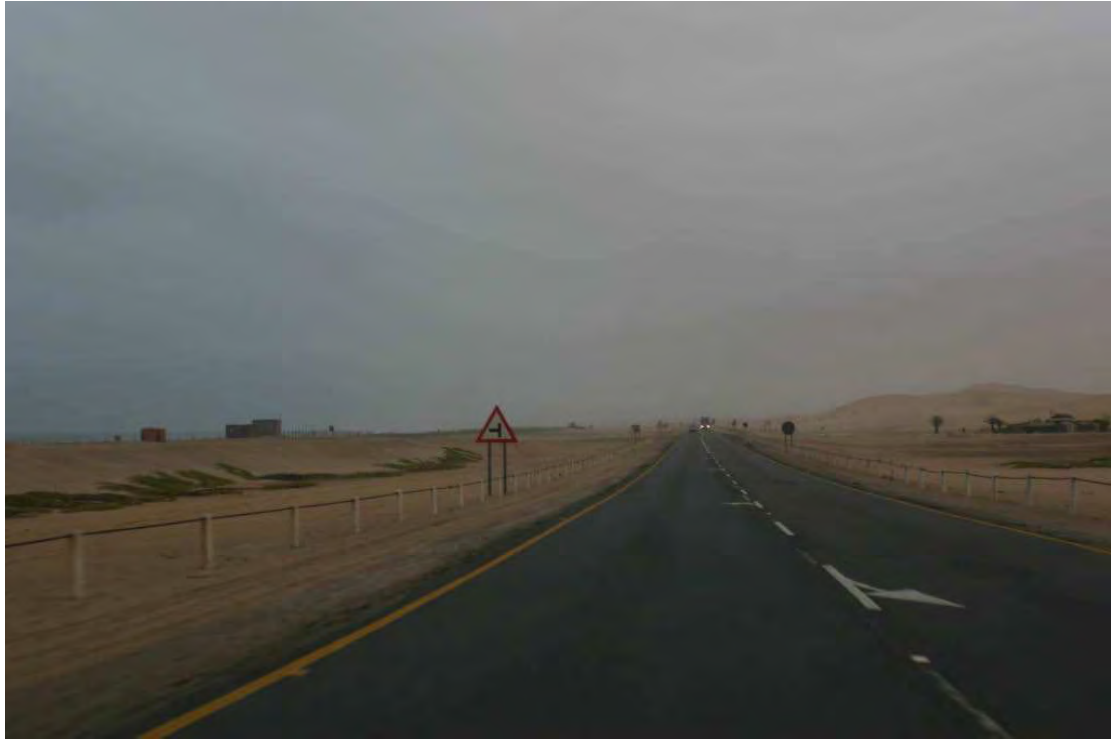
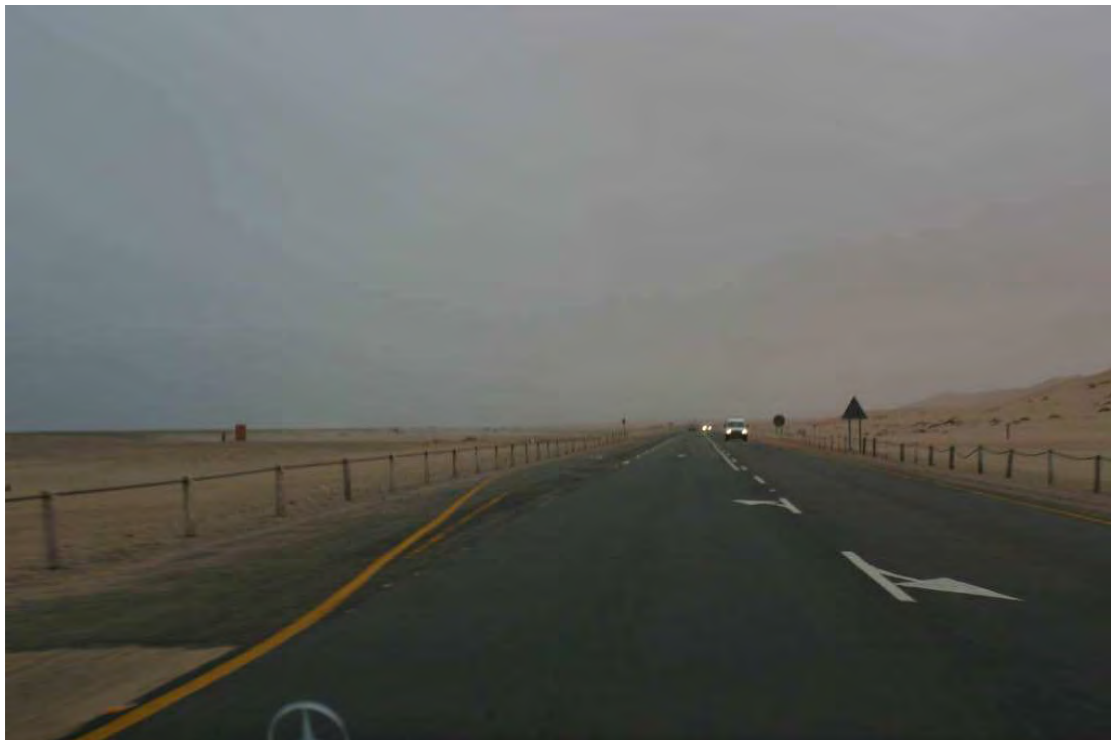
Exhibit 19

Post and cable barriers are provided to control access to route B2.

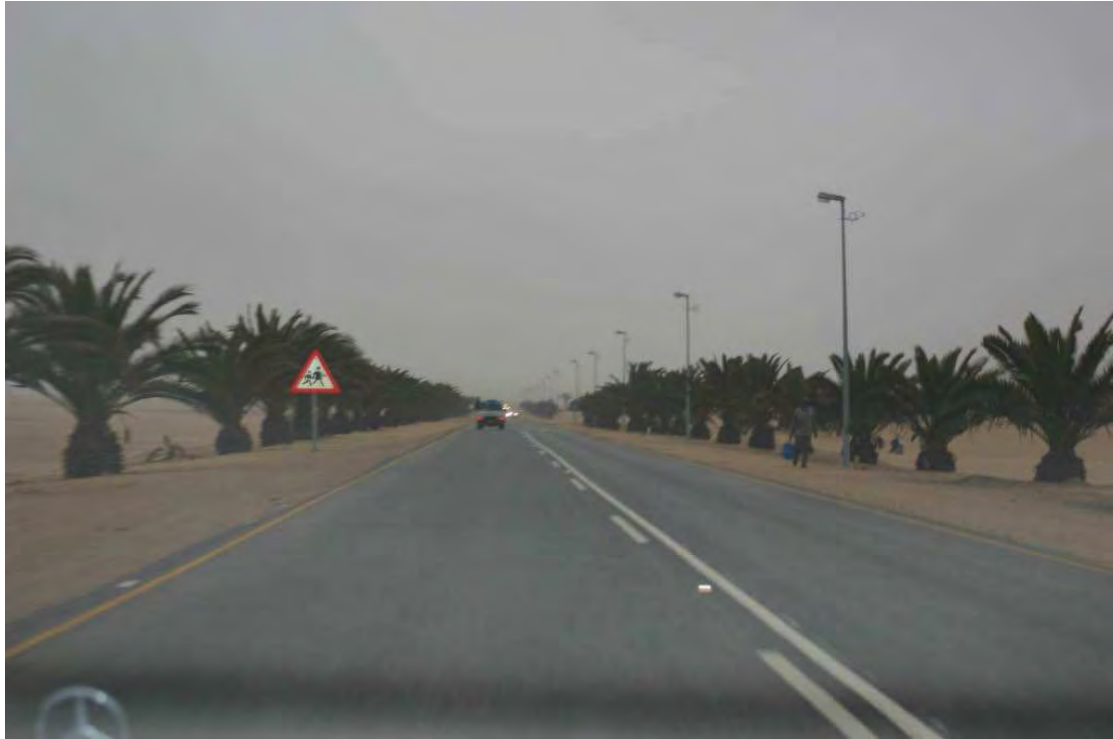
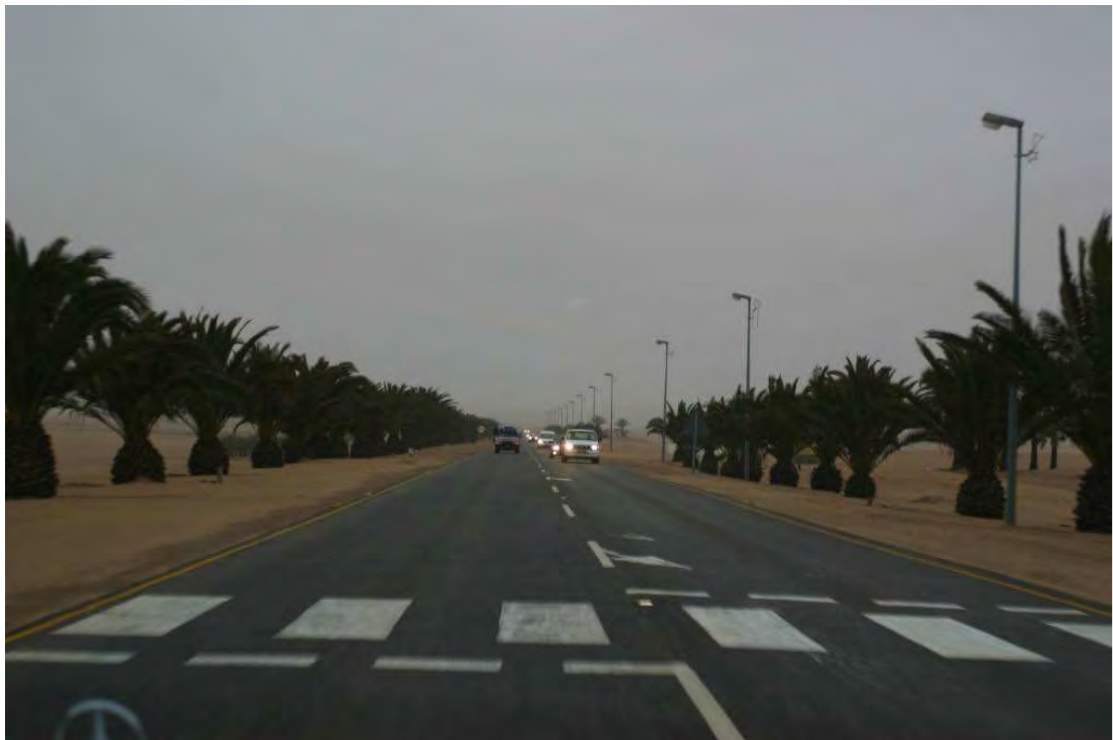
Exhibit 20

Pedestrian crossing on the outskirts of Walvisbay.

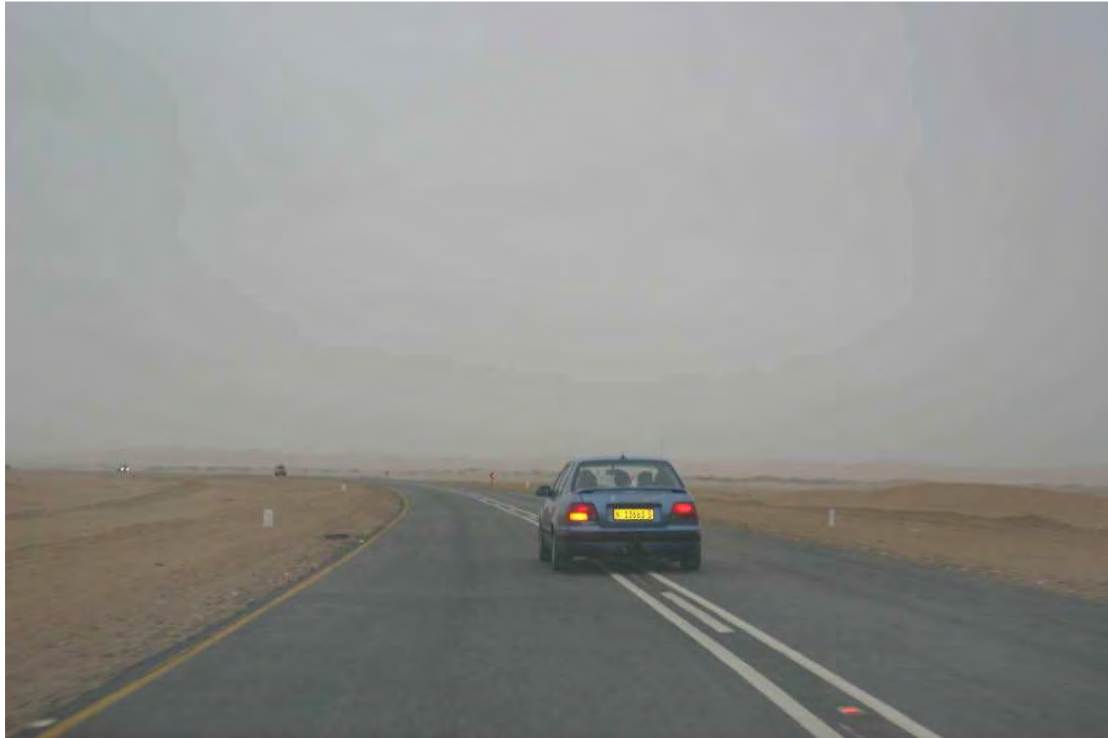
Note how a driver passes with disregard for the road markings.

The provision of regular passing lanes will give driver the choice to wait for safe passing opportunities.

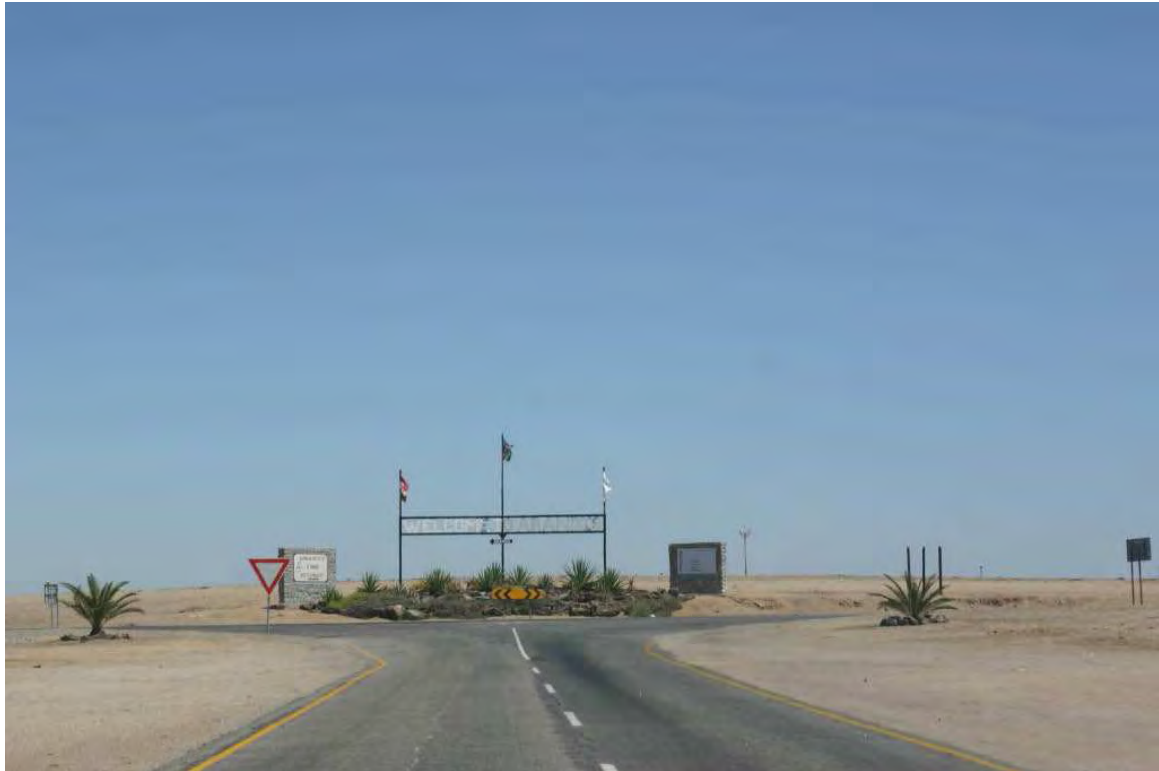
Note the outdated sign or wrong use of a construction sign in the form of the Junction chevron. This sign colours should be red and white.

Note no direction signage. Arandis is to the left, the Rossing Mine to the right.

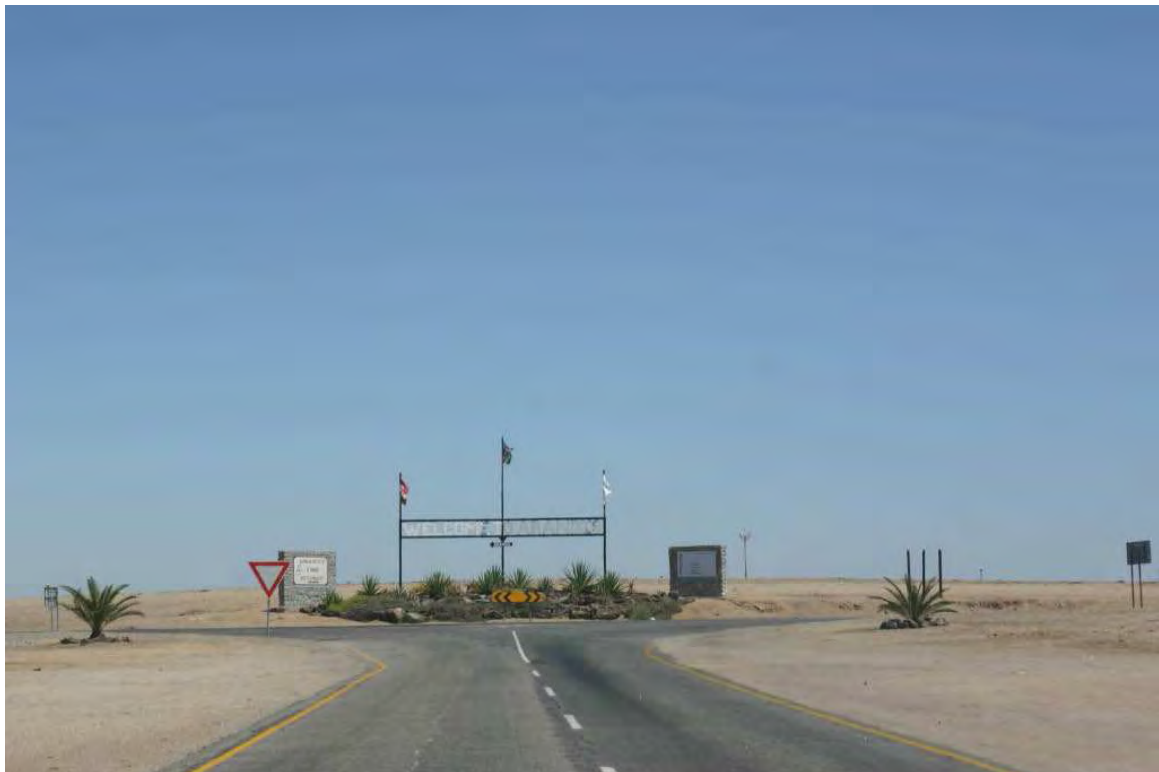
Note the outdated sign or wrong use of a construction sign as the Junction chevron. This sign colours should be red and white.

Note that no formal direction signage is provided. Arandis is to the left, the Rossing Mine to the right.

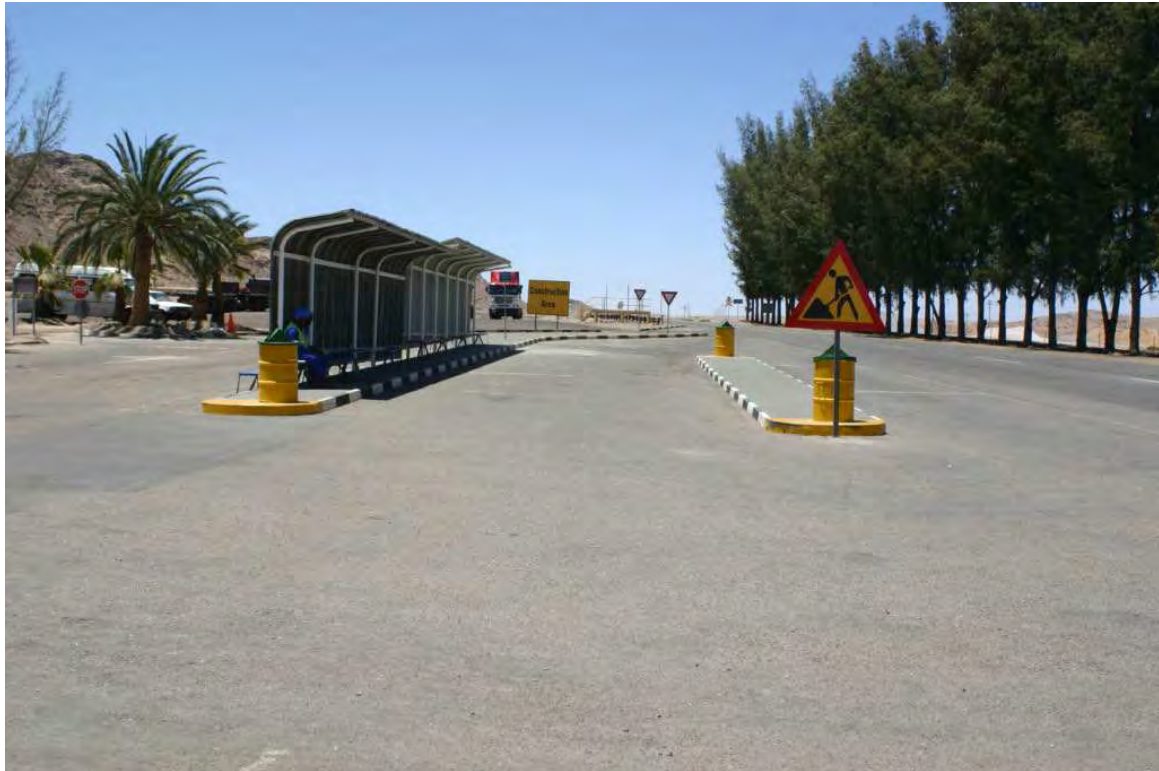
Islands should be demarcated by means of hazard markers as drivers turning into the area may not see the raised island and damage their vehicles.

The area should be provided with high mast lighting to define the entrance better.

The islands should be linked to the sidewalks by means of pedestrian crossings.

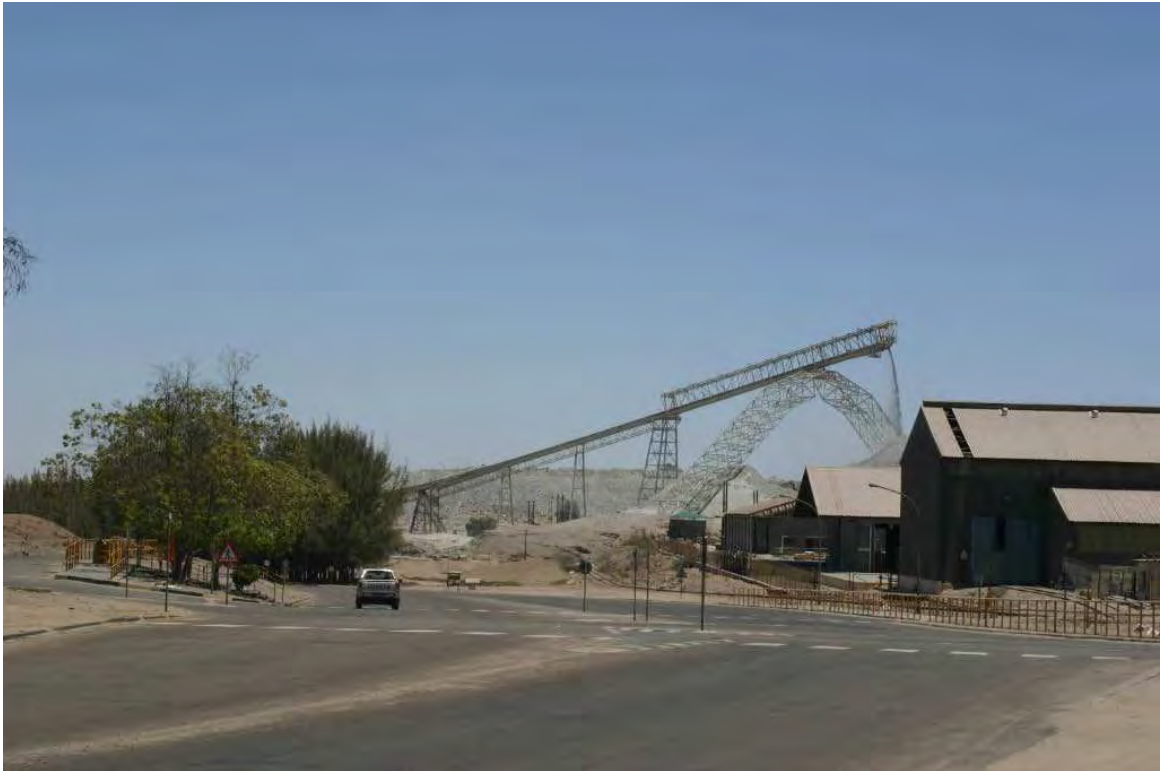
The intersection at the mine offices is not well defined and the large paved area can lead to conflict: this area should be reviewed to eliminate the small islands, possibly by means of a roundabout.

Note the difficulty to see the sign posts on the small islands.

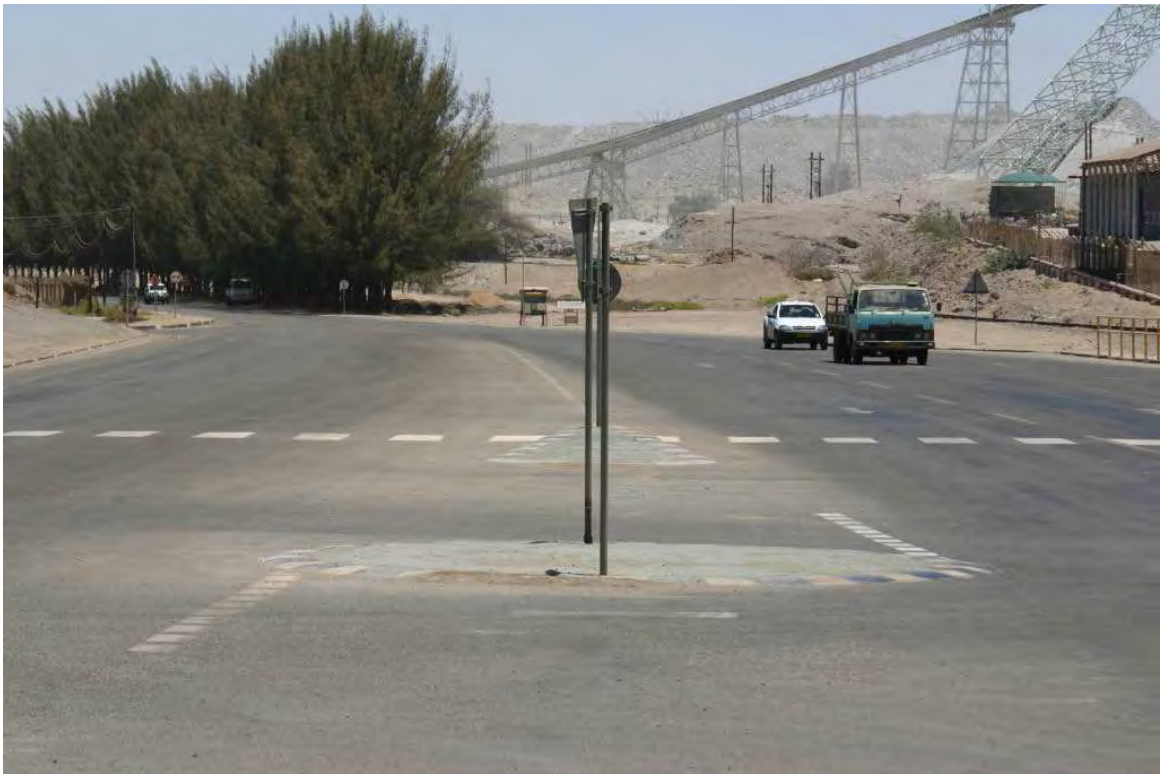
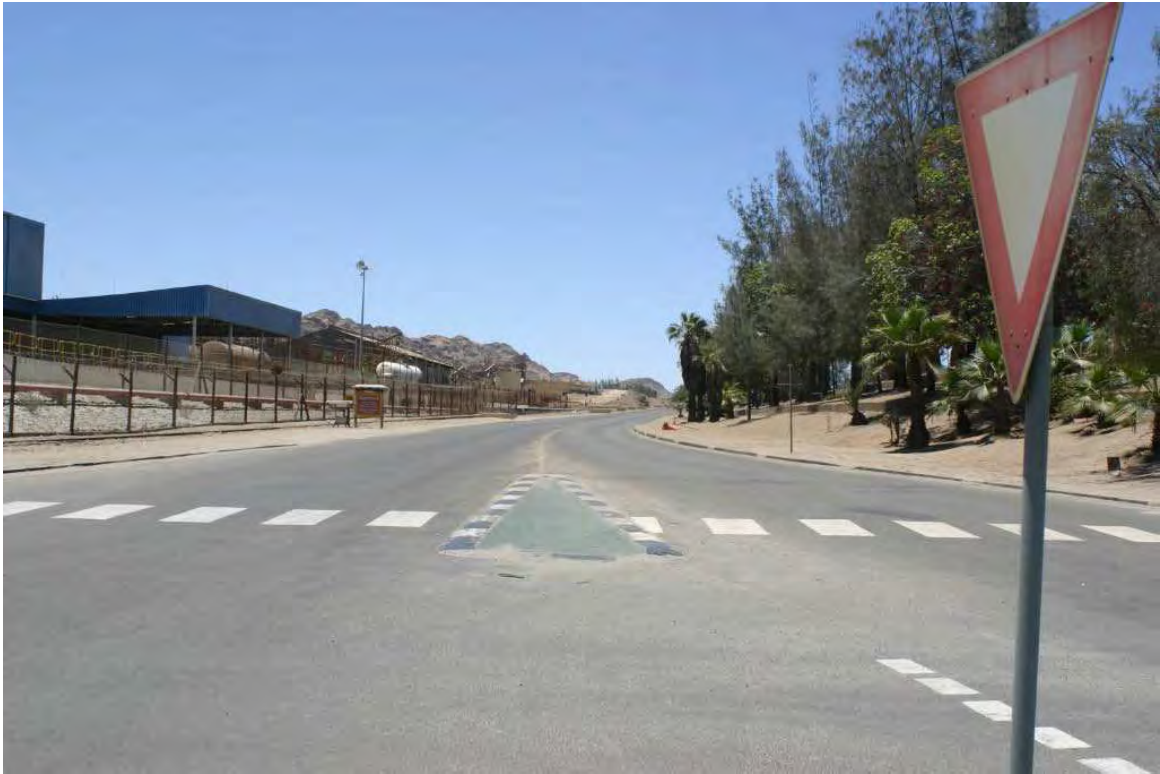
Exhibit 8 continued.

Note the difficulty to see the sign posts on the small islands.  
The splitter islands are not conspicuous.

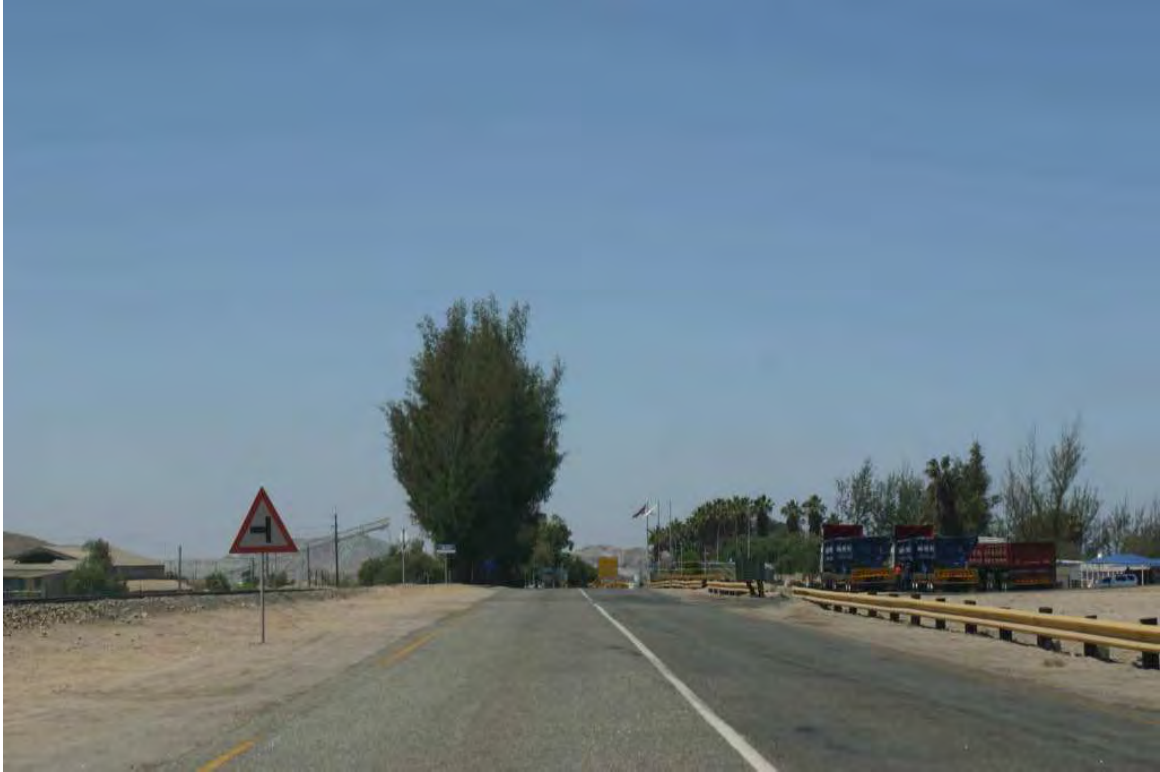
Exhibit 12  
Approach to the mine entrance: side road from right not clear.

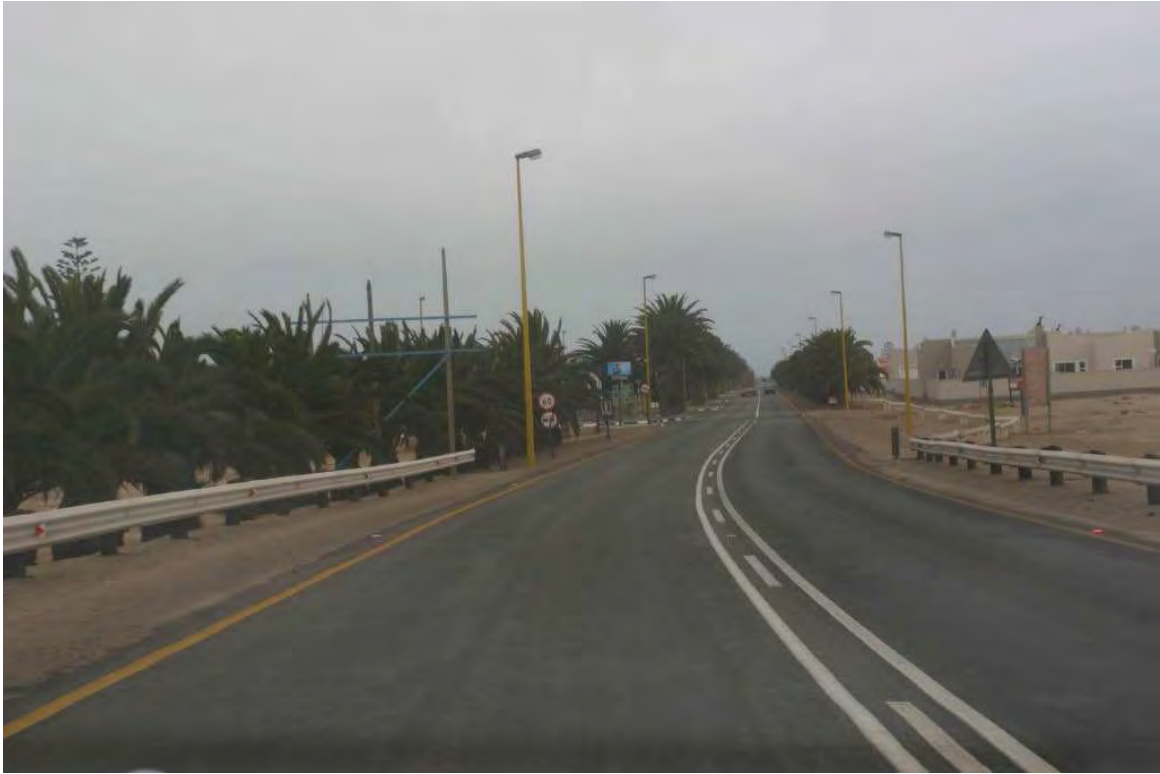
Exhibit 1

General topography as seen from the entrance from Usakos is flat.  
Routes are mainly straight and in a grid layout.

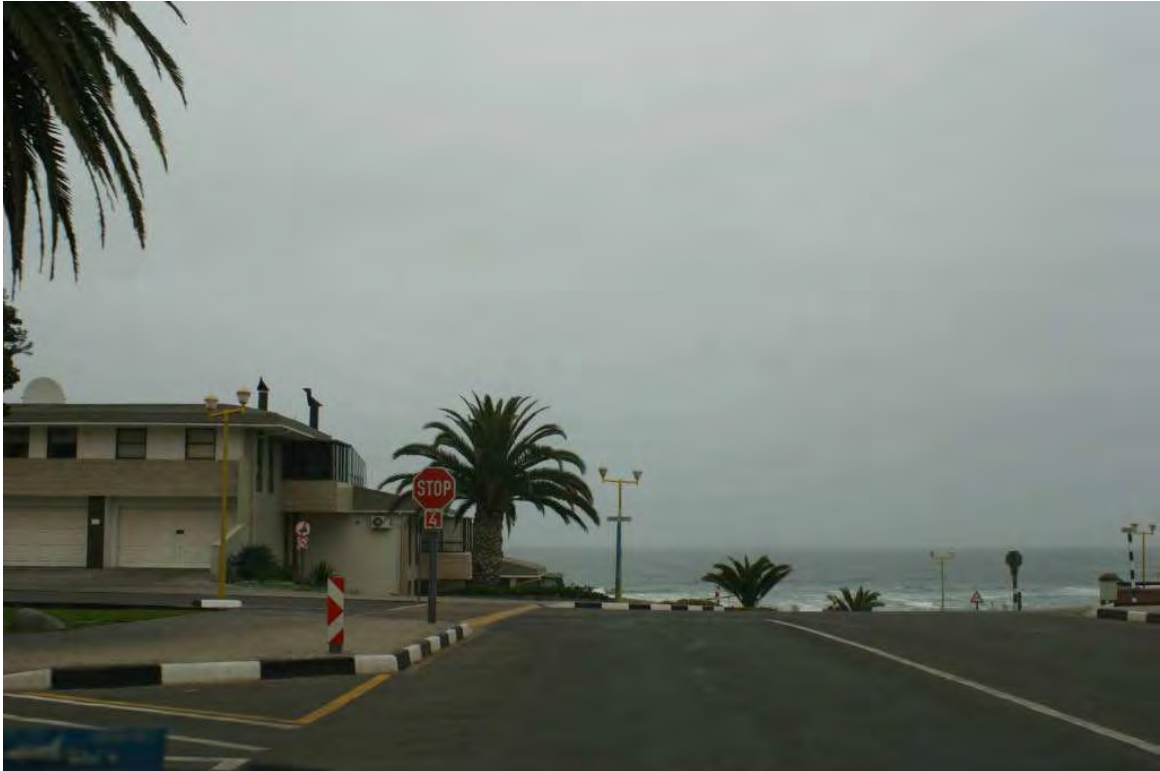
Exhibit 2

Curve to the right disappears over the sharp vertical crest. The danger is reduced by the Stop control on the approach to the curve.

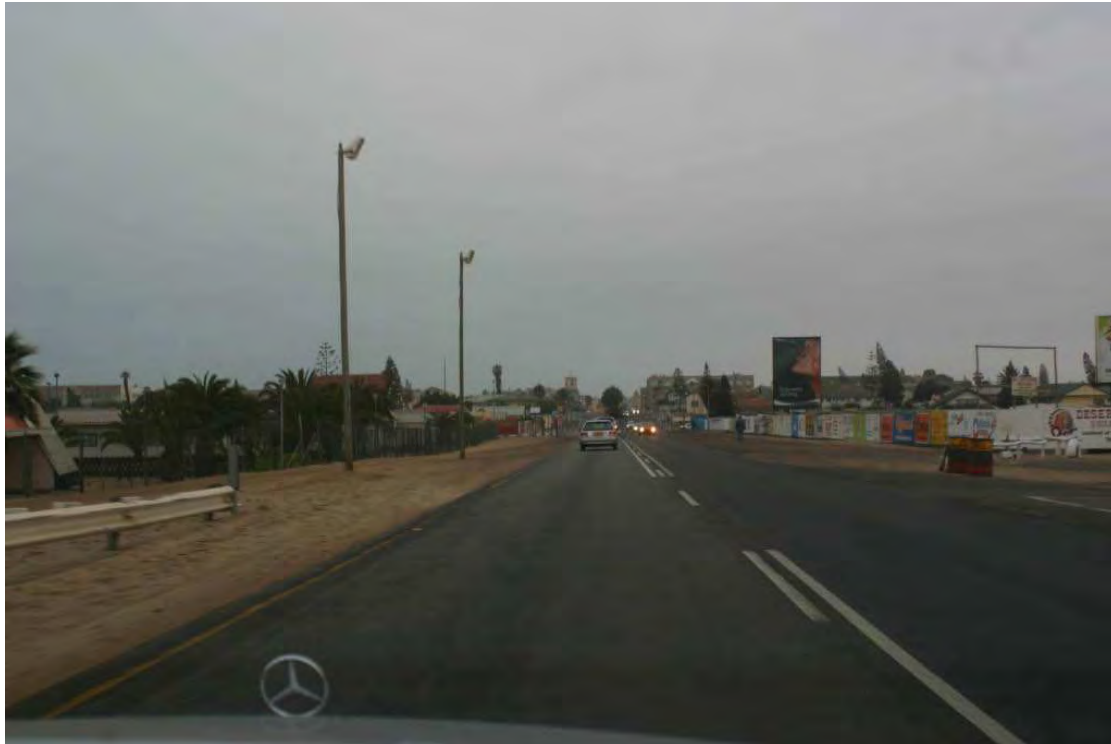
The change in the cross section of the road from rural to urban on the approach from Walvisbay is not well defined.

A defined gateway will change driver perception of the driving environment.

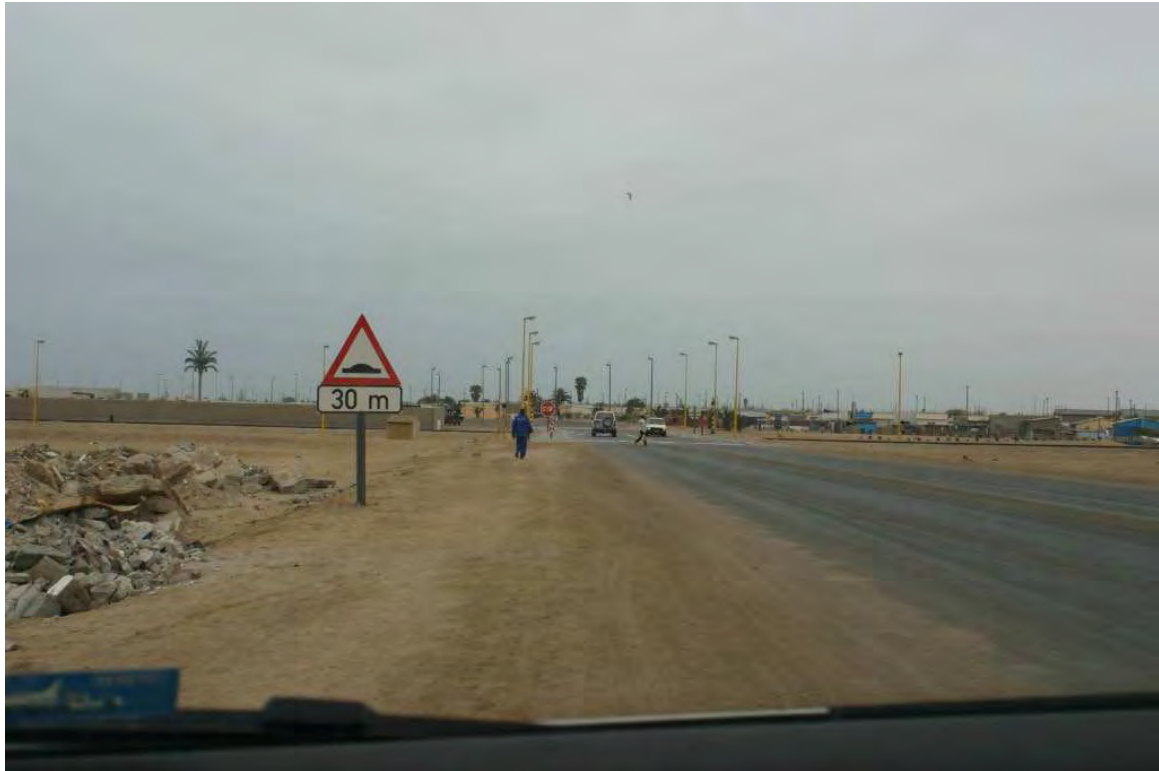
Exhibit 4.

No pedestrian facilities are provided on this section of Nelson Mandela Road between the B2 and the railway line. This section of road links the industrial area next to the B2 with the residential area north of the railway line.

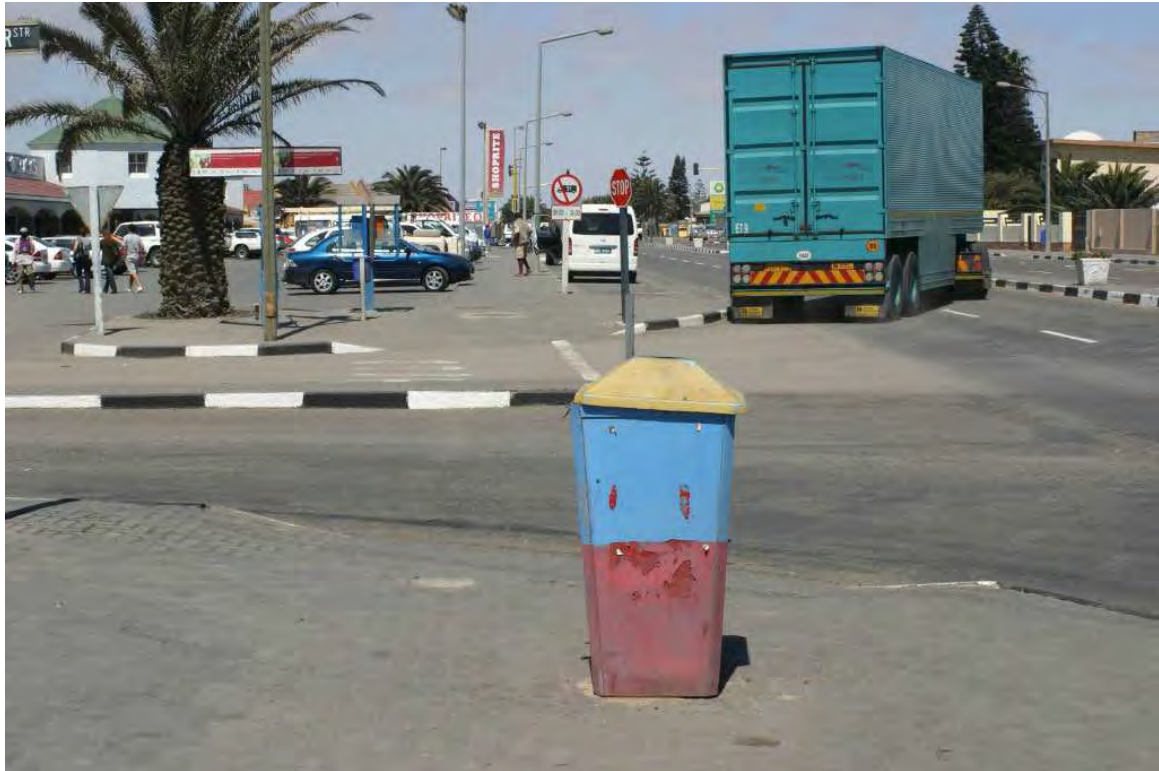
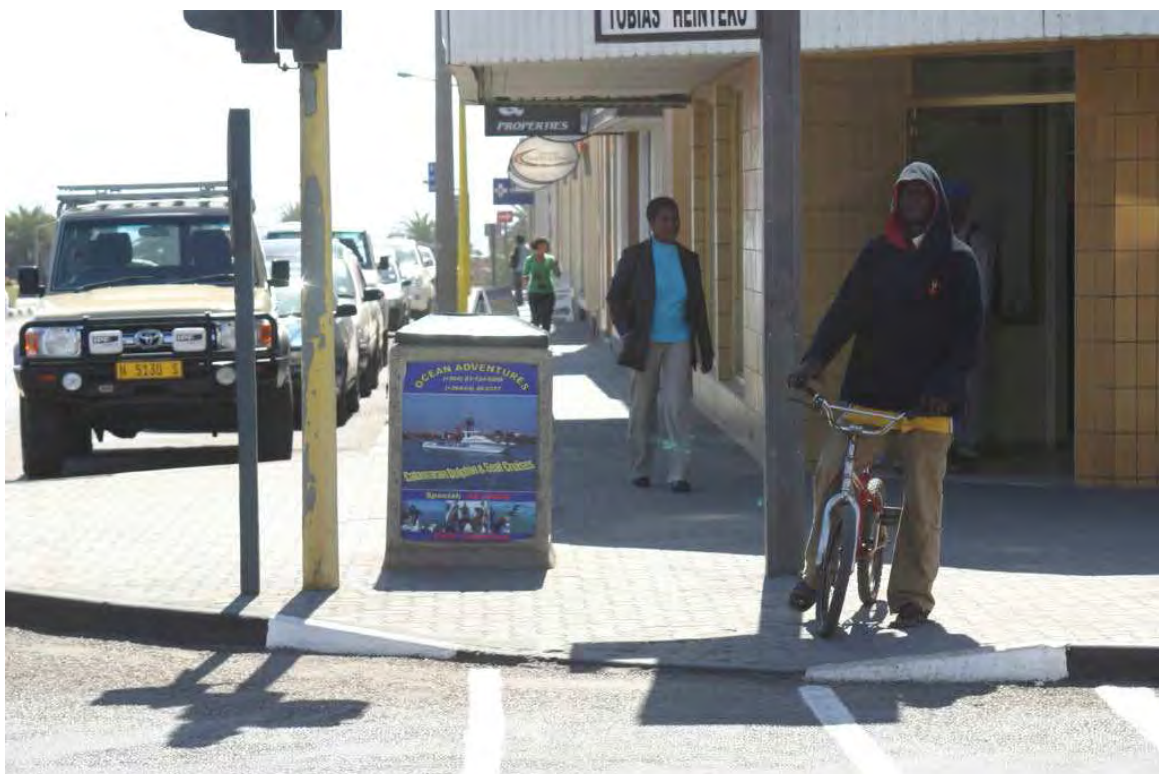
Exhibit 5.

Pedestrian facilities at intersections not provided in a consistent manner. This increase the risk of pedestrians walking in the road or getting hidden behind objects such as bins.

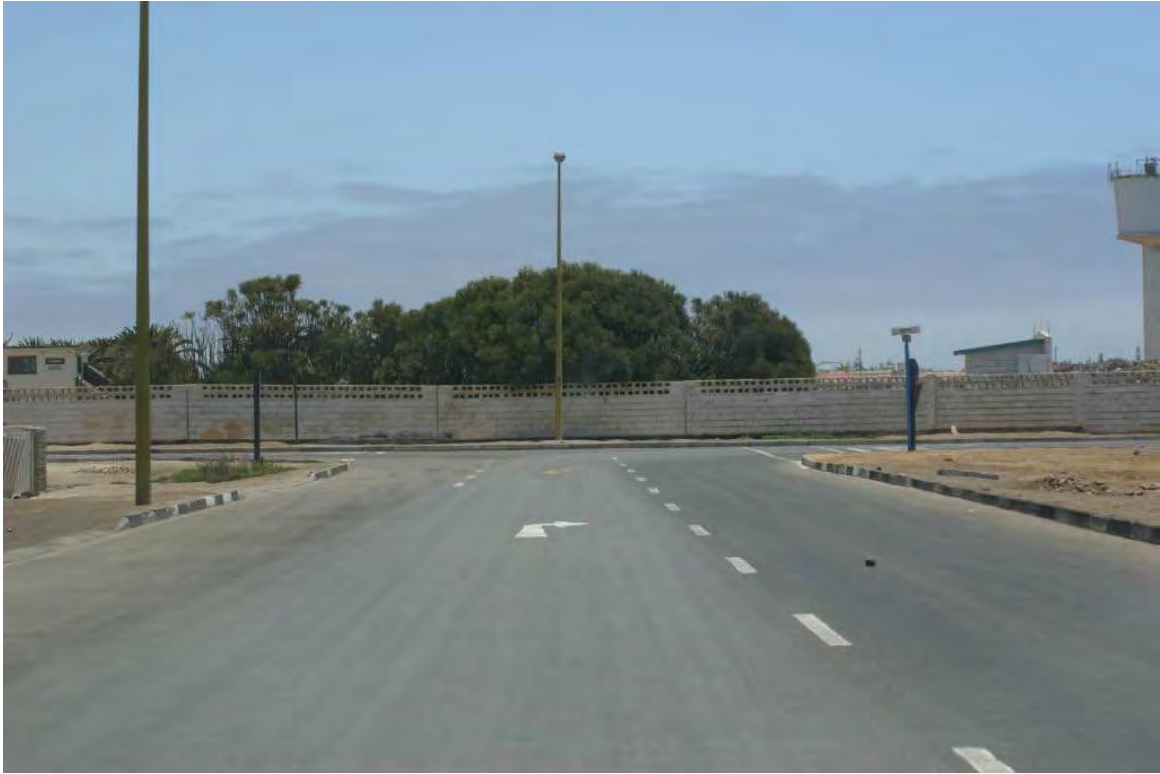
Exhibit 6.

The right turn from the T junction into the through road has priority. This is not an expected priority and unfamiliar drivers may brake unexpectedly.

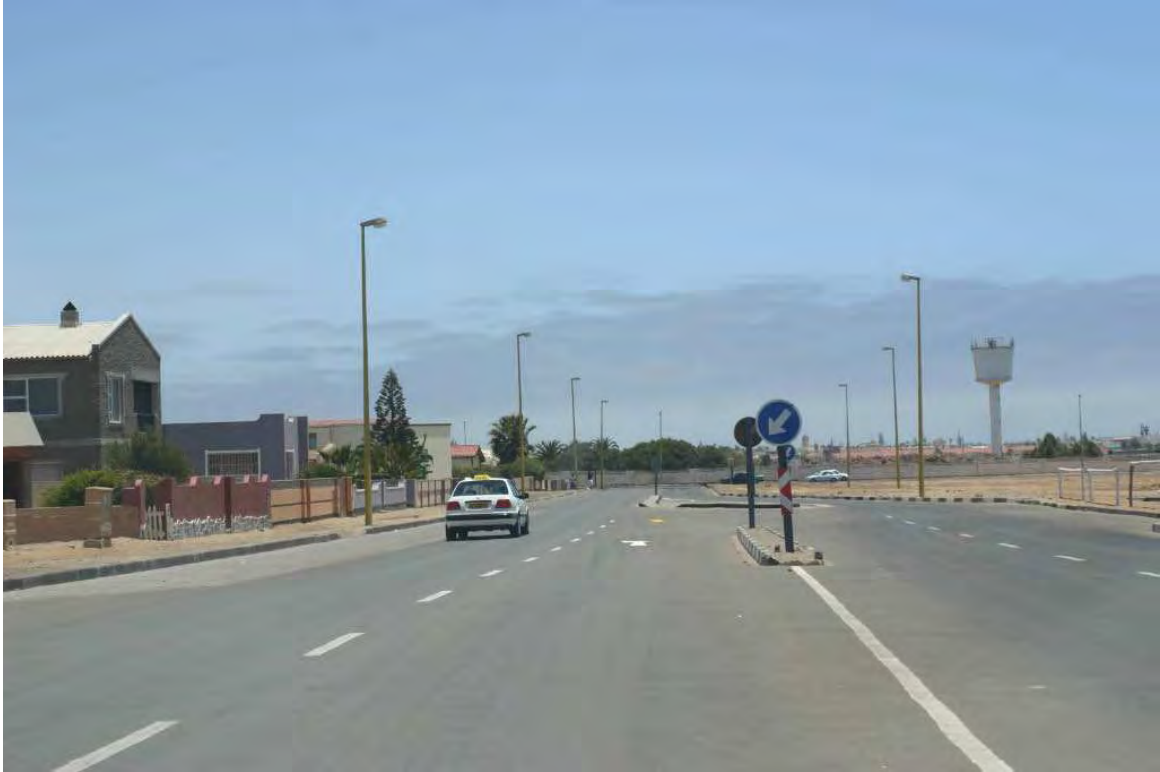
Exhibit 7.

Through lane stops and traffic is forced to merge to the right.

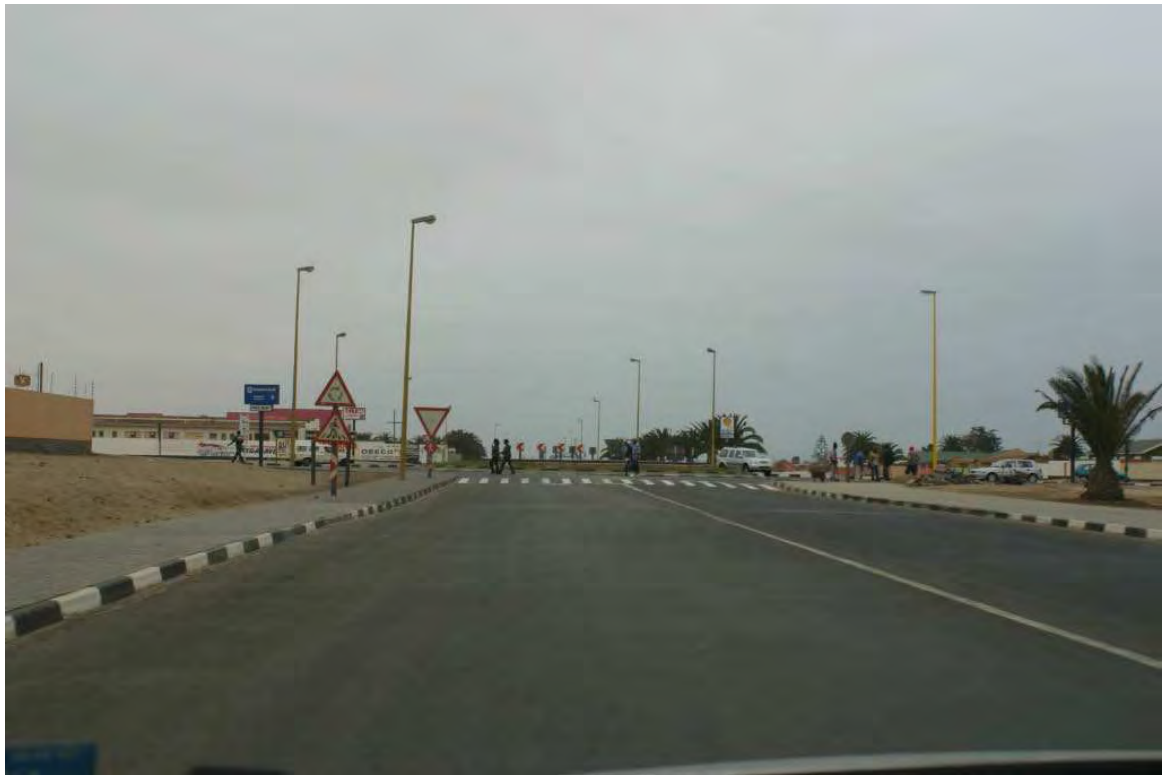
No deflection, splitter islands or signs on the central island may lead an unfamiliar driver to drive into the raised island.

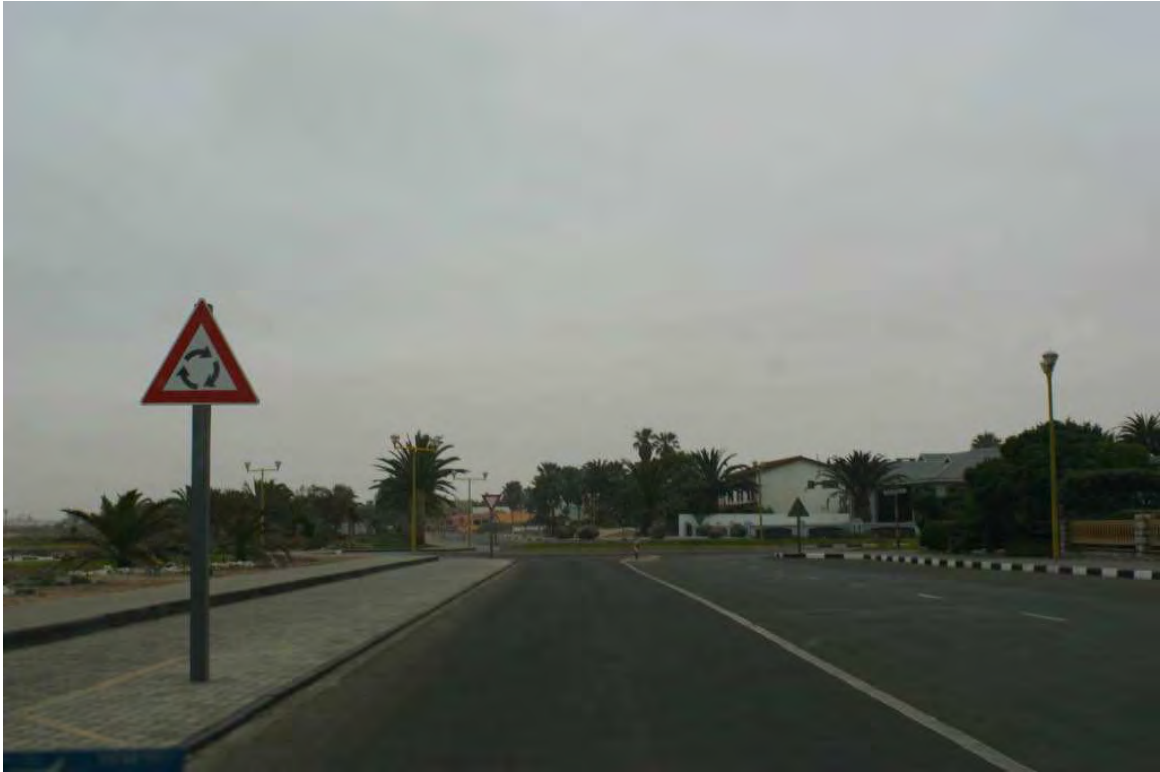
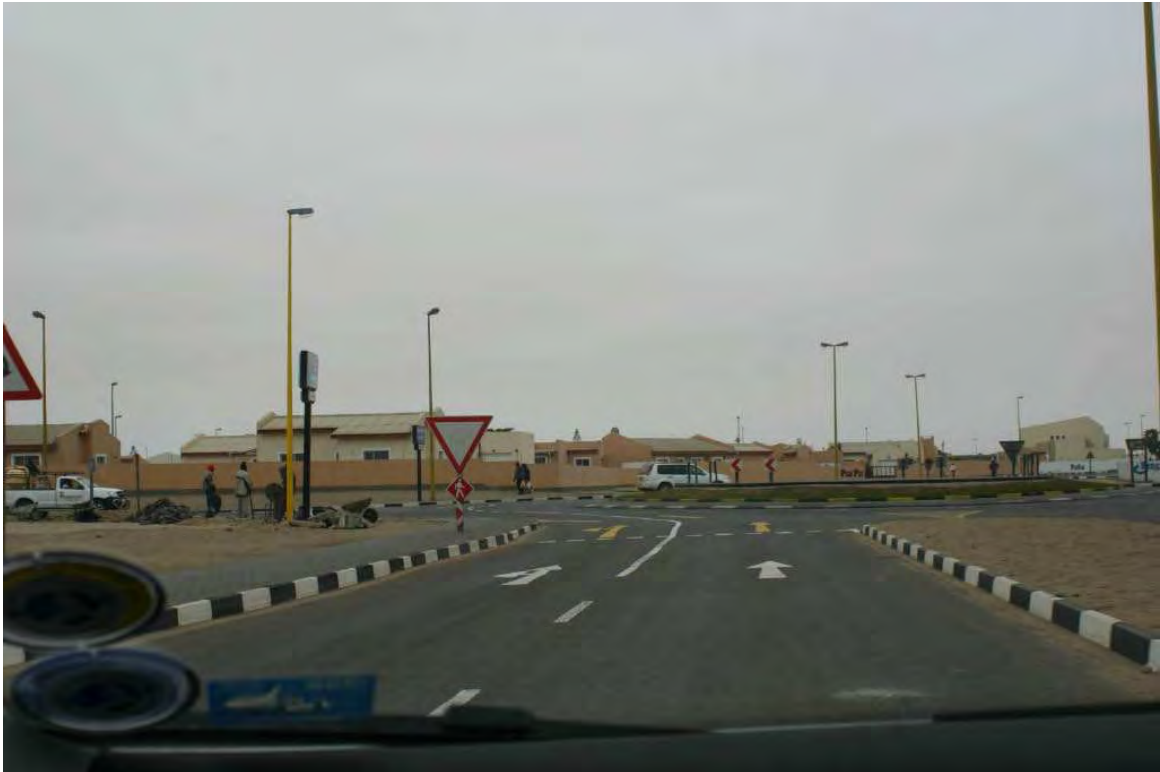
Exhibit 9 continued

Roundabout design elements: no deflection or signs on the central island.
