# **Traffic Impact Assessment Rio Tinto Rössing Uranium Limited**

## **FINAL REPORT MARCH 2010**

Road Safety Audit Report: Swakopmund to Arandis: Surfaced road B2

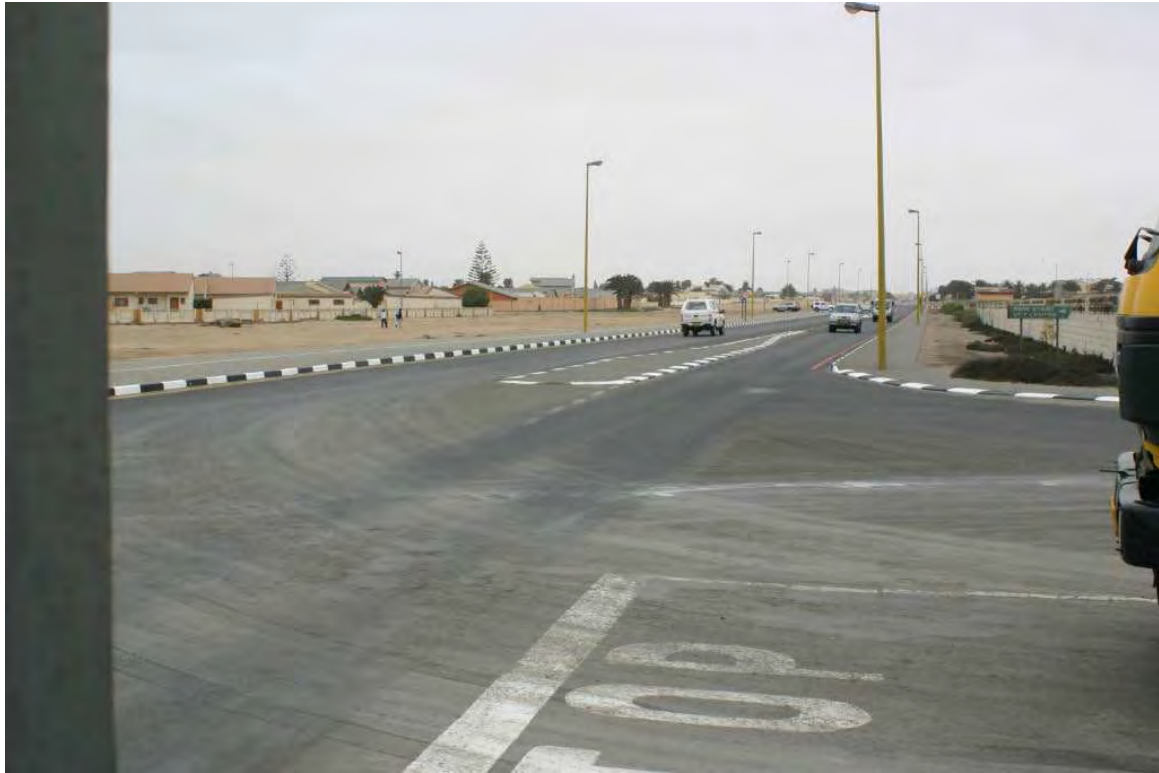
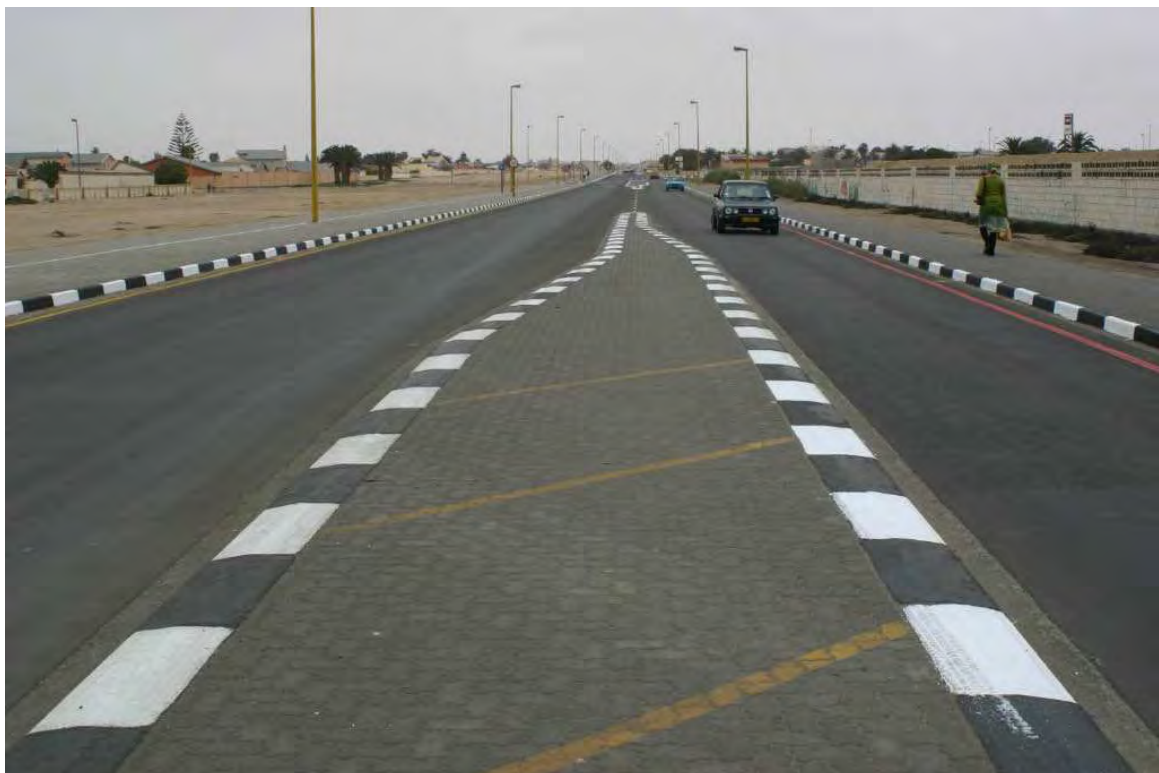
Exhibit 10.

See Exhibit 10 where small island cause lack of clearance.  
See Exhibit 13.

Small islands are difficult to see and drivers can collide into them or drive over them, thus affecting steering. Signs erected on small islands often do not have adequate clearance to the traffic flow paths.

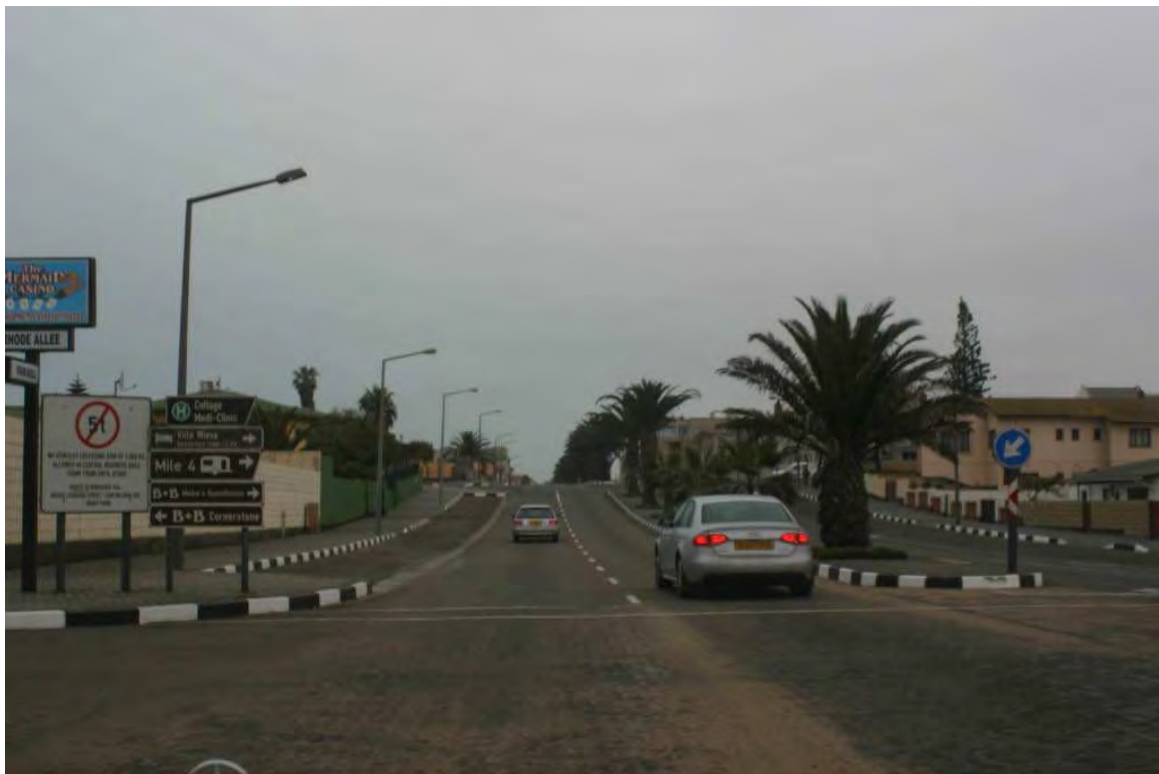
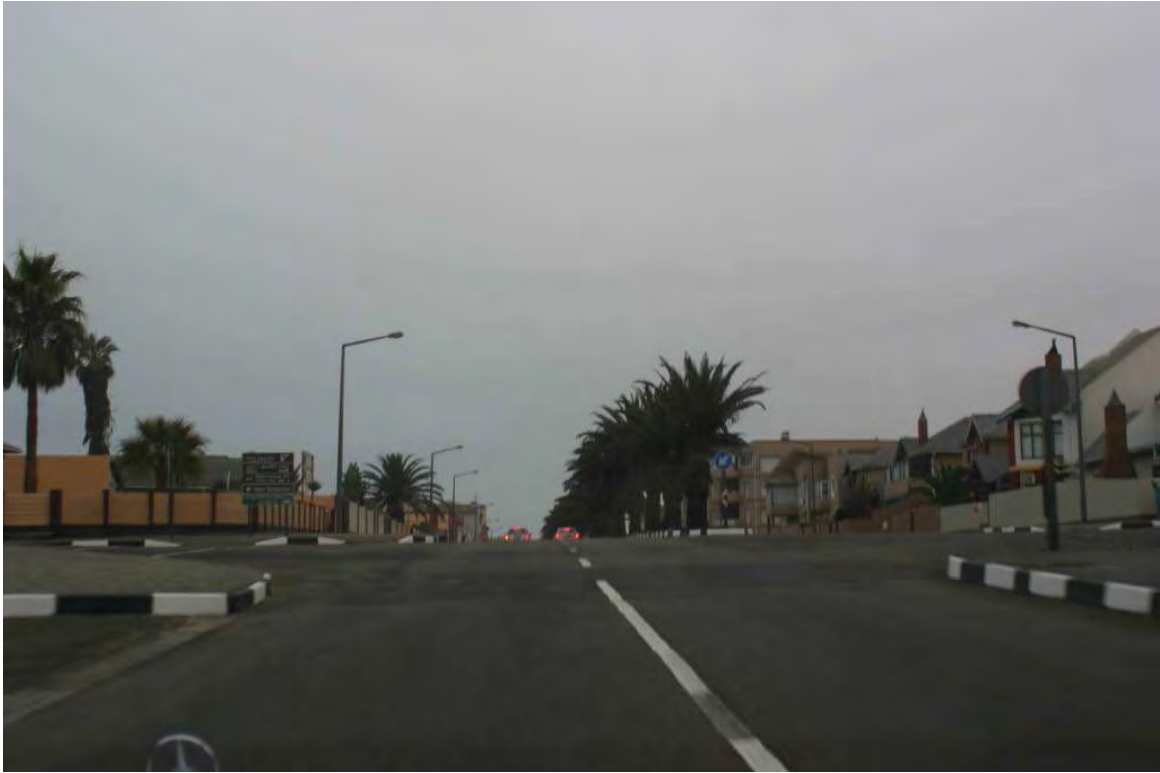
Exhibit 12.

Too many facilities signs are provided. The legibility of some destinations is questionable. Swakopmund must revised its policy for providing for facilities signs to avoid such crowding at intersections, where the driver must also attend to traffic conflicts and guidance.

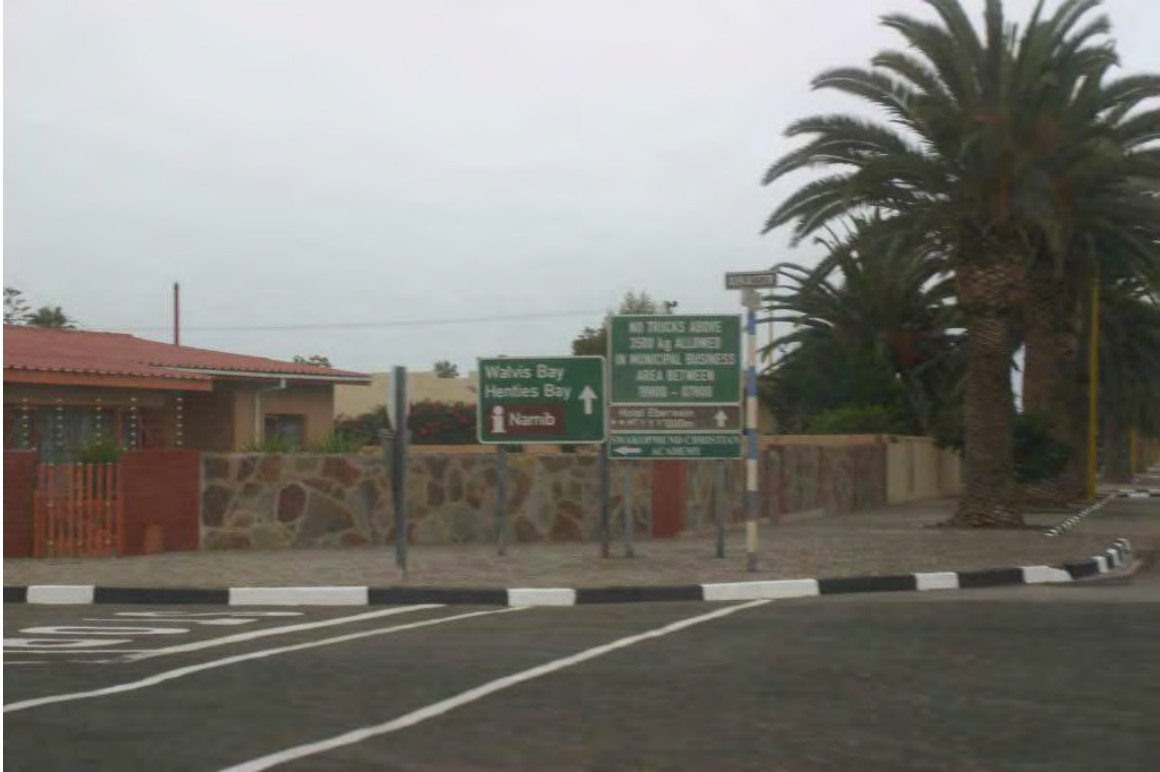
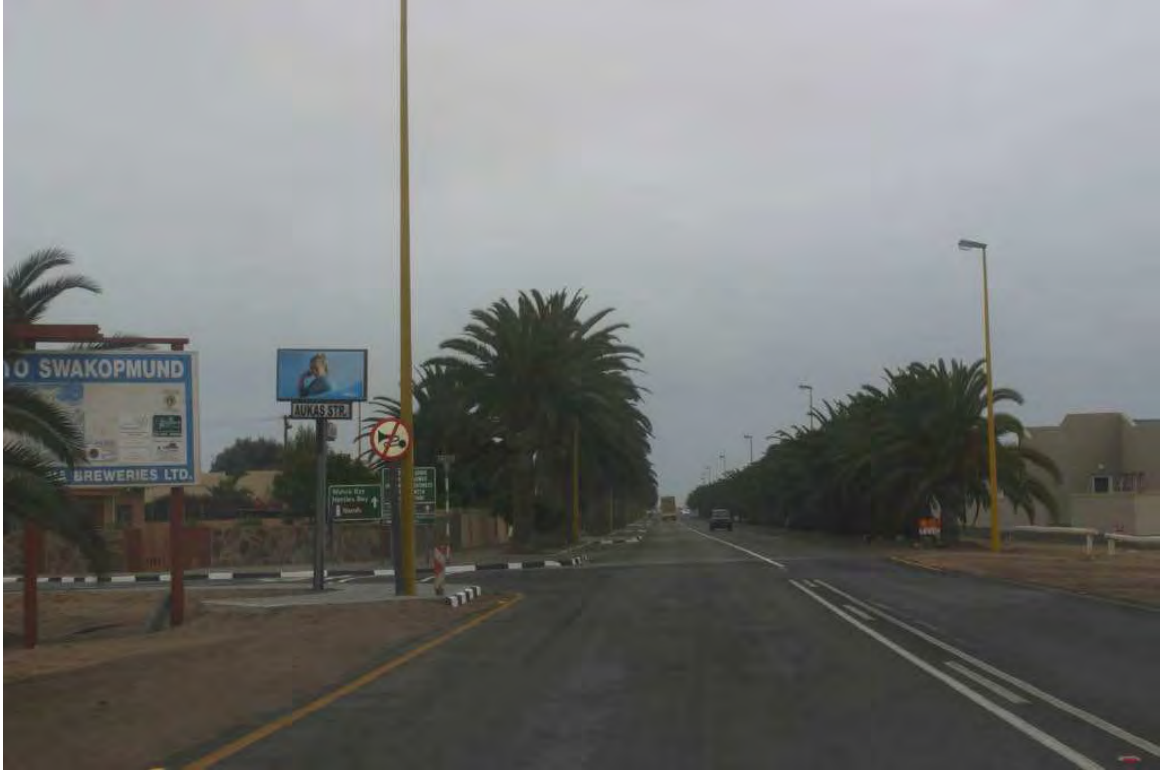
Exhibit 13.

Signs obstruction sight distance.

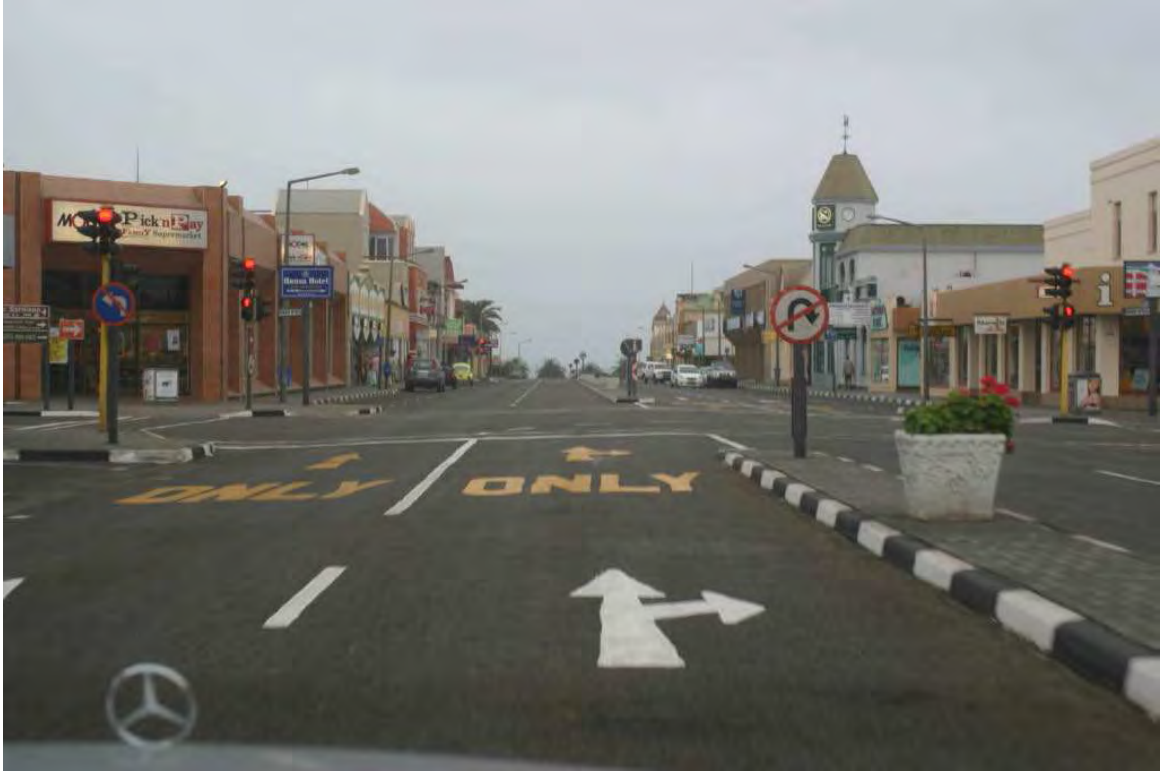
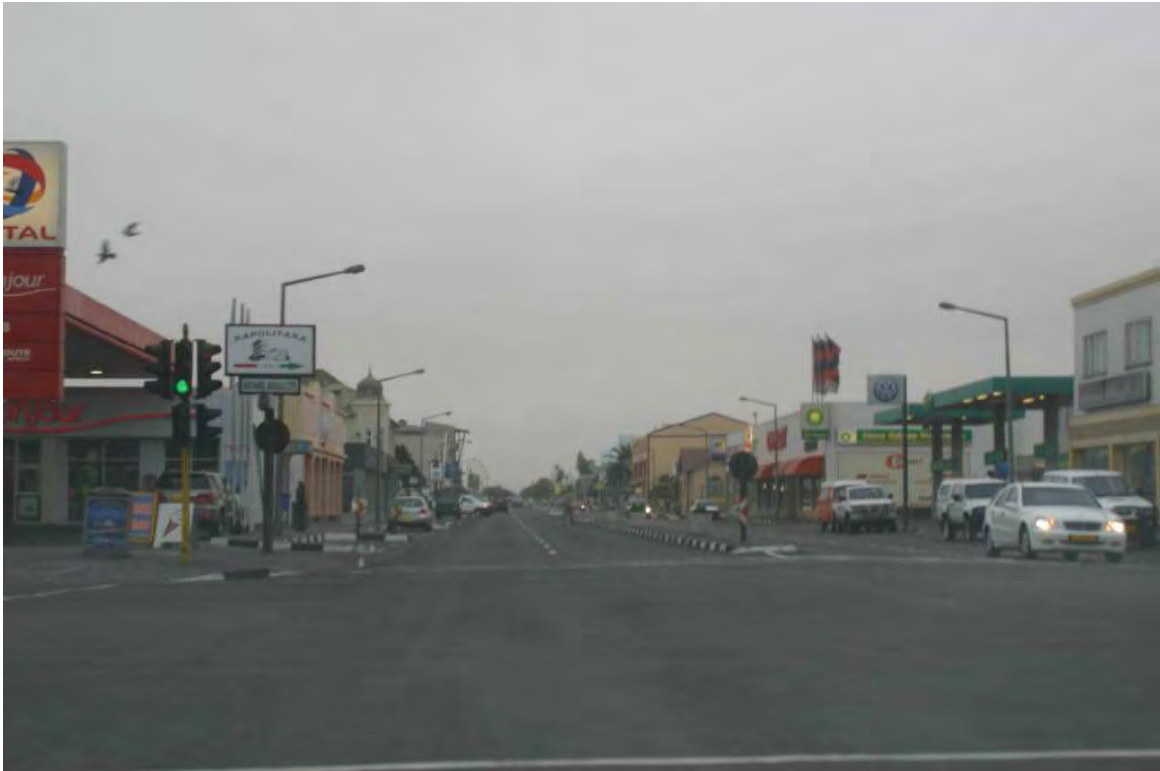
Exhibit 16 continued

Many instances were observed where the approach ends of median islands lacked hazards markers and or Keep left signs: some examples are shown in Exhibit 16.

Missing hazard markers on splitter islands: there should be markers pointing left and right.

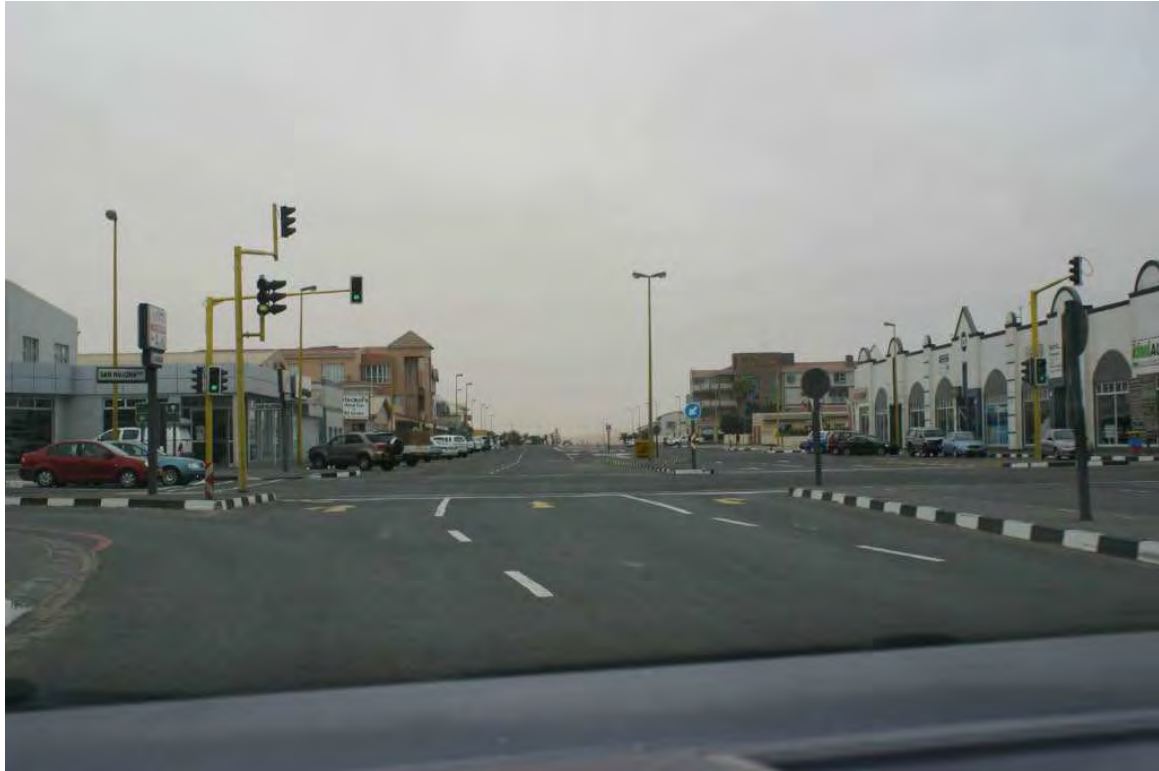
Exhibit 17.

Turning arrows at stop lines with short turn lane lengths give little guidance.  
Note the through and left arrow at the stop line while a slip lane is provided.

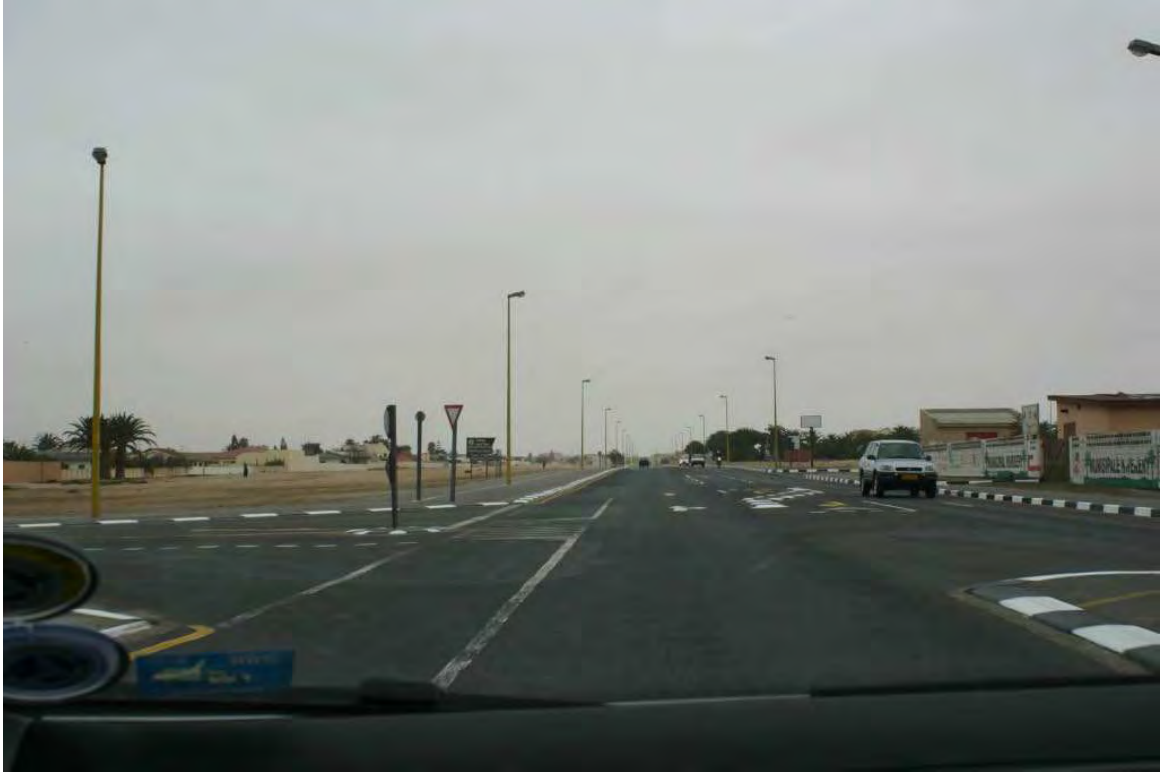
Exhibit 18.

Shoulder lane confusing.

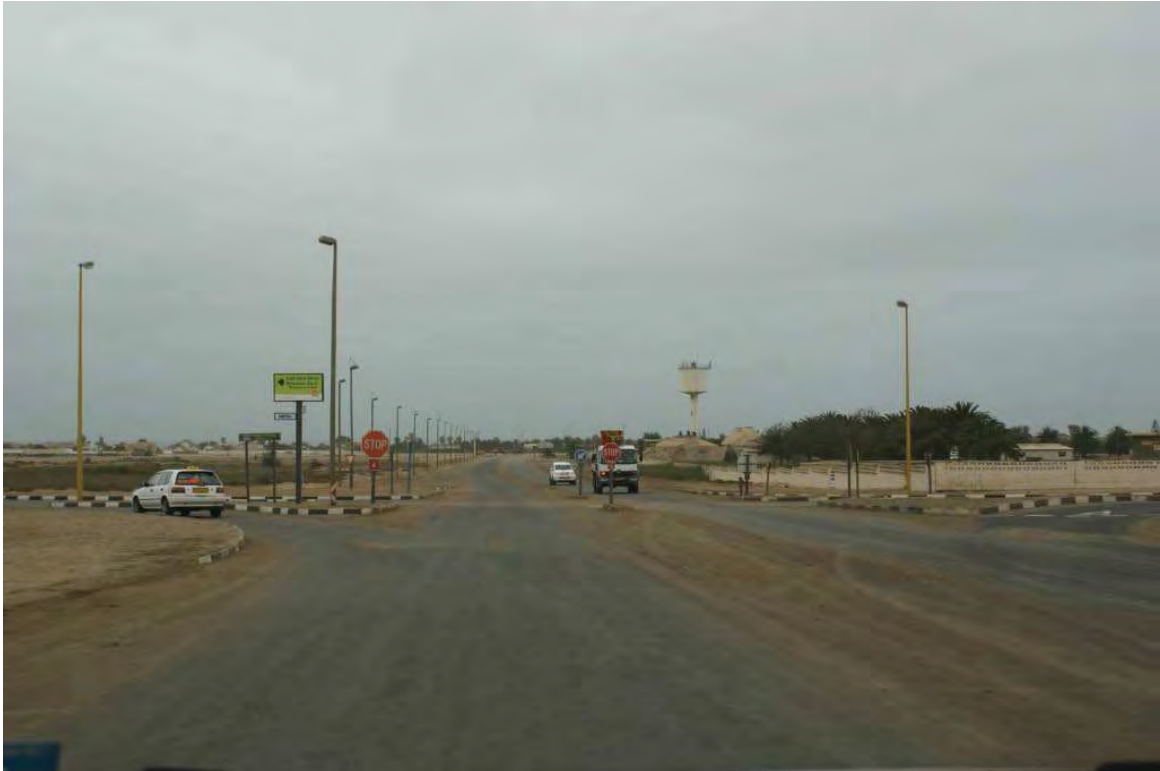
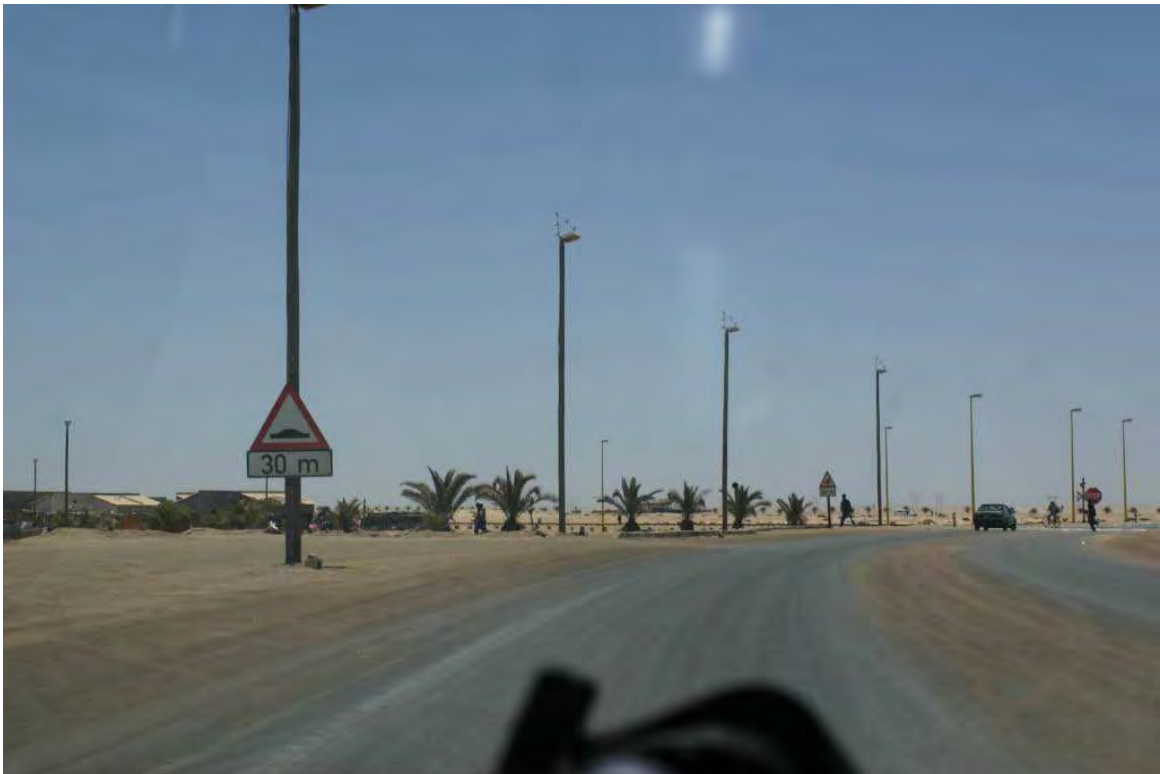
Exhibit 19.

Gravel surfaced roads has no road markings. On important routes such as Nelson Mandela Road, this increases risk for the users.

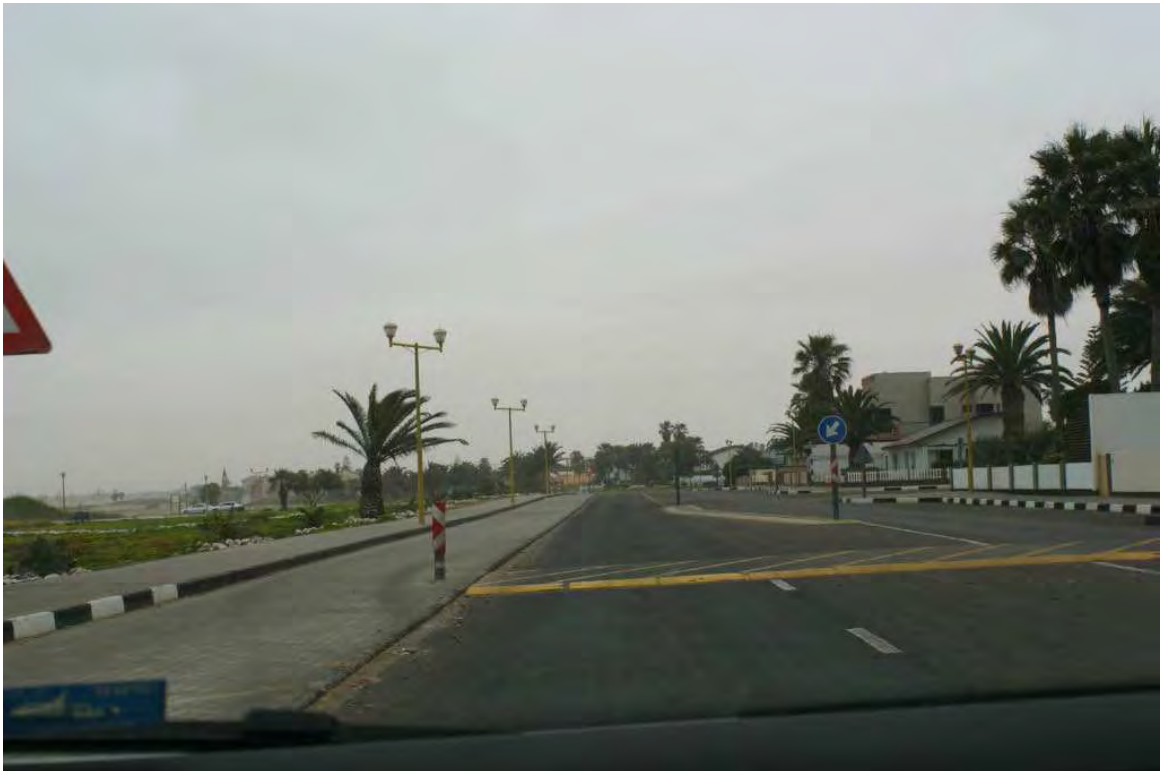
Traffic calming: note vehicles bypassing to the left.

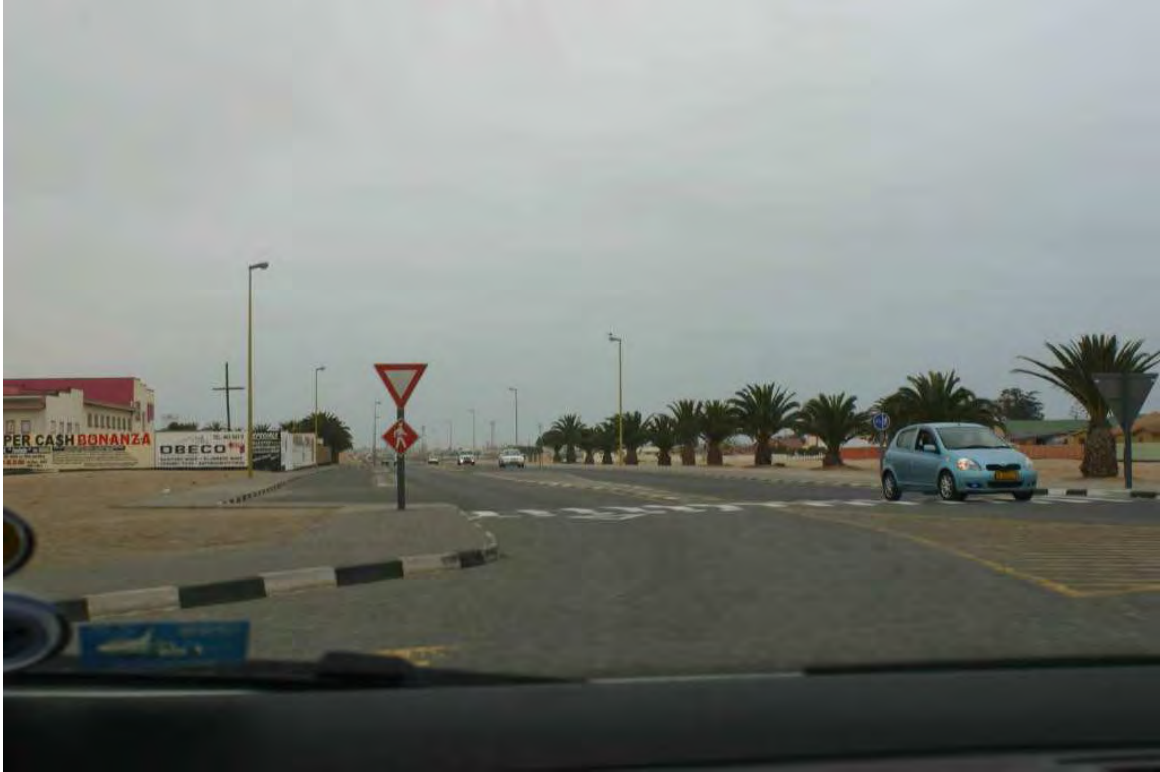
Exhibit 21.

Bus stops with street lighting.

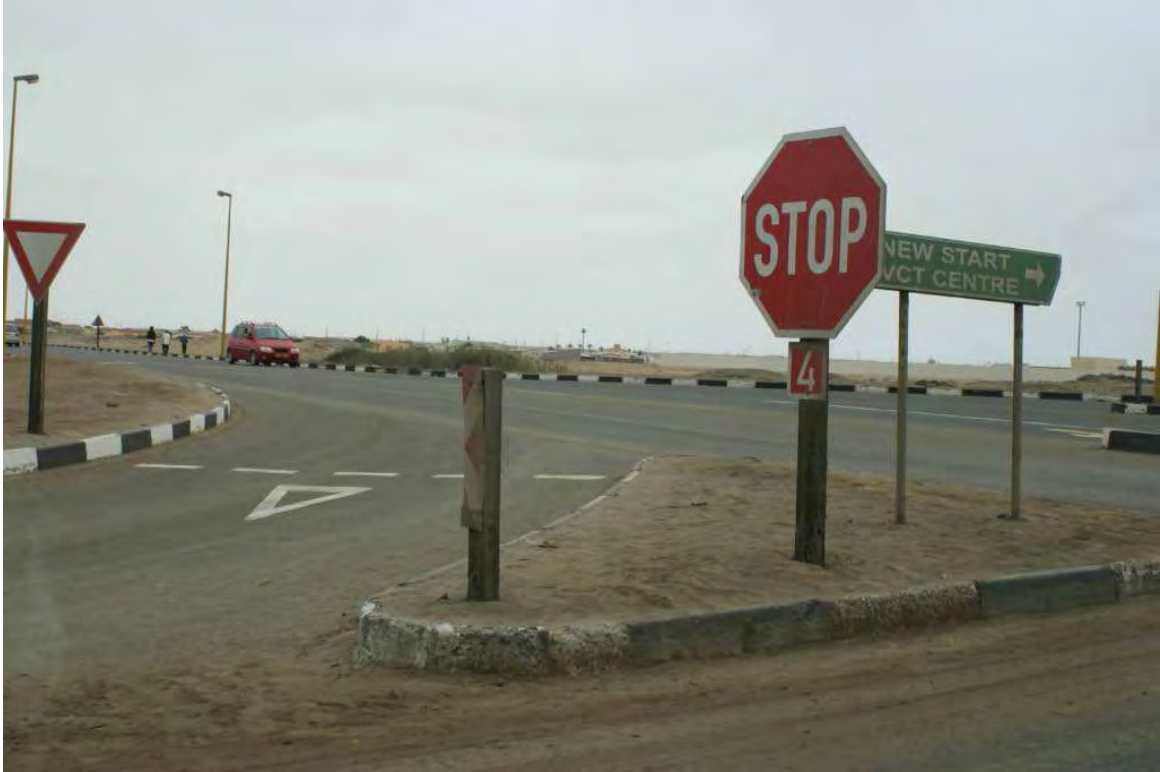
Exhibit 22.

Sand on signs and road.

- 4 The gateways to the town from Usakos and Walvisbay can be better defined to alert drivers to the change from rural to urban environment.
- 5 Sand on the road at intersections is problematic as it can cause skidding and wearing of road markings. Continuous maintenance is required.

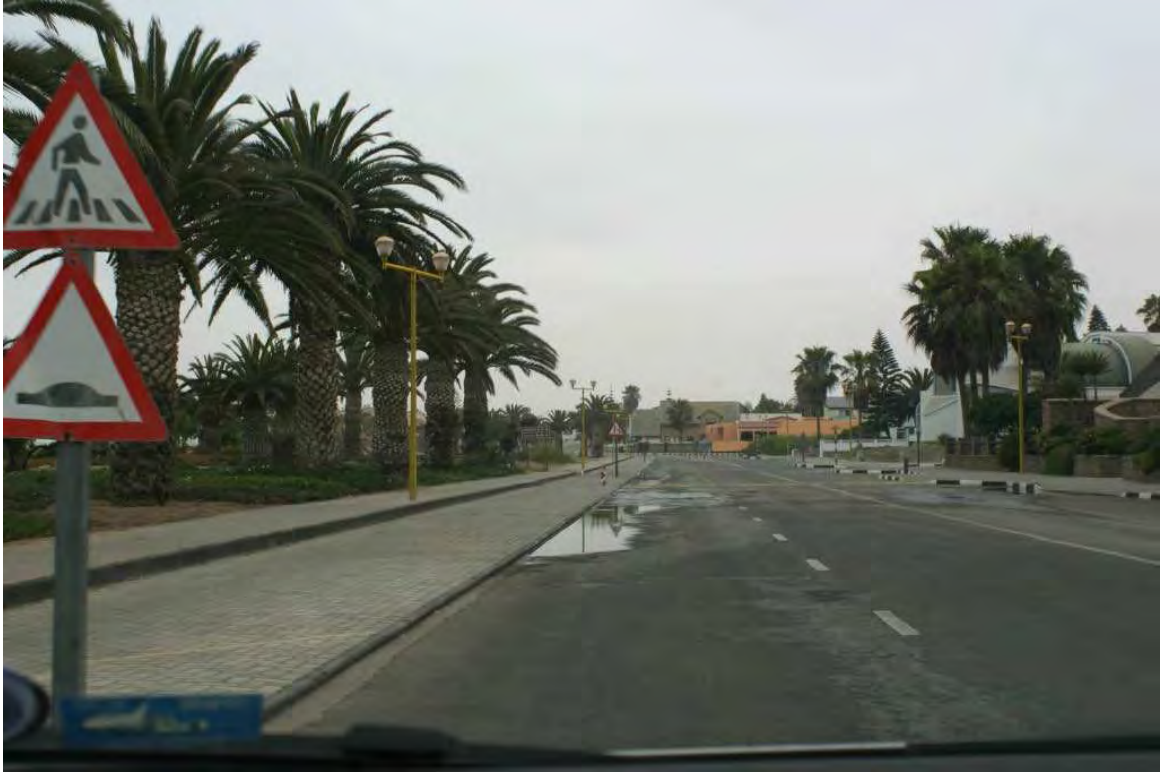
Exhibit 23.

Drainage problems.

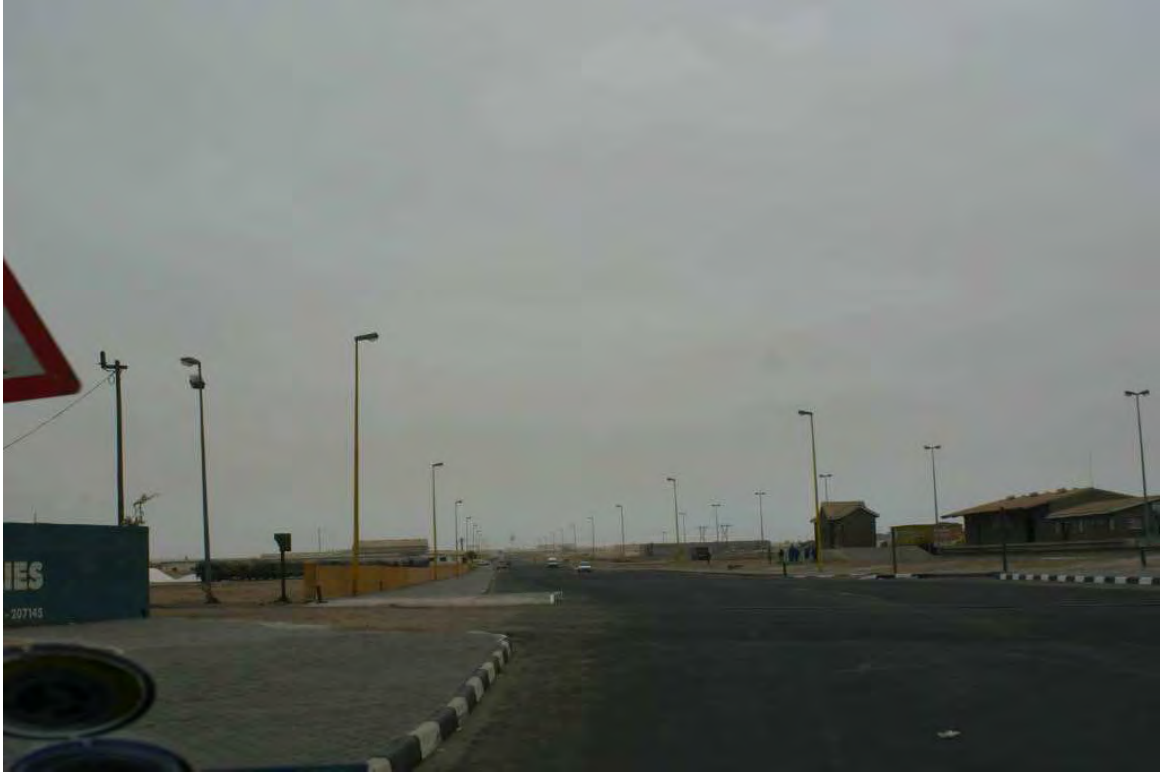
Exhibit 24.

Misaligned kerb.
